**NSWFB RETIREES FIRE NEWS  
INCIDENT REPORTS**

**4<sup>th</sup> ALARM GIRRAWEEEN FACTORY COMPLEX  
FIRE**

### **Incident Summary:**

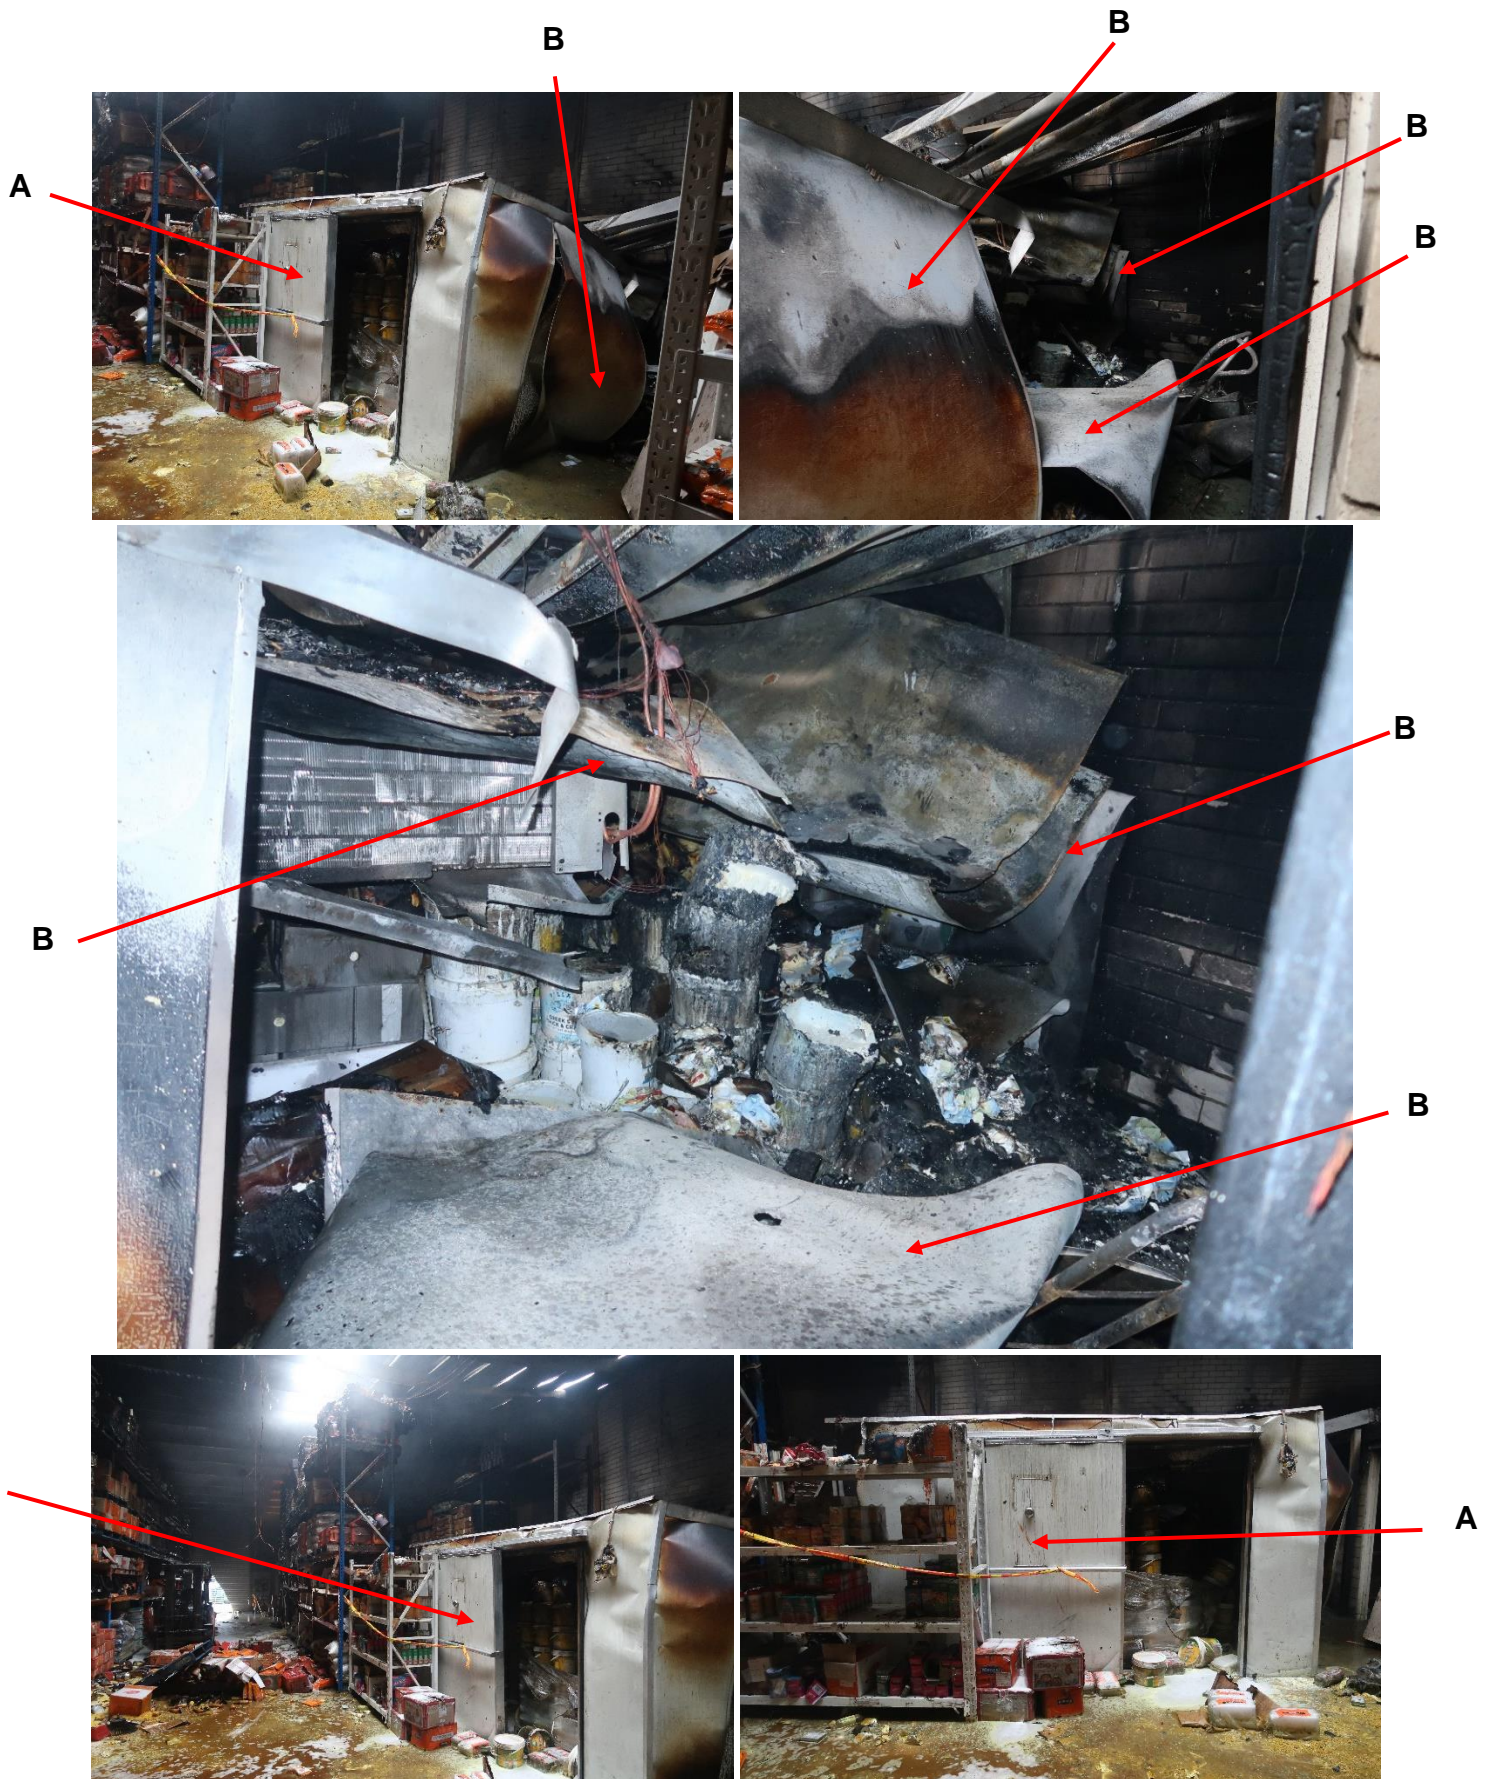
There are indications the fire initially involved electrical equipment that was part of the refrigeration system for one of the factory units two cool rooms, which were formed from expanded polystyrene insulated sandwich panels. The insulated sandwich panels at the front of the cool room (A) acted as a barrier, preventing thermal imaging cameras from detecting heat, allowing the fire to remain concealed at the rear of the cool room. Panel Delamination (B) occurred, allowing the expanded polystyrene panel cores to become involved in fire, producing extreme fire conditions.

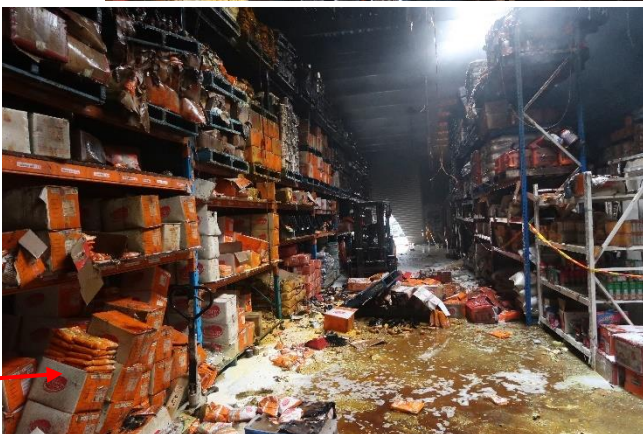
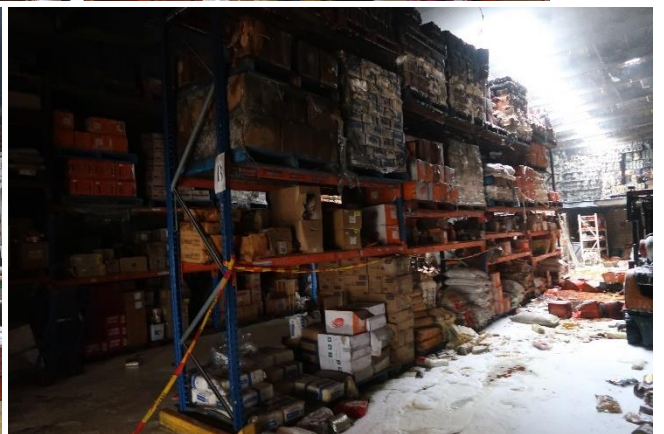
The Main Fire Occupancy contained elevated pallet racking, with stock stored almost to roof level, creating a number of hazardous conditions for firefighters. Fire burning within the stock piles caused the material to become unstable, resulting in collapse occurring **A** or material becoming unstable and likely to collapse **B**. Water from firefighting streams can dislodge stored products, weaken the base of stored materials or increase the weight of stored materials, either causing collapse or increasing collapse potential. Firefighters established internal exclusion zones **C** within the main fire occupancy due to collapse risks. A further problem encountered by firefighters were pockets of fire located in materials behind stock located on racking, preventing firefighting streams from being able to access the fire. It is important to constantly monitor for signs of internal collapse when working inside structures where elevated racking is present.

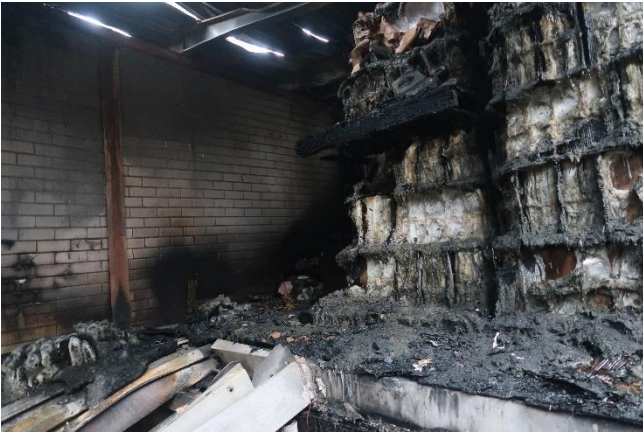
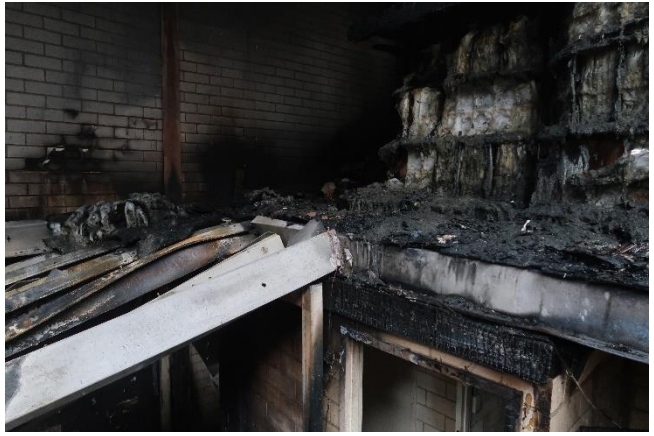
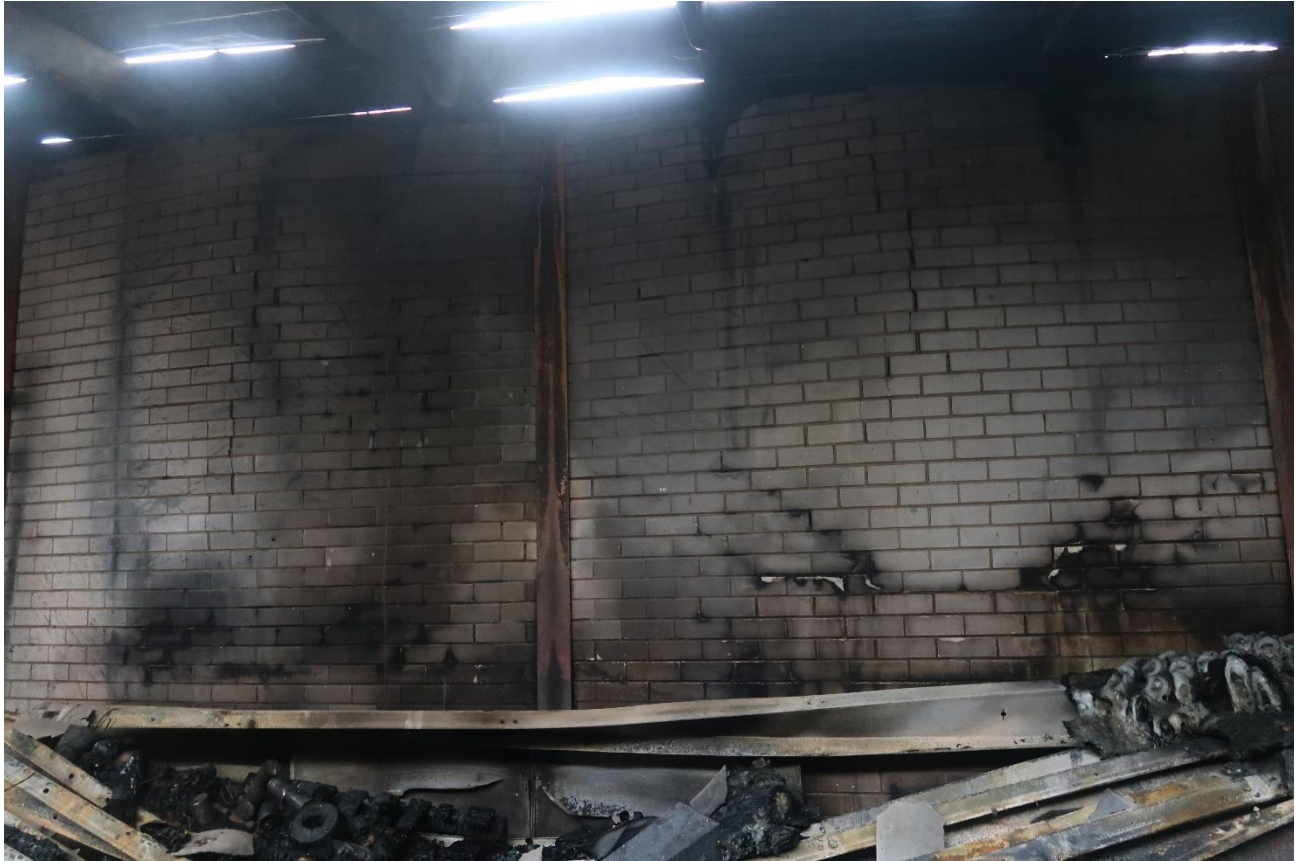
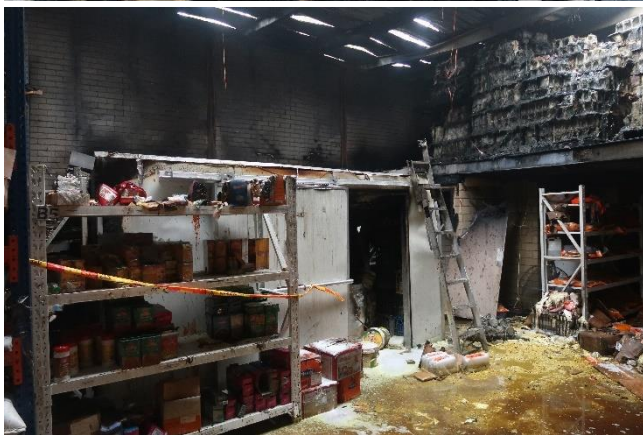
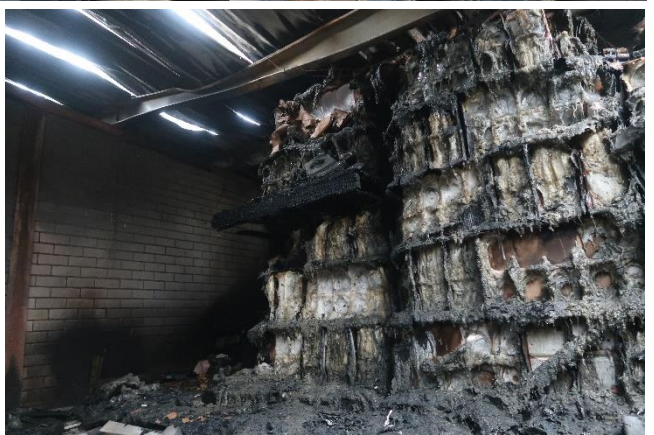
Firefighters observed an area of severe wall buckling and cracking, involving the brick separation wall between Units 4 and 5. The area of deformation extended for a distance of approximately eight metres from the Charlie wall. Collapse exclusion zones were established either side of the wall in Units 4 and 5.

Intense heat from the burning expanded polystyrene within the insulated sandwich panels caused expansion of the structural steel building frame, resulting in movement and subsequent cracking and bowing of the brick wall (evident in the middle photograph) tied into the steel frame. The wall provided separation between Factory Units 4 and 5. The I.C. withdrew crews and conducted a defensive attack when fire conditions worsened; a very wise decision due to the strong possibility of internal wall collapse.

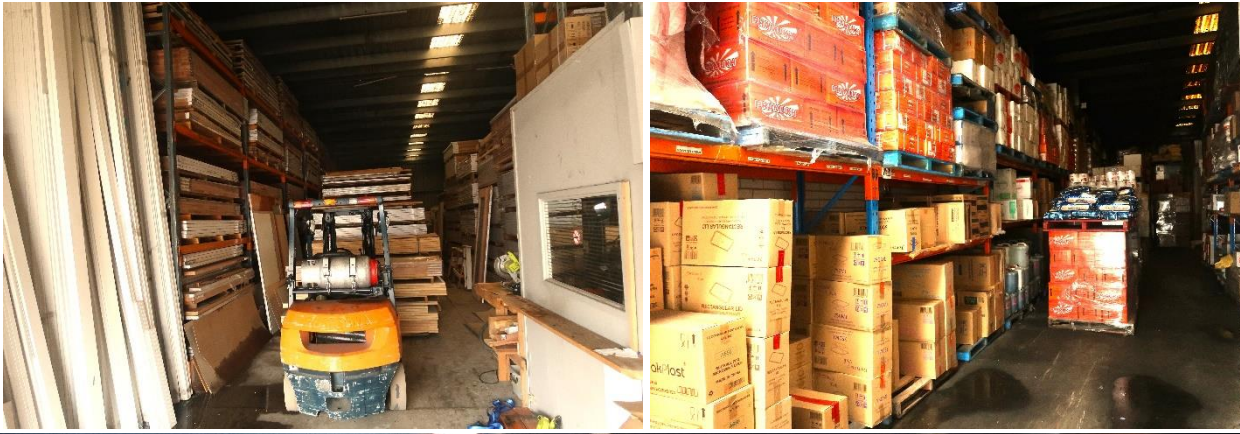
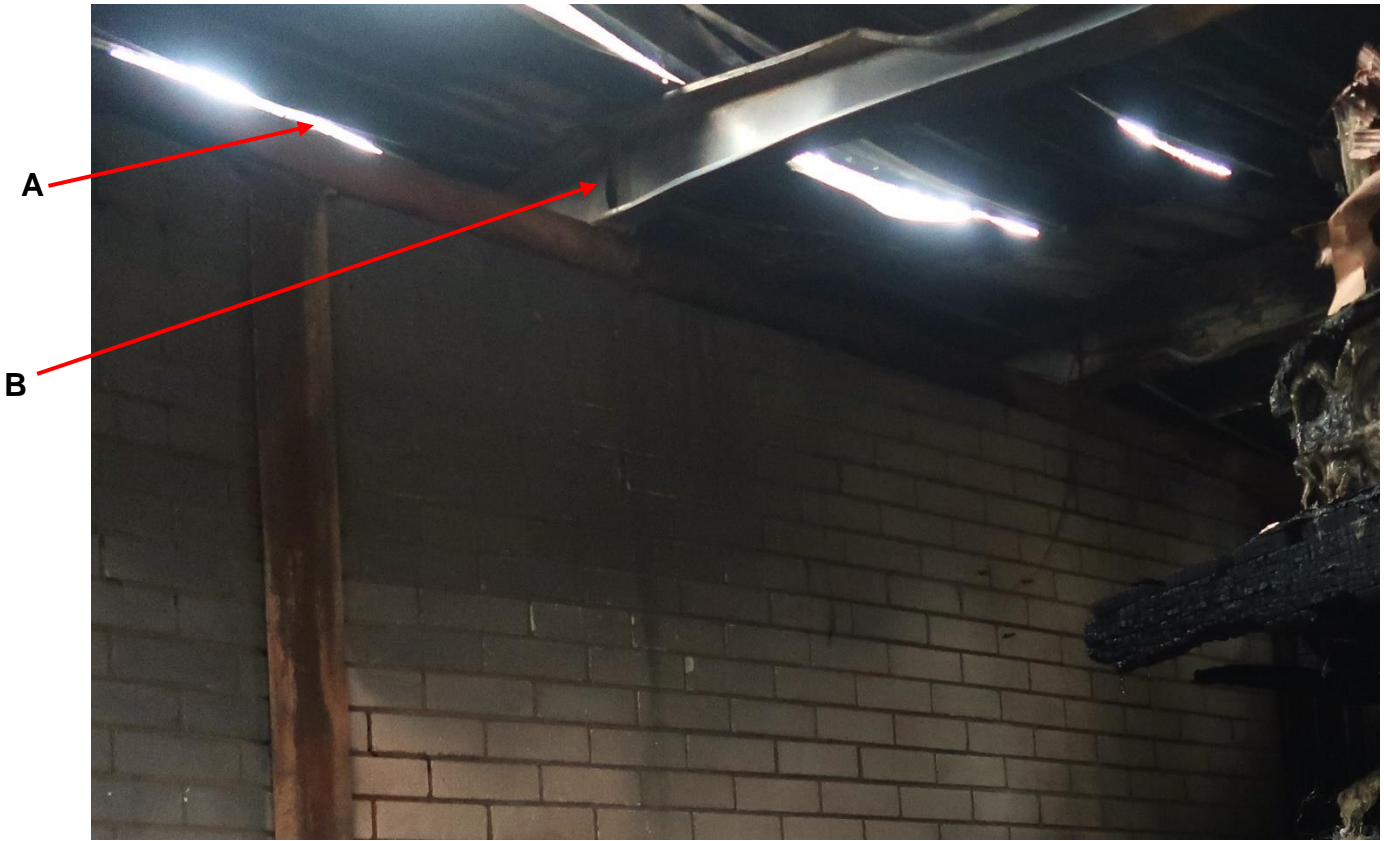
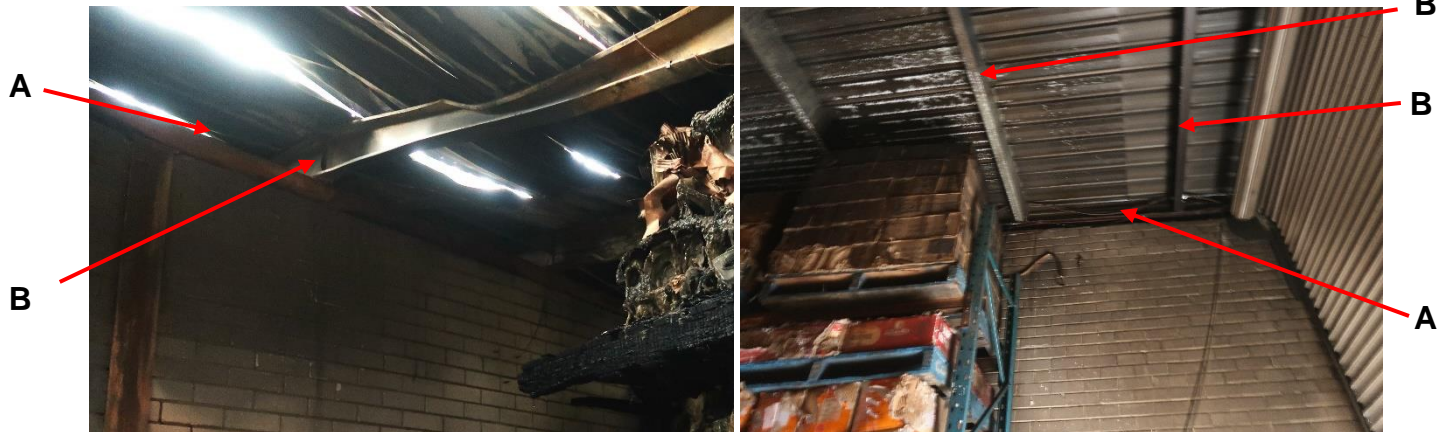
Factory units were separated by double brick walls 120 mm wide. The separation walls were tied into the structural steel frame. A 12 cm gap existed between the top of the wall and the roof line due to the presence of the roof purlins; therefore, **full separation did not exist between factory units and the openings at the top of the walls potentially allowed travel of smoke, fire and fire gases between units.** Exposure Bravo (unit 4) was a food storage warehouse. Exposure Delta was a joinery containing a large quantity of stored timber.

A gap of 12 cm (A) existed between the top of the brick wall separating factory units and the roof line due to the presence of steel roof purlins (B), allowing fire, superheated gases and smoke to spread from the factory unit of origin to adjoining units. Firefighters successfully fire from spreading through these openings with 38 mm protective streams, resulting in the most severely threatened Exposure Bravo 1 (top left) and Delta 1 (top right) being saved. It is sometimes advantageous to gain entry to a non-involved unit to determine if openings exist near roof level that could facilitate fire spread.

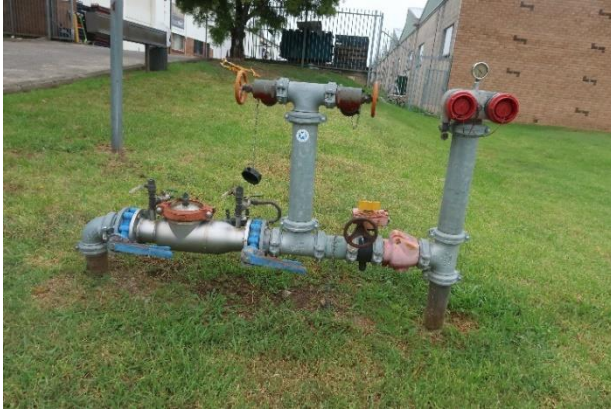
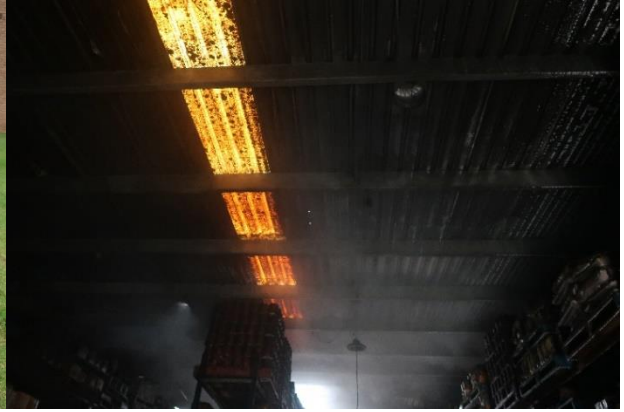
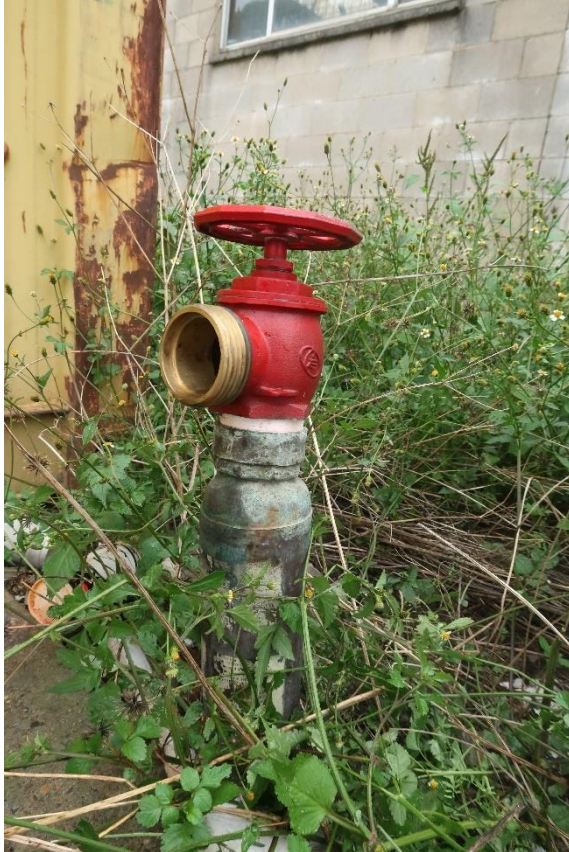
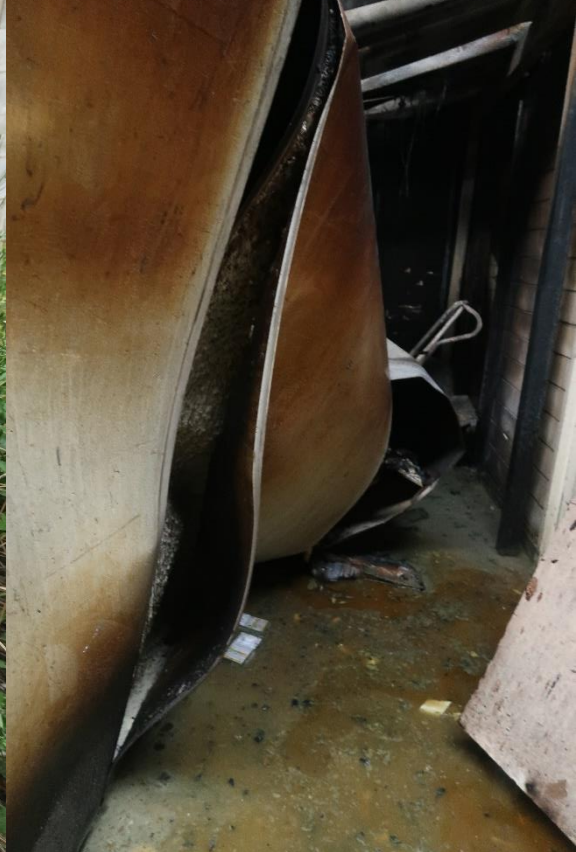
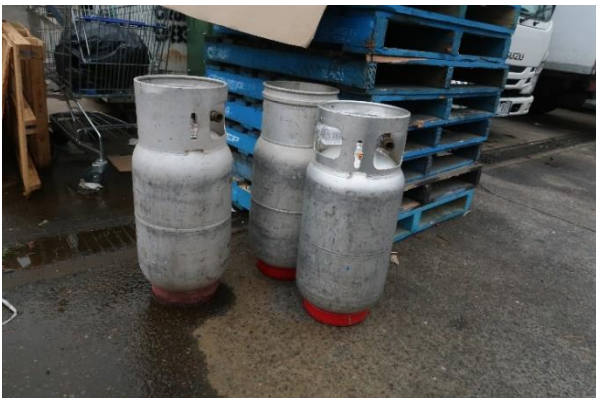
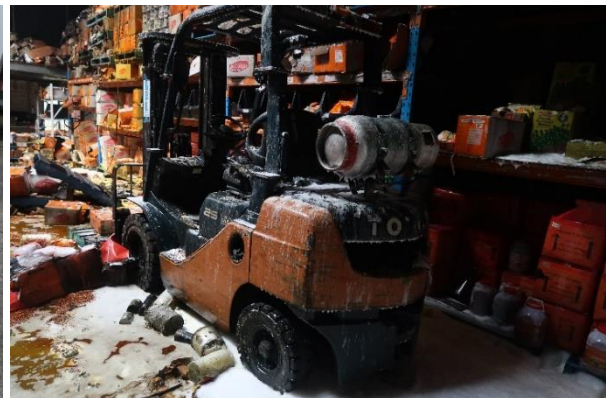
One CO<sub>2</sub> extinguisher was located against the Delta wall 2.0 metres from the roller door within the MFO. The site was fitted with an installed 100 mm hydrant system, originally installed as an Ordinance 70 system and upgraded to an AS2419.1 system (Originally consisting of two 65 mm booster inlets, these were replaced with two inlets and two feed hydrants at the booster). The hydrant system consisted of one single headed attack hydrant located 72 metres from the entrance to the site. The hydrant was located in close proximity to a shipping container amongst overgrown grass and bushes, surrounded by stored materials and was very difficult to identify. **There was no signage at the Fire Brigade booster assembly. There was no block plan at the booster assembly identifying the location of the fire main and hydrants.** Consequently, it was difficult for firefighters to identify the location of attack hydrants.

The site was fitted with an AS 2419.1 Fire Brigade booster system (top right). Lack of a block plan prevented from identifying critical information including the location of the site fire main and attack hydrants. The one attack hydrant found at the site (middle left) was surrounded by bushes and stored materials and was difficult to locate. Polycarbonate roof panels failed above the fire area, allowing heat and smoke to vent and providing an avenue for the aerial steam to attack the fire. Delaminated insulated sandwich panels exposed expanded polystyrene to the fire, creating extreme fire conditions (middle right). Firefighters removed a number of LPG cylinders used to power forklifts units in the fire's path (lower).

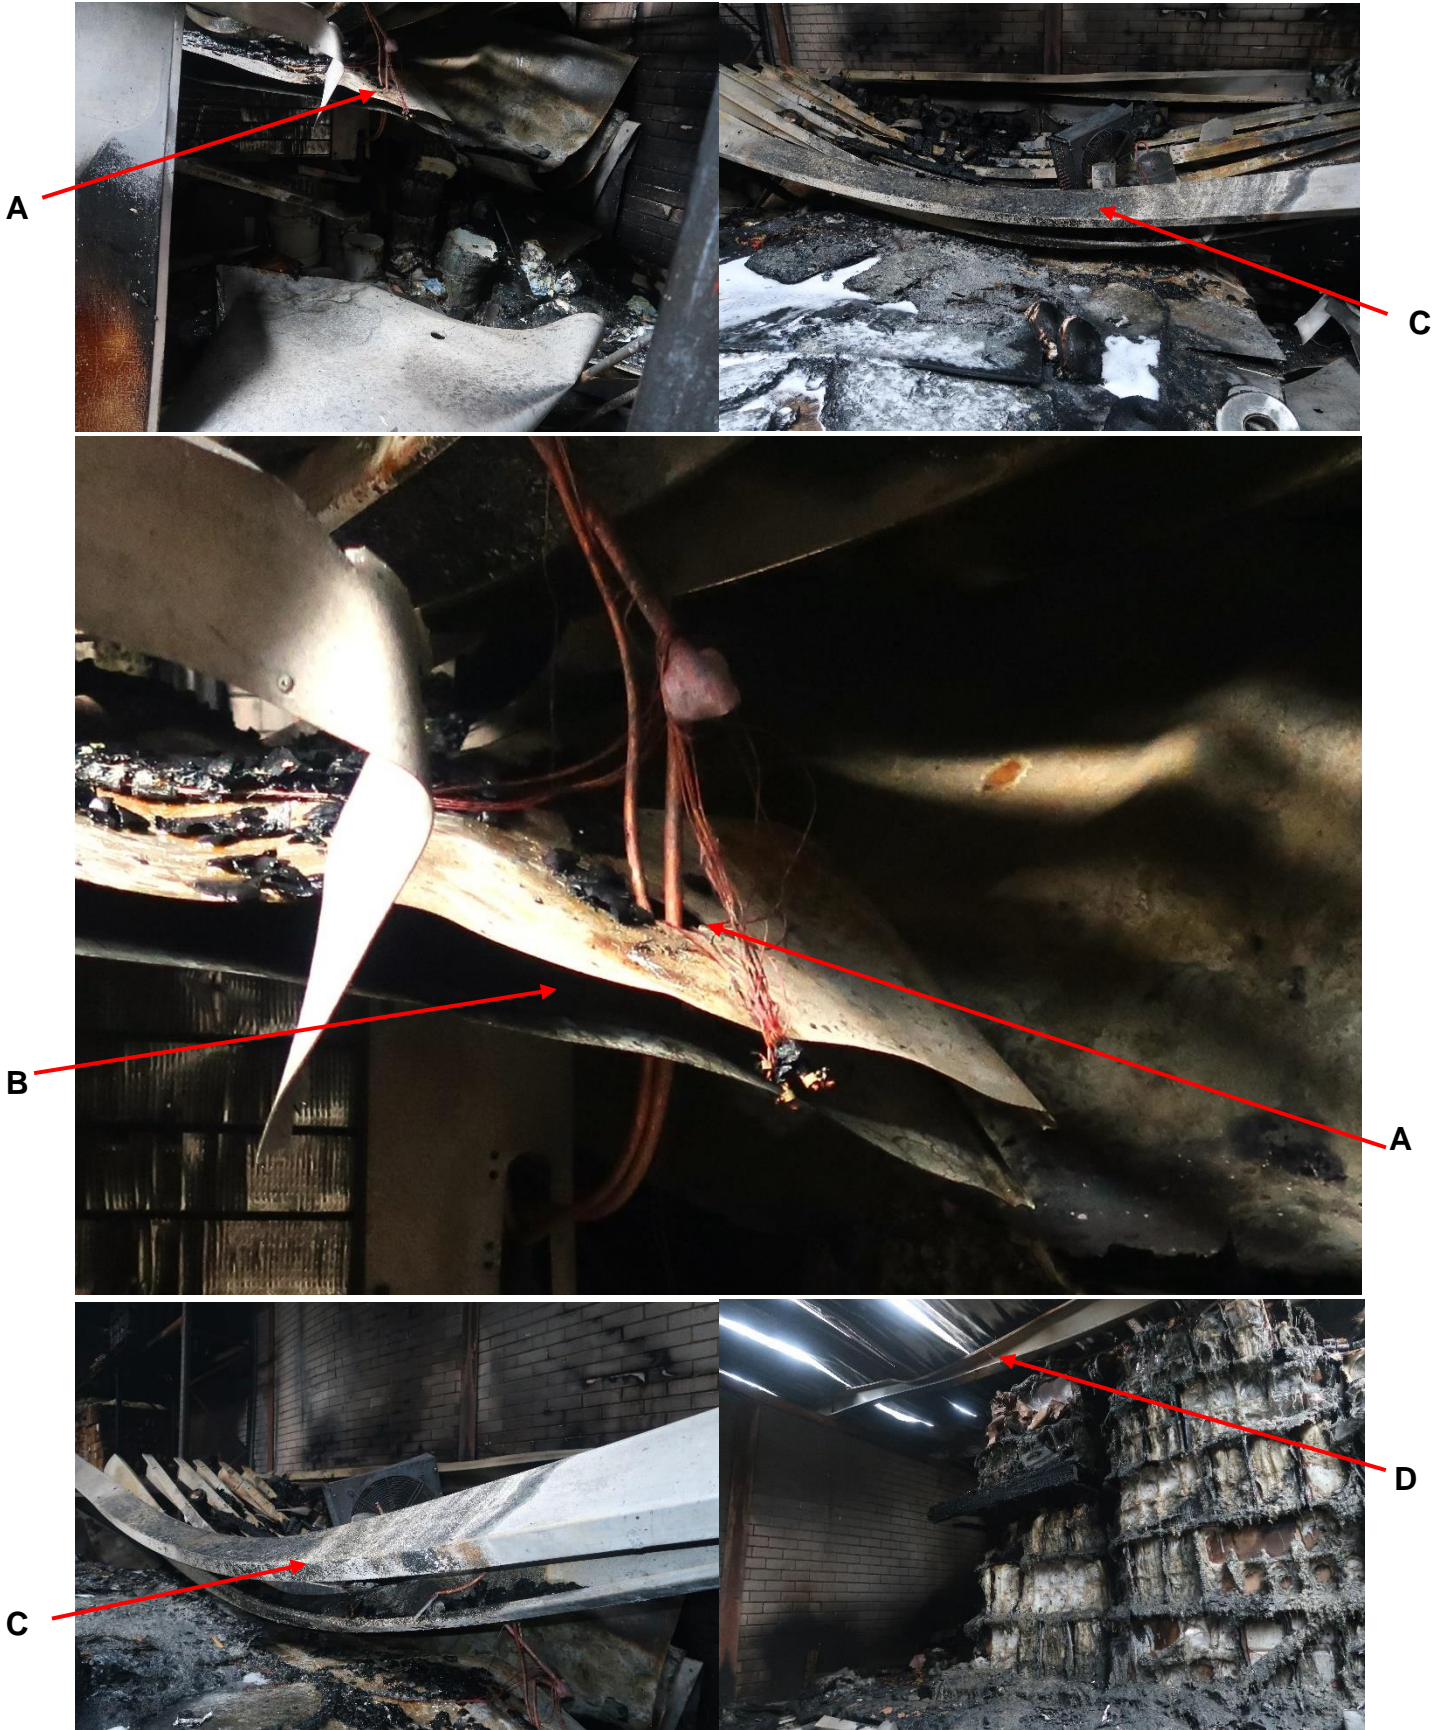
3. Post fire examination of the cool room near the Bravo/Charlie corner of Factory Unit 5 identified an event known as “**panel delamination**” had occurred. Such an event is extremely dangerous. Panel delamination is characterised by the following events:

Breaches (**A**) in the outer facings of the insulated sandwich panels allowed fire to impact the expanded polystyrene core (**B**) of the ISPs, resulting in extreme fire behaviour occurring, including temperatures that exceeded 1,000°C resulting in deformation of structural (**C**) and non-structural (**D**) steel. No where else was fire damage as severe as the area around the ISPs. The ISP Code of Practice recommends that openings in ISPs for the passage of services be sealed to prevent exposure of the core to fire.

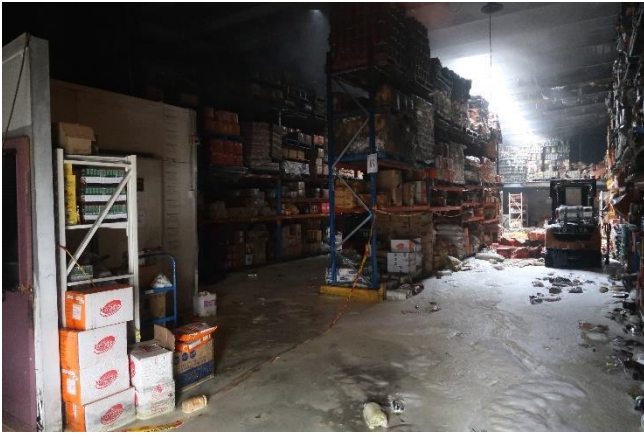
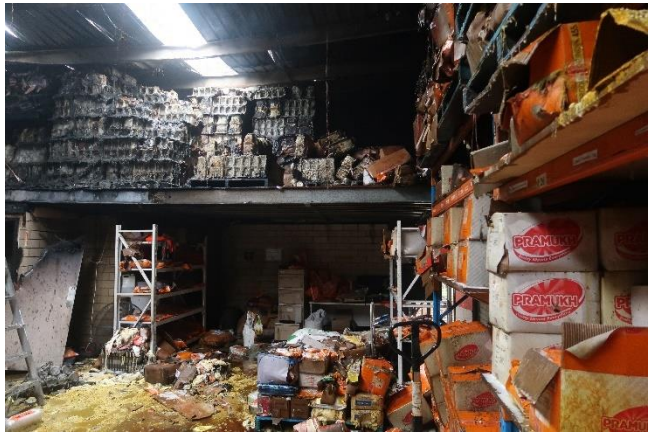
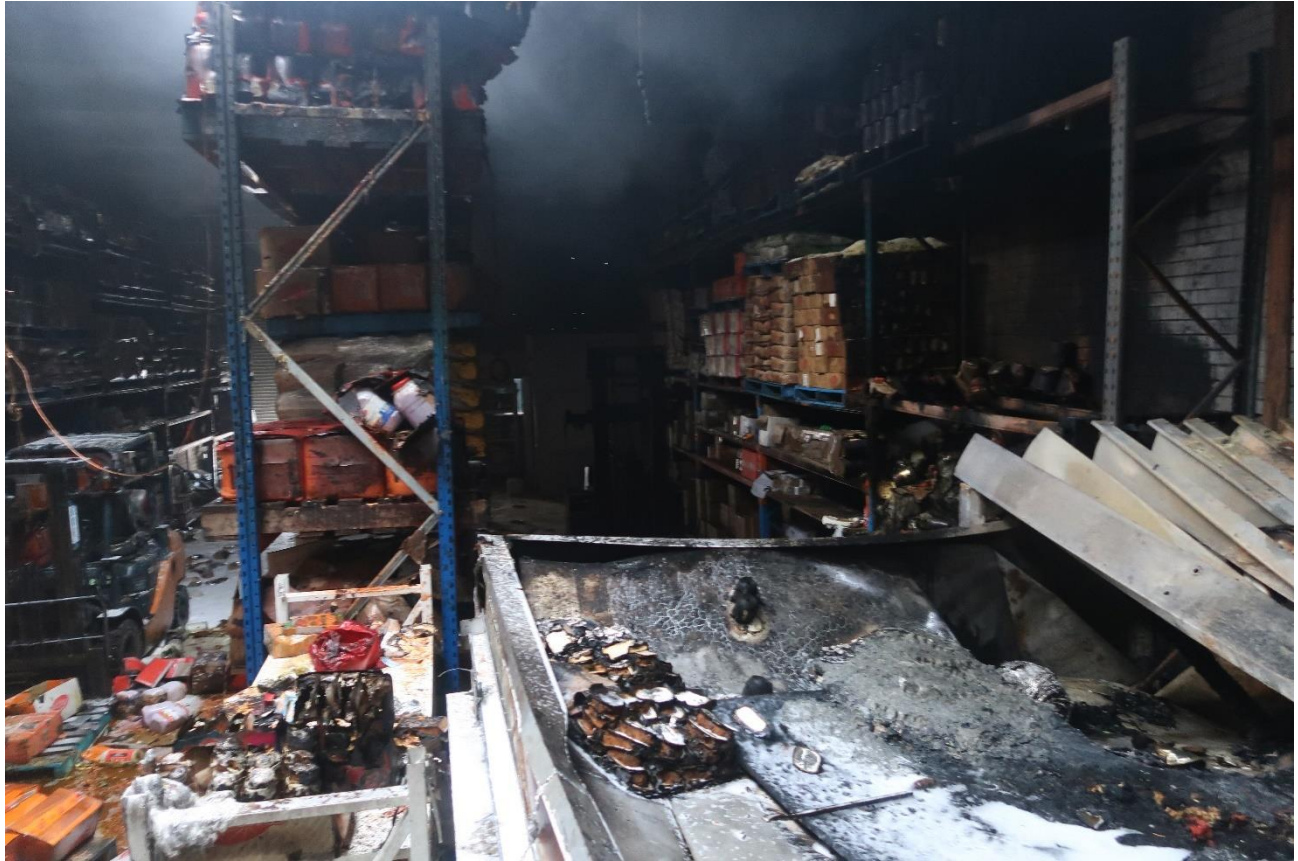
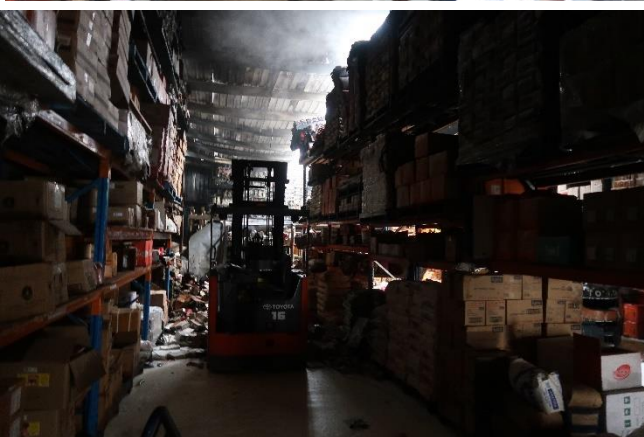
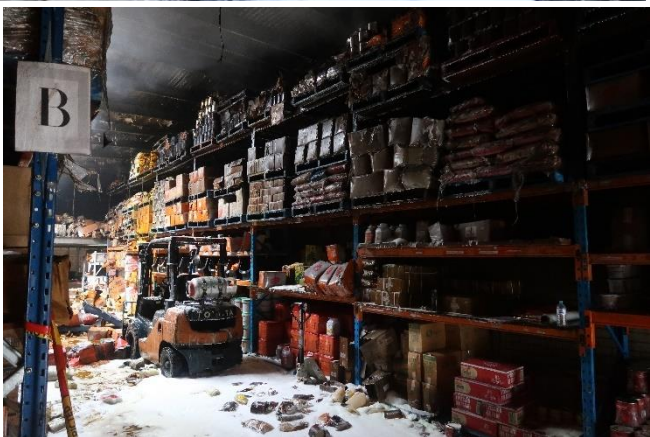
One of the problems for firefighters associated with stock burning on pallet racking were areas of fire burning behind elevated stock, preventing fire attack streams from reaching areas of fire. Ultimately, these fires could only be extinguished through the slow and careful removal of stored products allowing firefighters to access areas of fire.

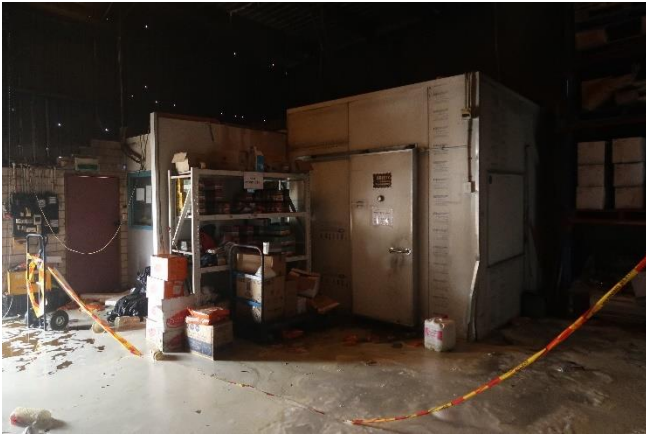
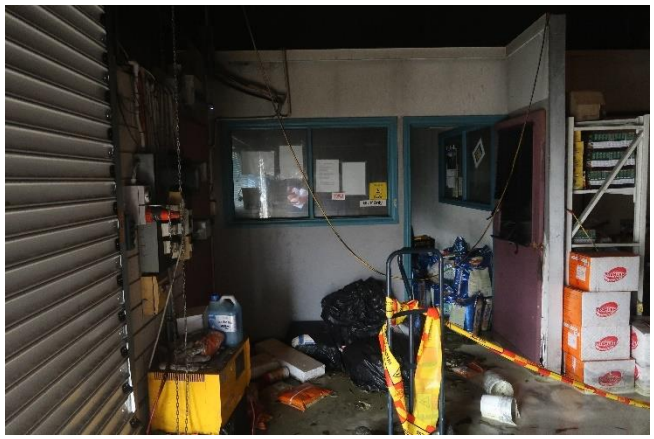
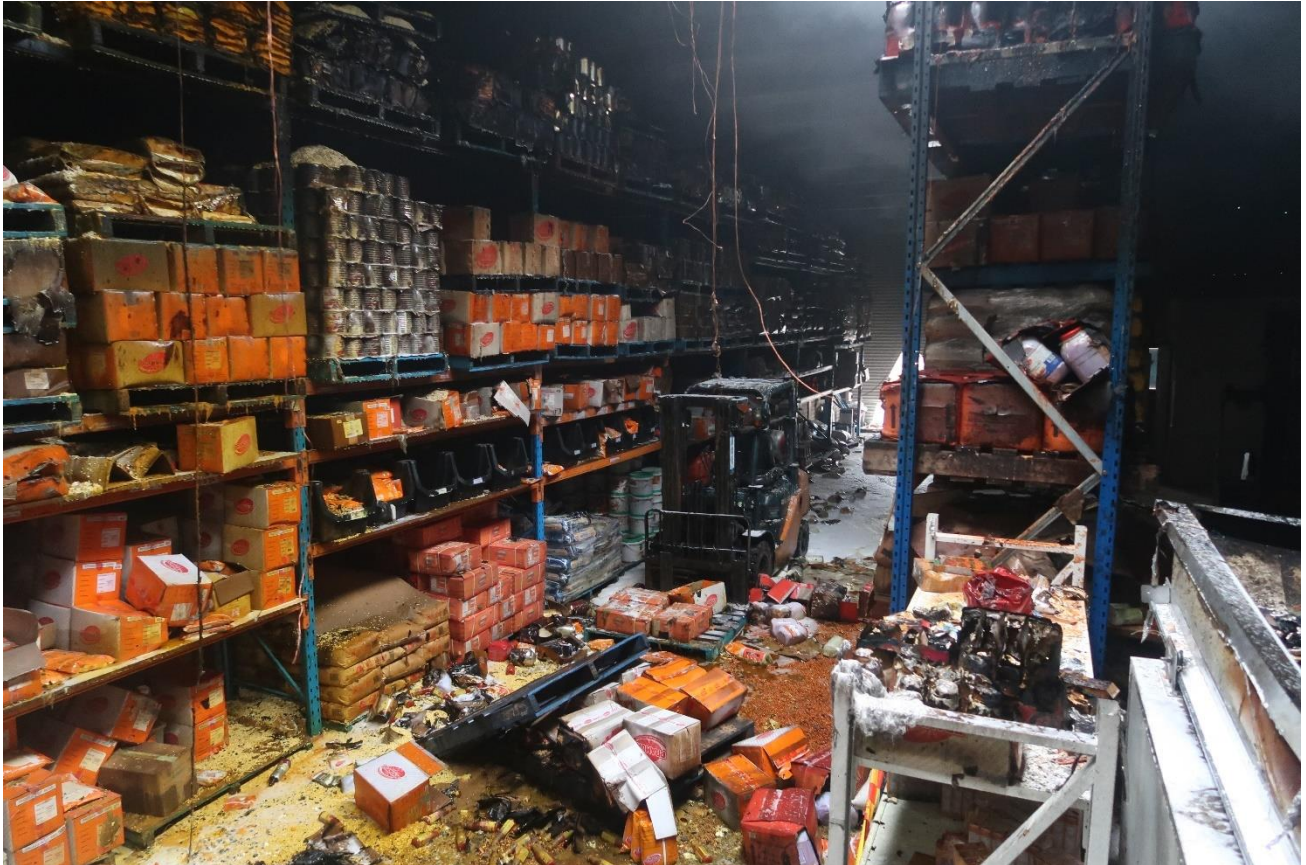
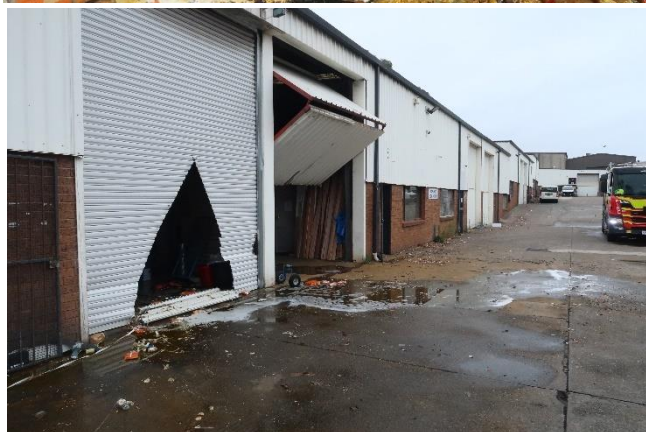
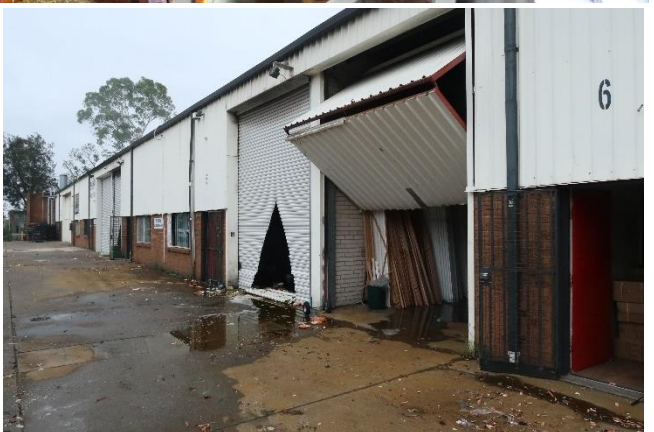
The main fire occupancy contained a second cool room (top left) and an office (top right). A combination of fire activity and hose streams resulted in some elevated stock becoming unstable and collapsing (middle). The factory units were fitted with two types of doors; steel roller shutter doors (lower left) and steel horizontal bi-folding doors (lower right).
