NSWFB RETIREES FIRE NEWS INCIDENT REPORTS

4th ALARM CAMPBELLTOWN SERVICE STATION FIRE

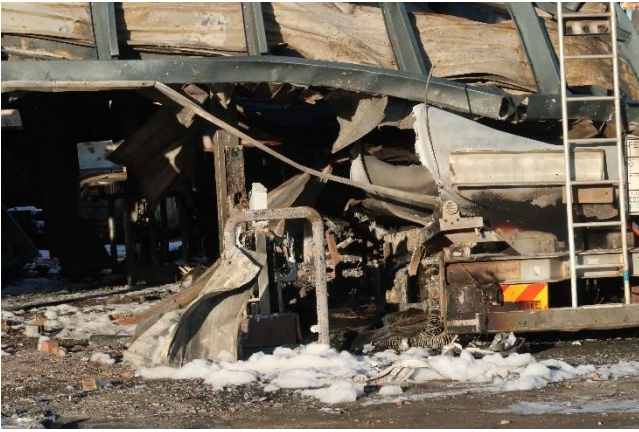
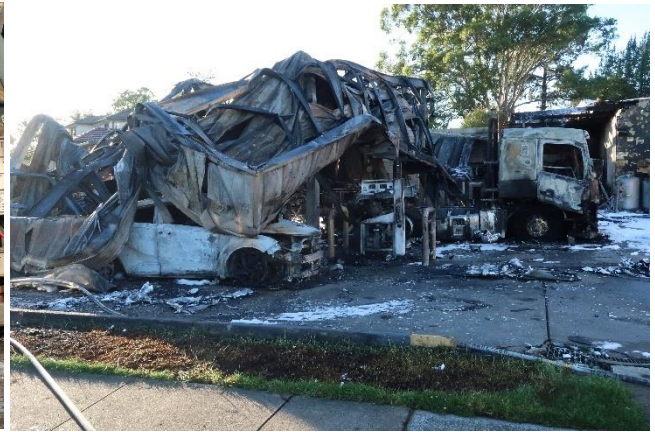
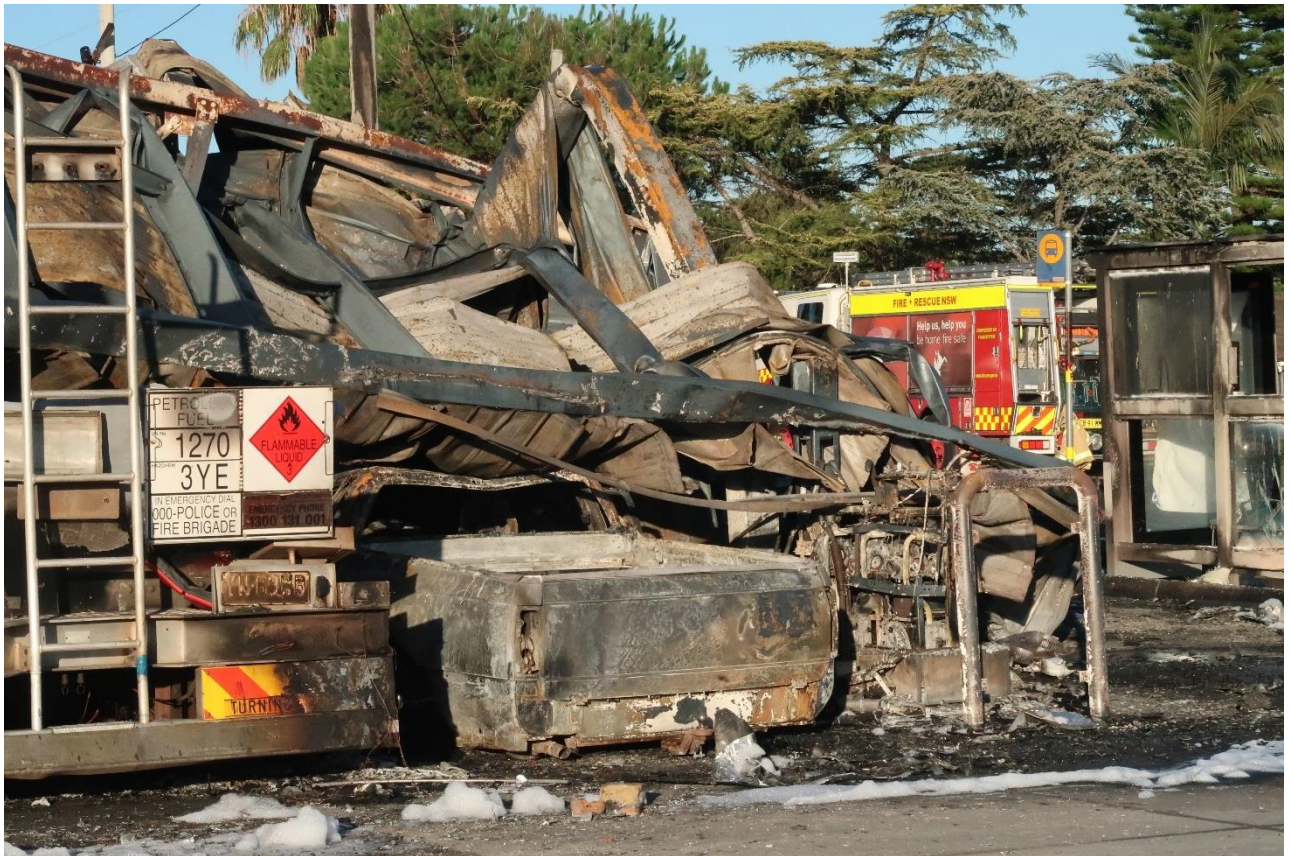
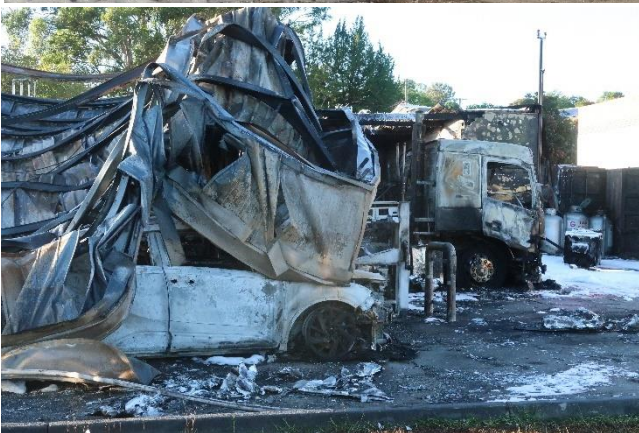
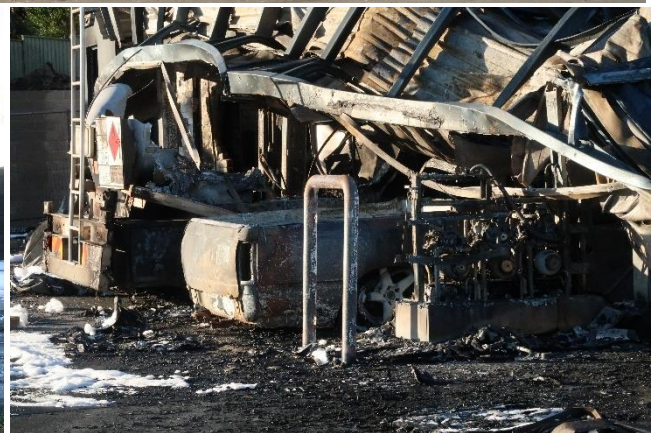
9. The structure supporting the awning forecourt was formed from unprotected steel and rapidly began to fail, resulting in a slow progressive collapse of the iron sheet awning onto the tanker. Structural steel begins to lose tensile strength at around 300°C. At this temperature, the steel will begin to soften. Significant loss of strength rapidly occurs after 400°C. At about 550°C, steel will lose half its load bearing capacity. At about 1,000°C, steel will only have about 10% or less of its load bearing capacity. The flame temperature for the burning petroleum was in excess of 1,000°C, resulting in significant failure of the unprotected structural steel and subsequent collapse.

The tanker was parked beneath the service station awning when the fire broke out. Intense heat from the burning petroleum caused the structural steel supporting the awning to collapse. Steel roof sheets collapsed onto the tanker, acting as a barrier restricting firefighting streams from reaching the fire.

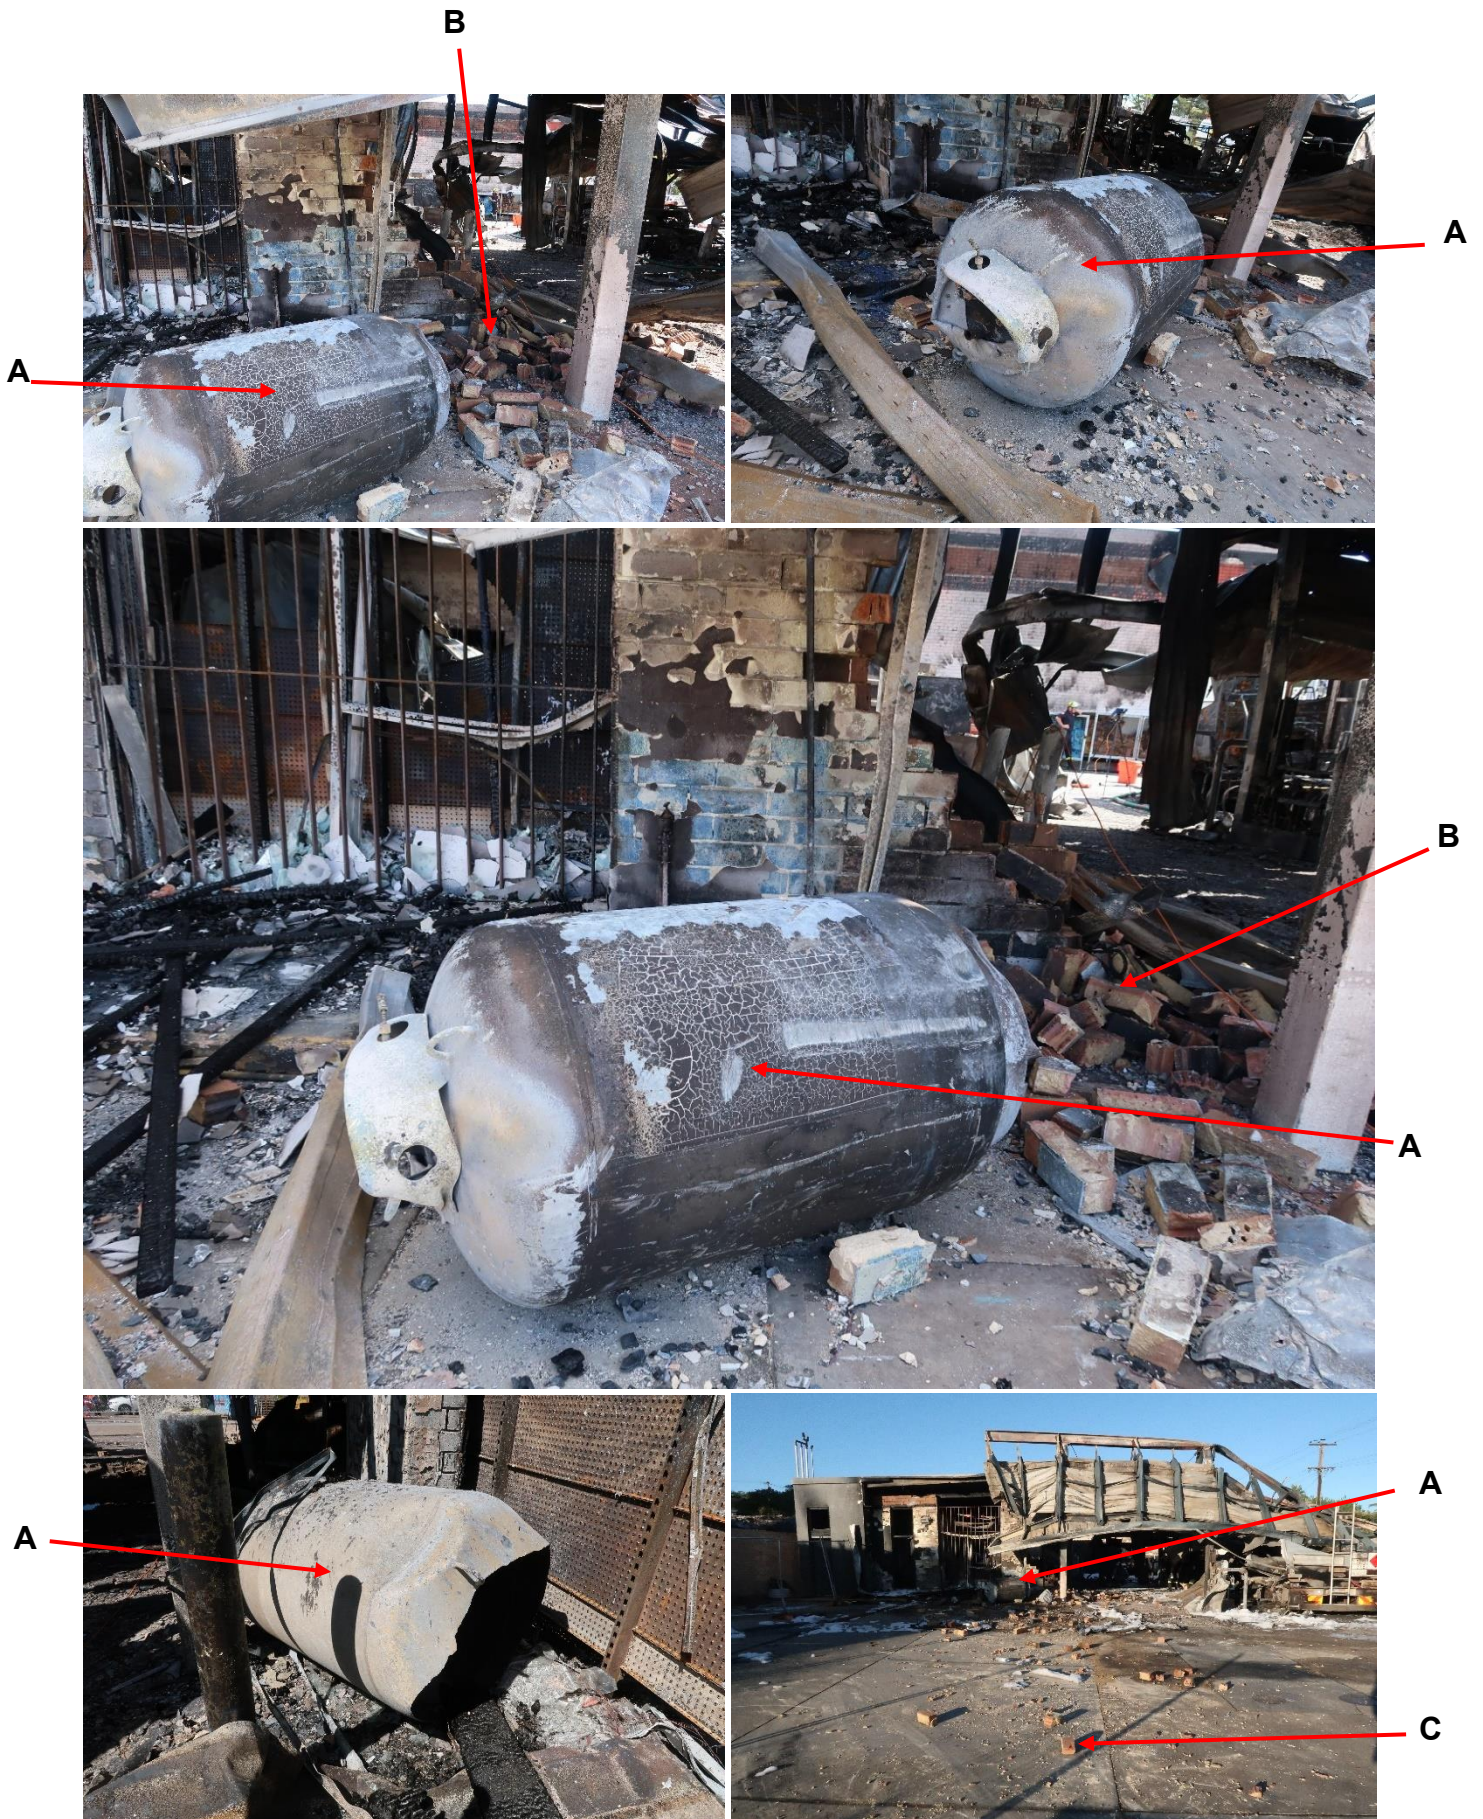
13. The increase in internal pressure of two of the 210 kg LPG cylinders was greater than pressure could be released at, resulting in an overpressure of the cylinder occurring, causing the steel cylinder to fail at the weld seams. Cylinder casing failure resulted in the rapid release of the cylinder's liquid contents. The escaping liquid was rapidly transformed into an expanding gas cloud that mixed with the surrounding air, producing a large flammable gas cloud that ignited, resulting in a large explosion, known as a **BLEVE** (Boiling Liquid Expanding Vapour Explosion) occurring. BLEVE events are characterised by the sudden release and explosive ignition of cylinder contents. The cylinder was transformed into a violent and destructive projectile, in reaction to the sudden and explosive release of burning flammable product, with sufficient force to travel through two brick walls at the service station.

Seven 210 kg LPG cylinders were located at the front of the service station retail building and a storage shipping container. The impact of intense heat from the tanker fire resulted in boiling liquid expanding vapour explosions (BLEVEs) occurring to two of the cylinders. Firefighters directed cooling streams onto the remaining cylinders, preventing further BLEVEs from occurring.

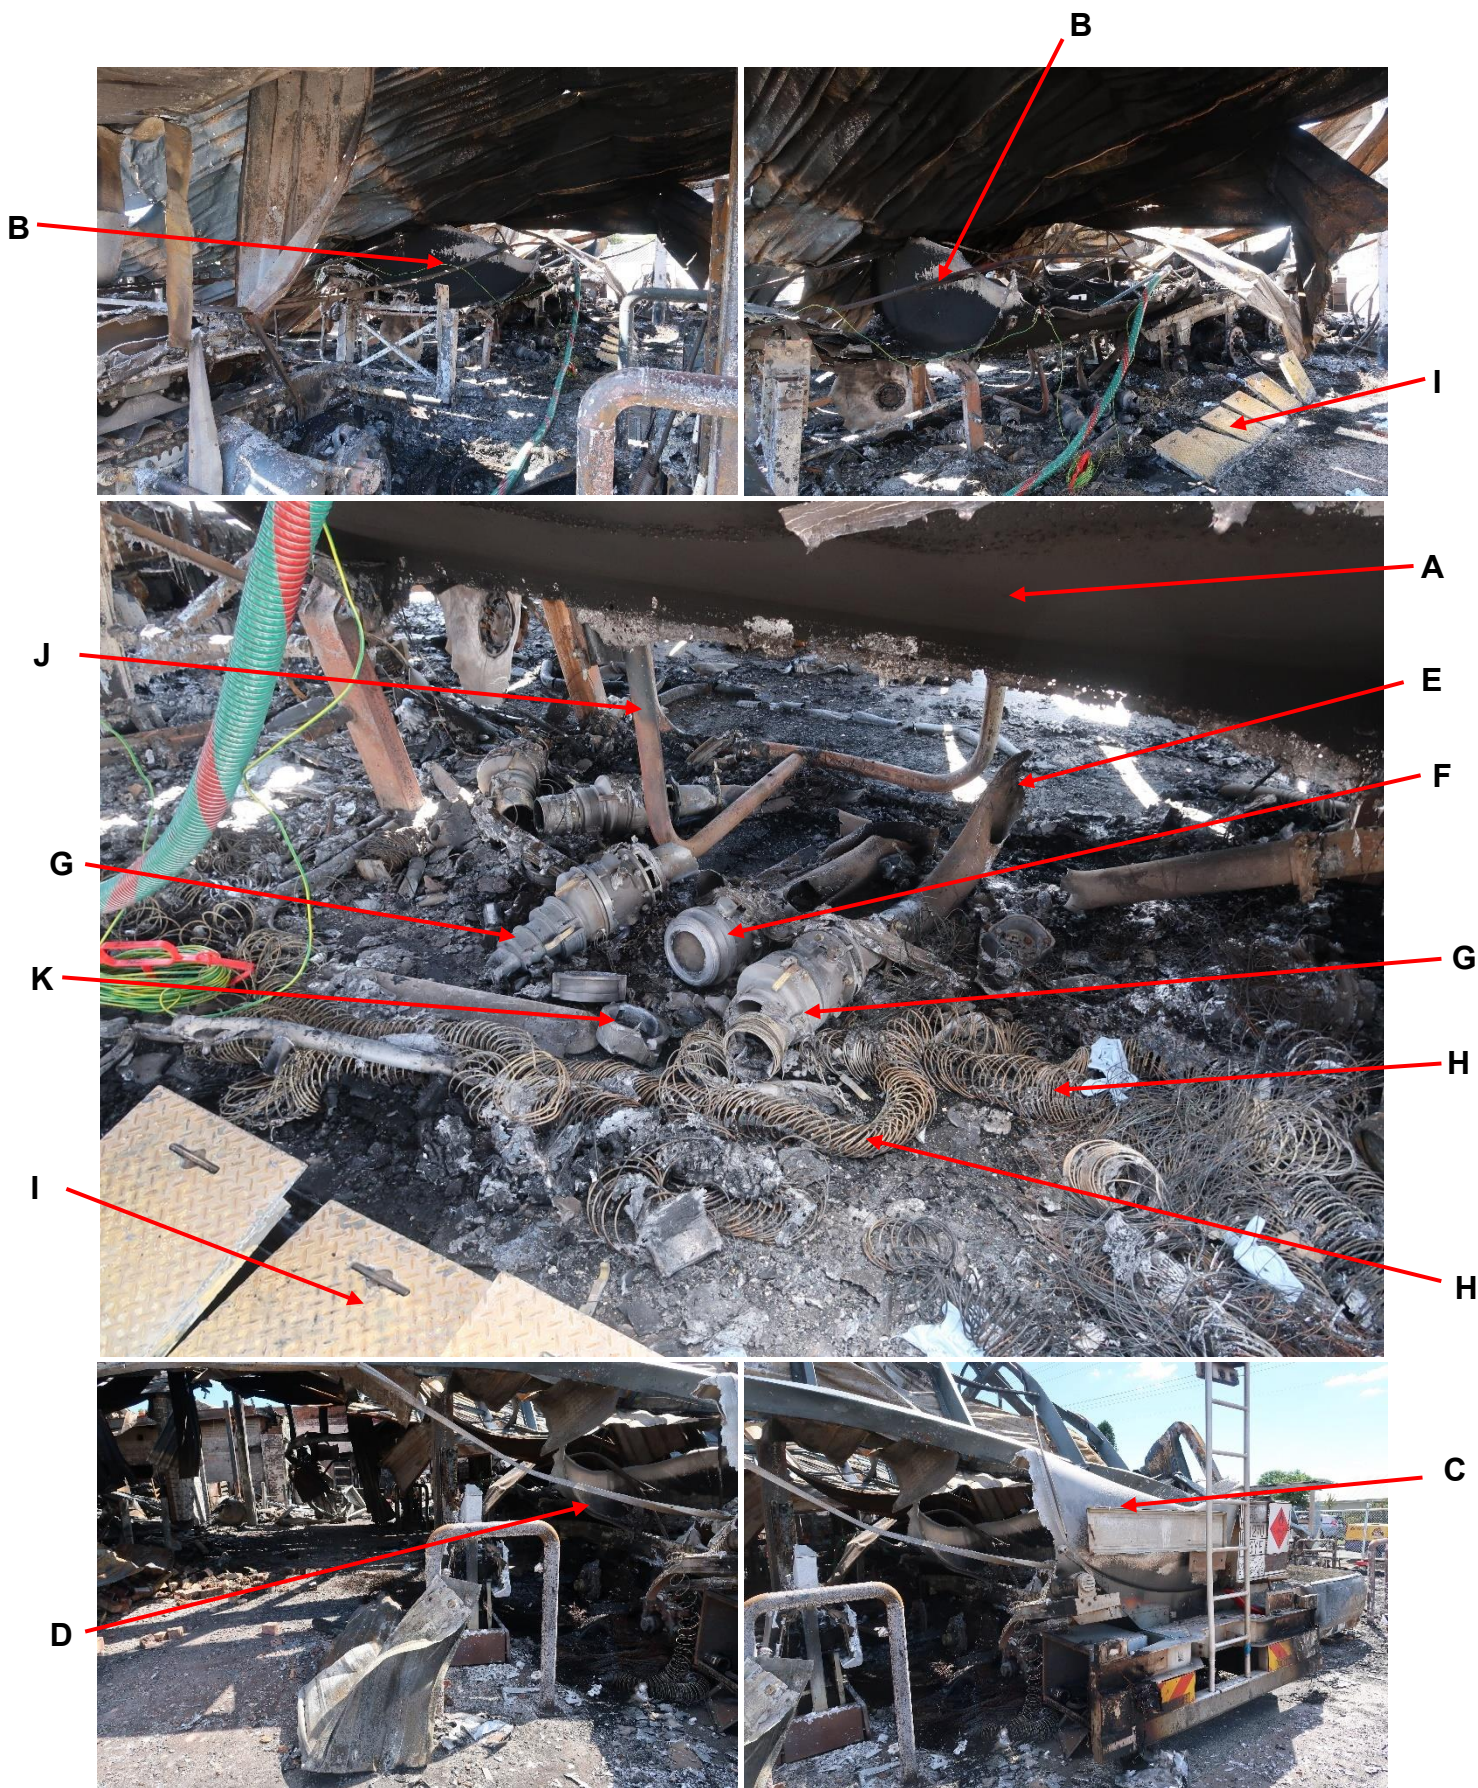
As a result of boiling liquid expanding vapour explosions (BLEVEs) of two 210 kg LPG cylinders, the cylinders became projectiles with sufficient force to breach the brick walls of the service station building. These views show where the two cylinders (A) came to rest after breaching the walls (B) and displacing brick debris 20 metres beyond the wall (C).

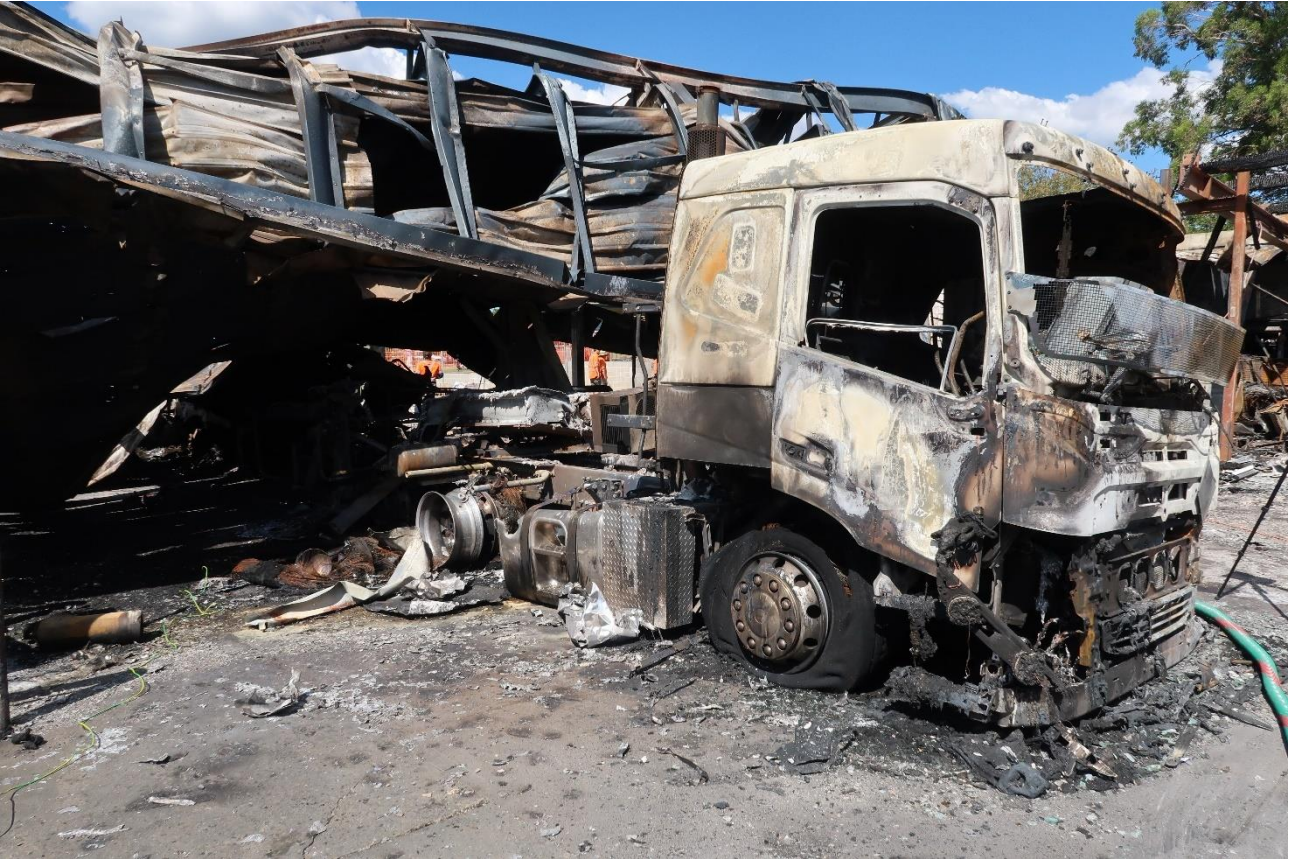
The tanker following the fire: **A** Tanker shell, **B** Tanker shell bulkhead (forward), **C** Tanker shell bulkhead (rear), **D** Internal compartment wall, **E** Pipe from compartment to outlet (x 6), **F** outlet valves fitted with standard camlocks (x 6), **G** Outlet adaptor (x 6), **H** Static lines fitted to tanker unloading hoses (x 6), **I** Underground tank fill point covers (x 6), **J** Unloading valve assembly under-tank collision protection bar, **K** hose coupling.

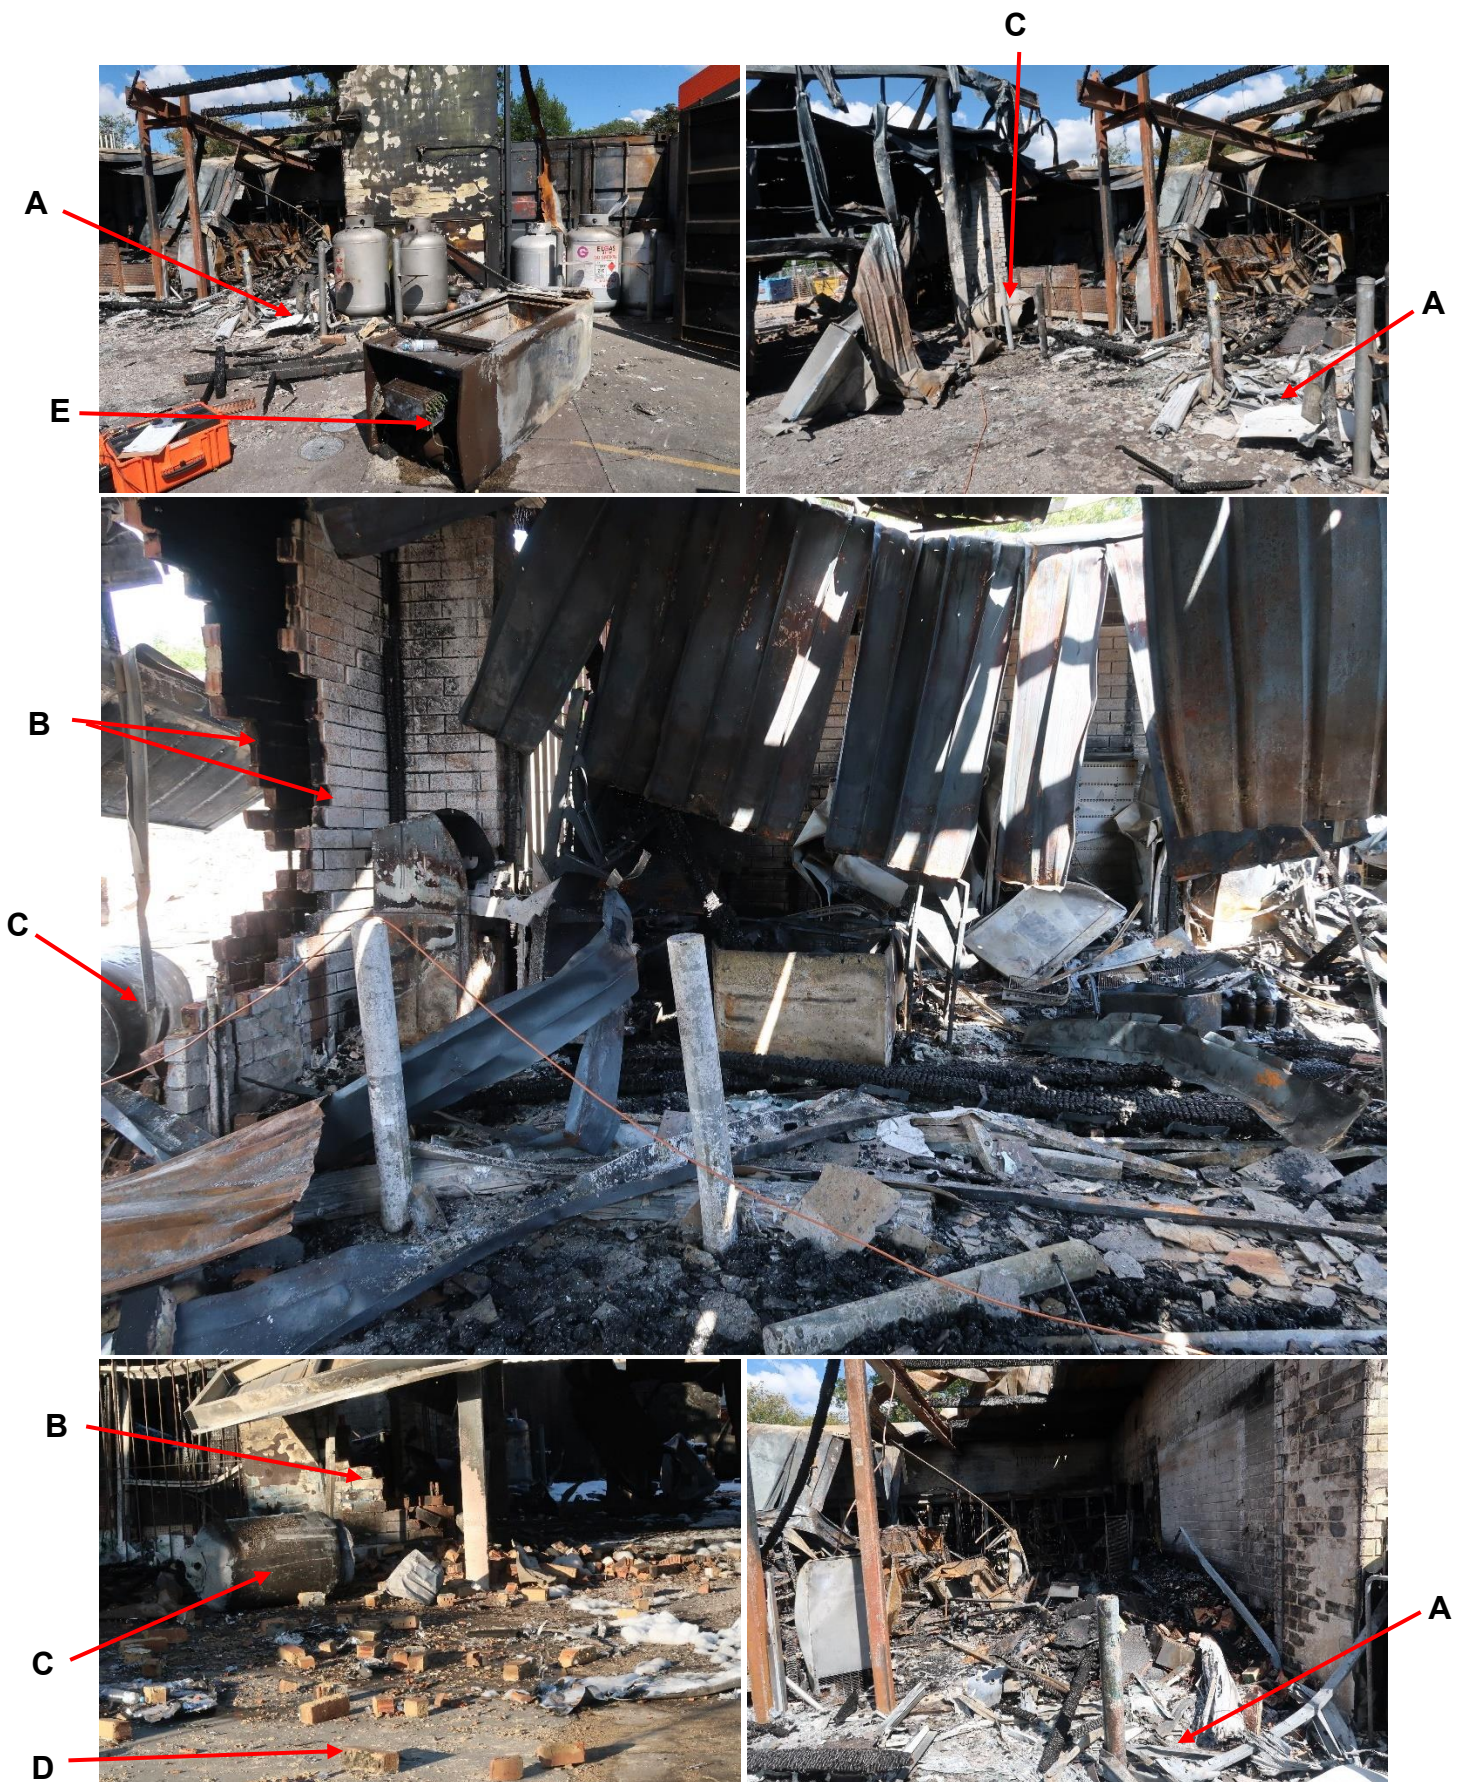
Significant damage occurred to the petrol tanker, several motor vehicles, fuel pumps, the service station building and overhead steel awning due to the fire intensity.

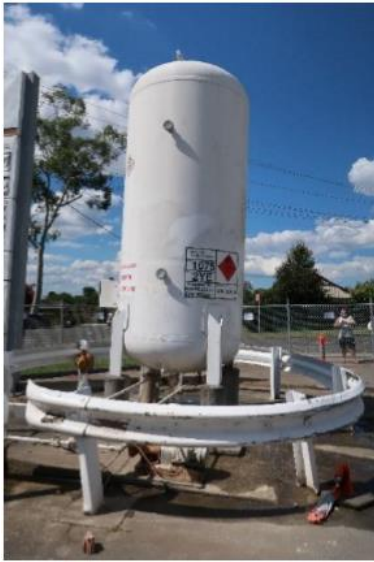
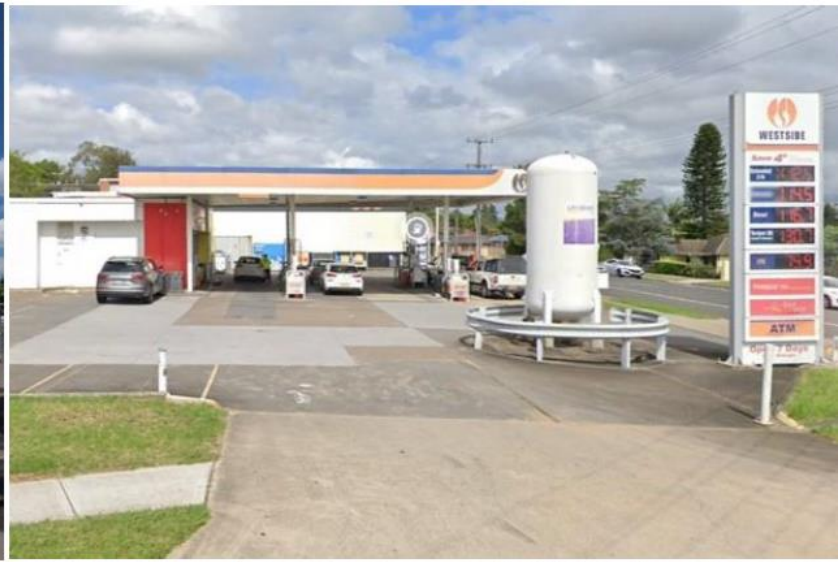
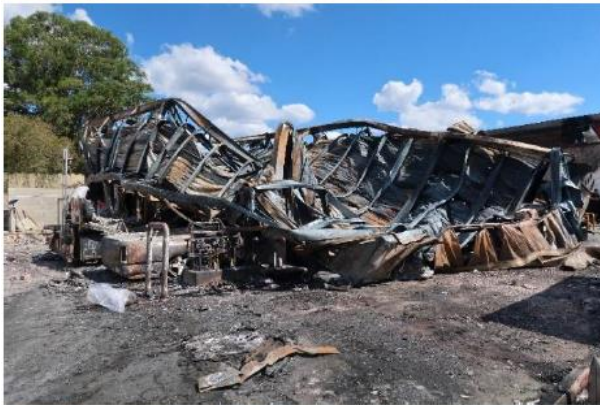
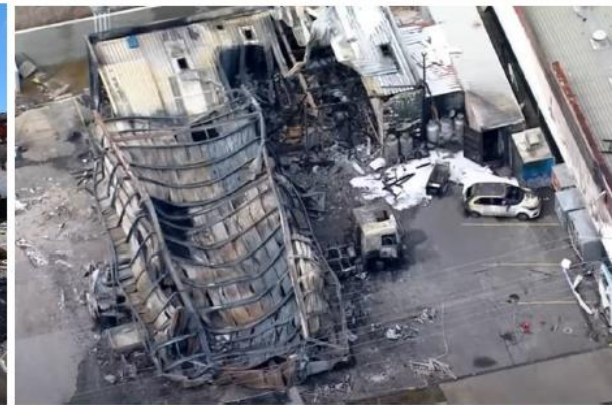
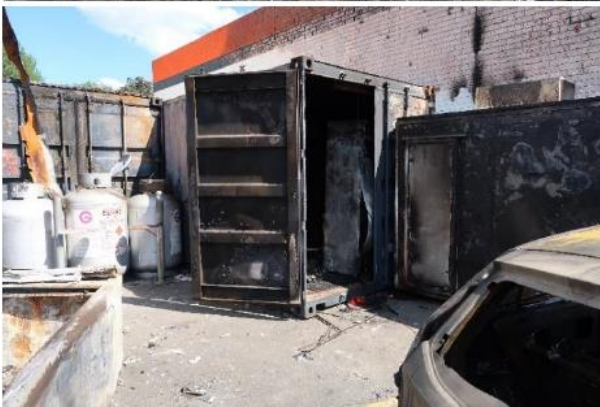
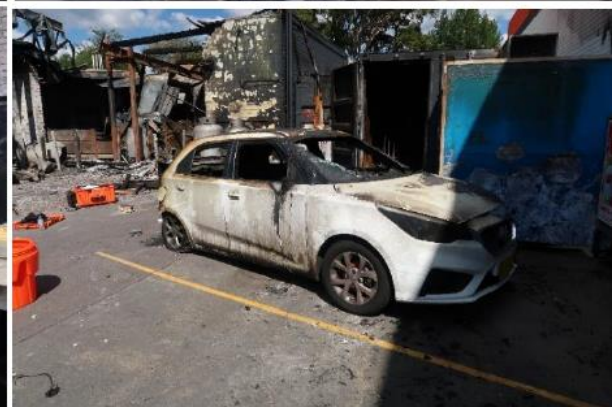
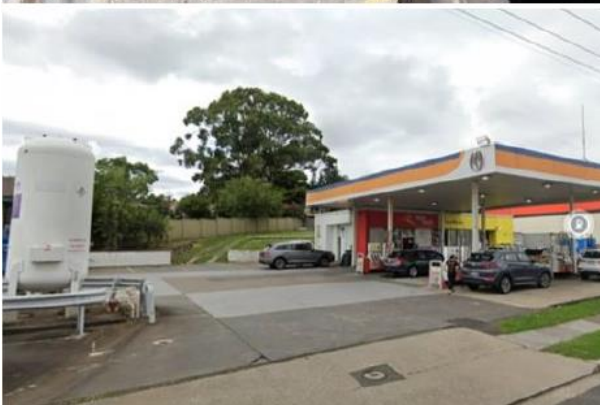
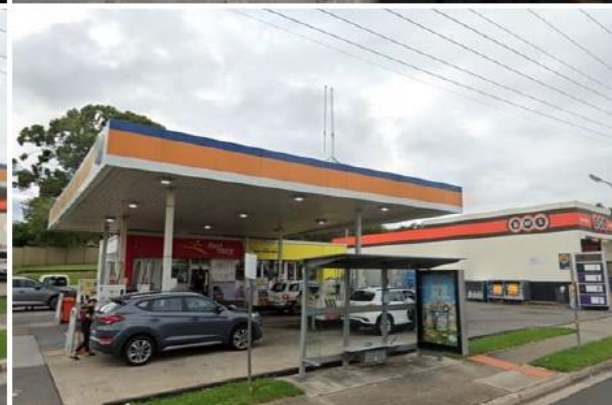
Boiling Liquid Expanding Vapour Explosions (BLEVEs) occurred involving two 210 kg LPG cylinders located at (A) the front of the service station building. The force of the explosion was so powerful one cylinder demolished (B) a double brick wall before (C) coming to rest after breaching the wall and (D) scattering debris. The shockwave associated with the BLEVE of a second cylinder caused the displacement of (E) an ice making machine. Firefighters used distance and shielding to protect against the effects of the BLEVEs.
