NSWFB RETIREES FIRE NEWS
INCIDENT REPORTS

**2ND ALARM ST MARYS GARAGE COMPLEX
FIRE**

Incident Summary:

Incident Type: Garage Complex Fire.

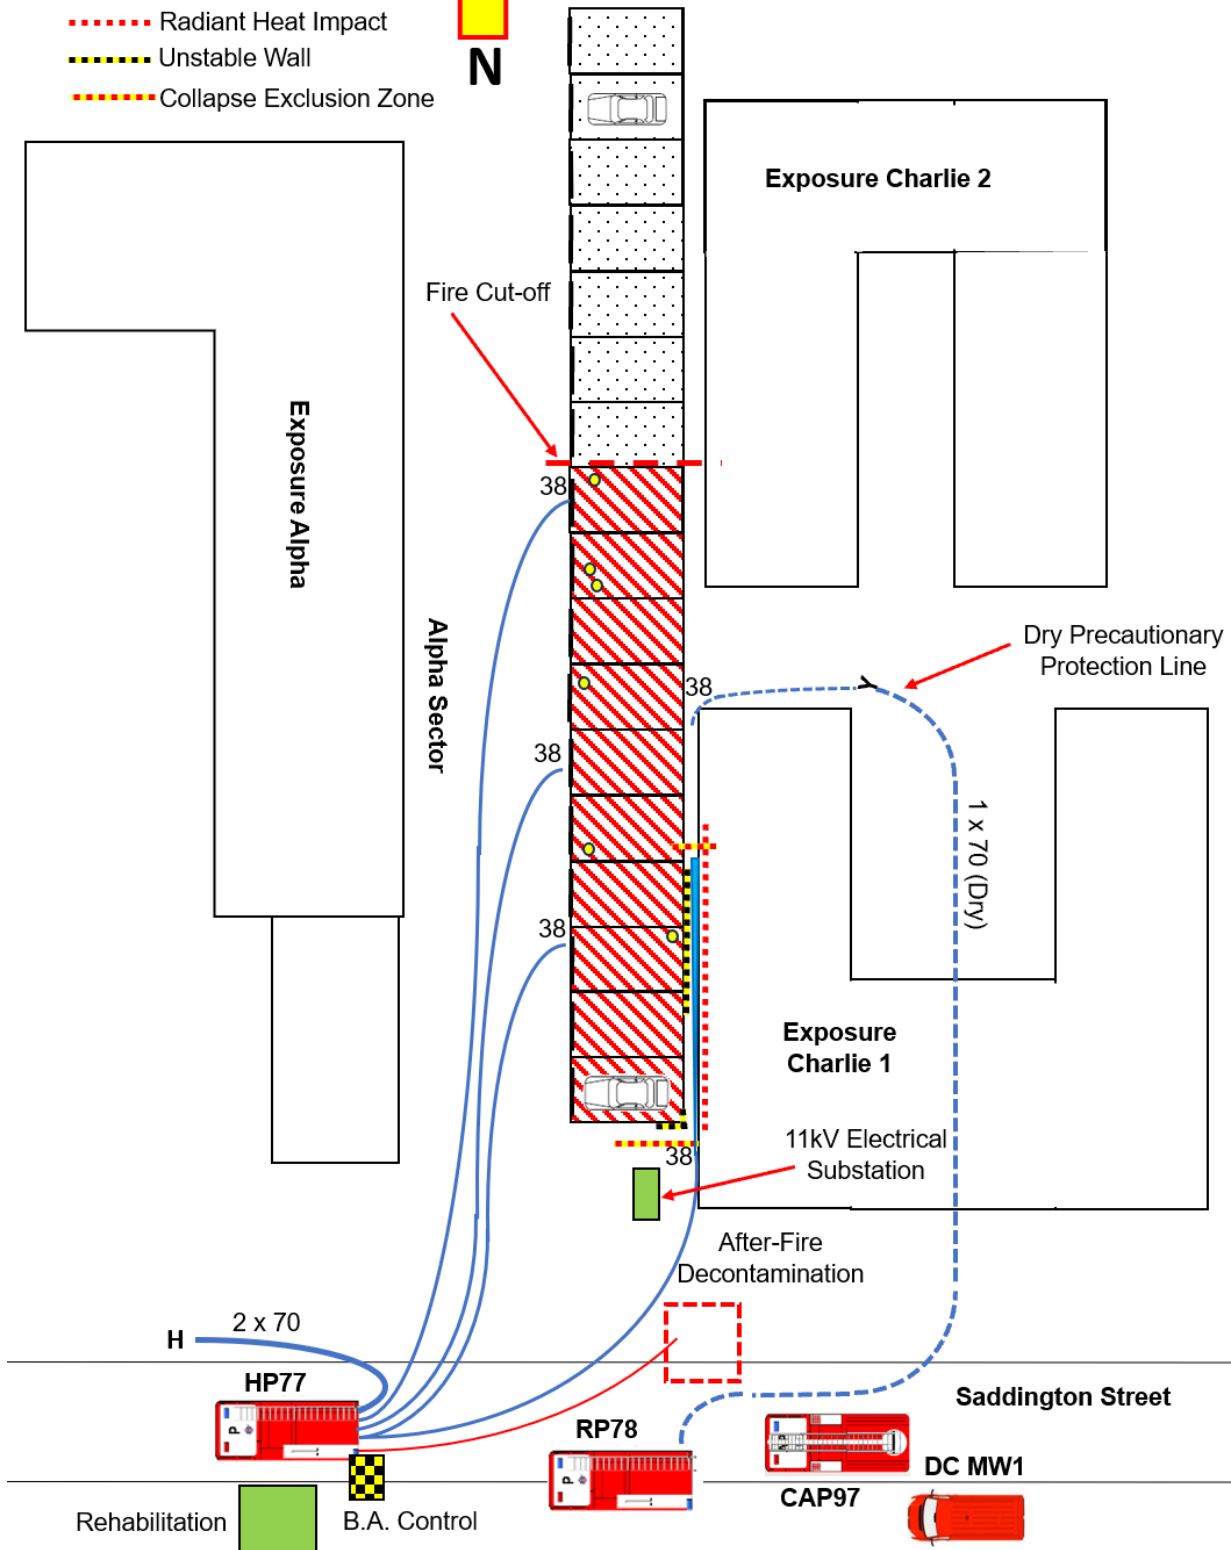
Fireground Drawing
Not to Scale

Fire Area
-

Heat and Smoke
-

LPG Cylinders
-

Radiant Heat Impact
-

Unstable Wall
-

Collapse Exclusion Zone

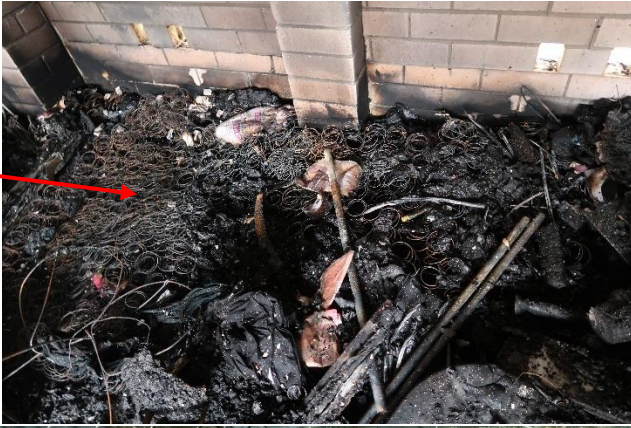
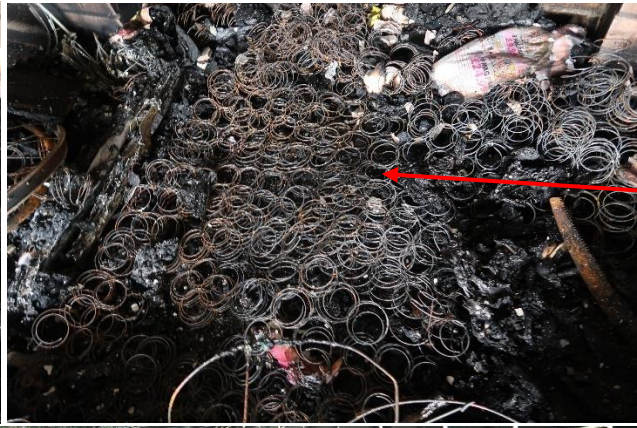
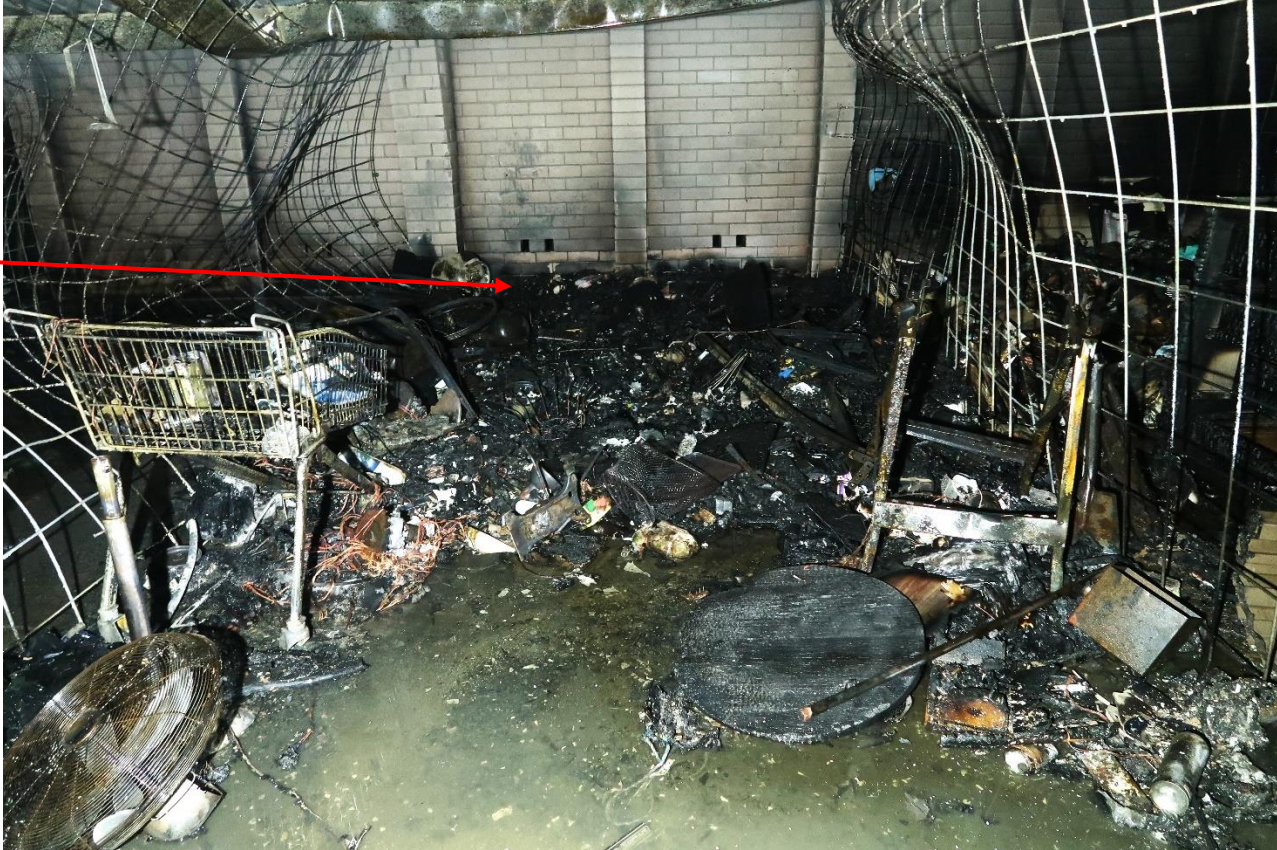
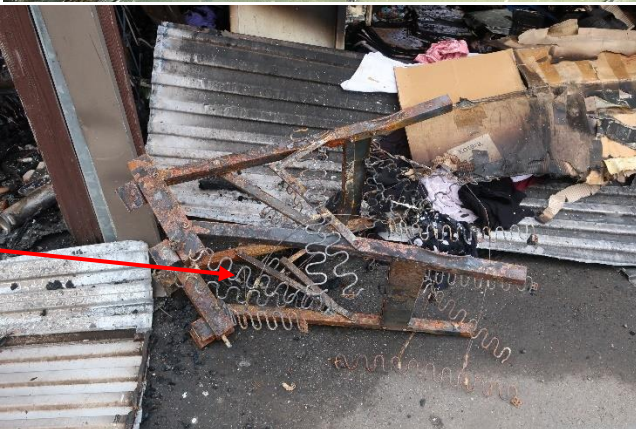
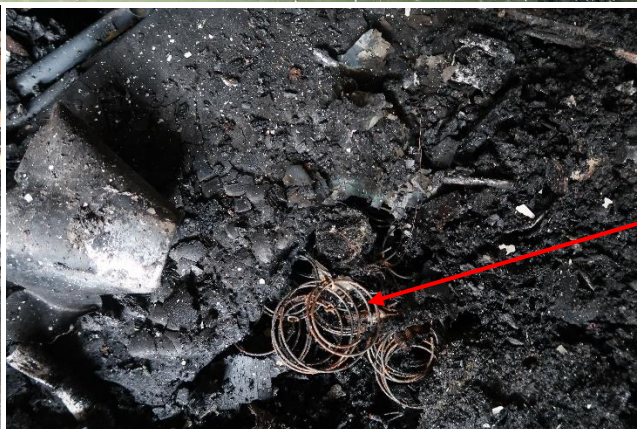
1. There were indications the fire started in the third garage from the southern end of the complex. Material initially involved in fire consisted of a polyurethane foam-based mattress and lounge chairs, plastic products and timber materials. Following ignition, superheated gases ascended vertically to the steel roof and travelled beneath the roof in all directions. Air was being drafted into the fire area through ventilation holes at the base of the garages on the Charlie side, increasing fire intensity.

The fire is believed to have started within garage number 3. This garage contained a number of ordinary household furniture items formed from polyurethane foam (indicated by arrows), resulting in intense fire behaviour, including rapid progression to flashover, intense flames and high-heat release rates of 1070 kW to 1110 kW (temperature exceeding 820°C, peak heat flux density (heat rate per unit area) of 760 kW/m² and the production of large volumes of superheated, hydrocarbon-laden, thick, black smoke.

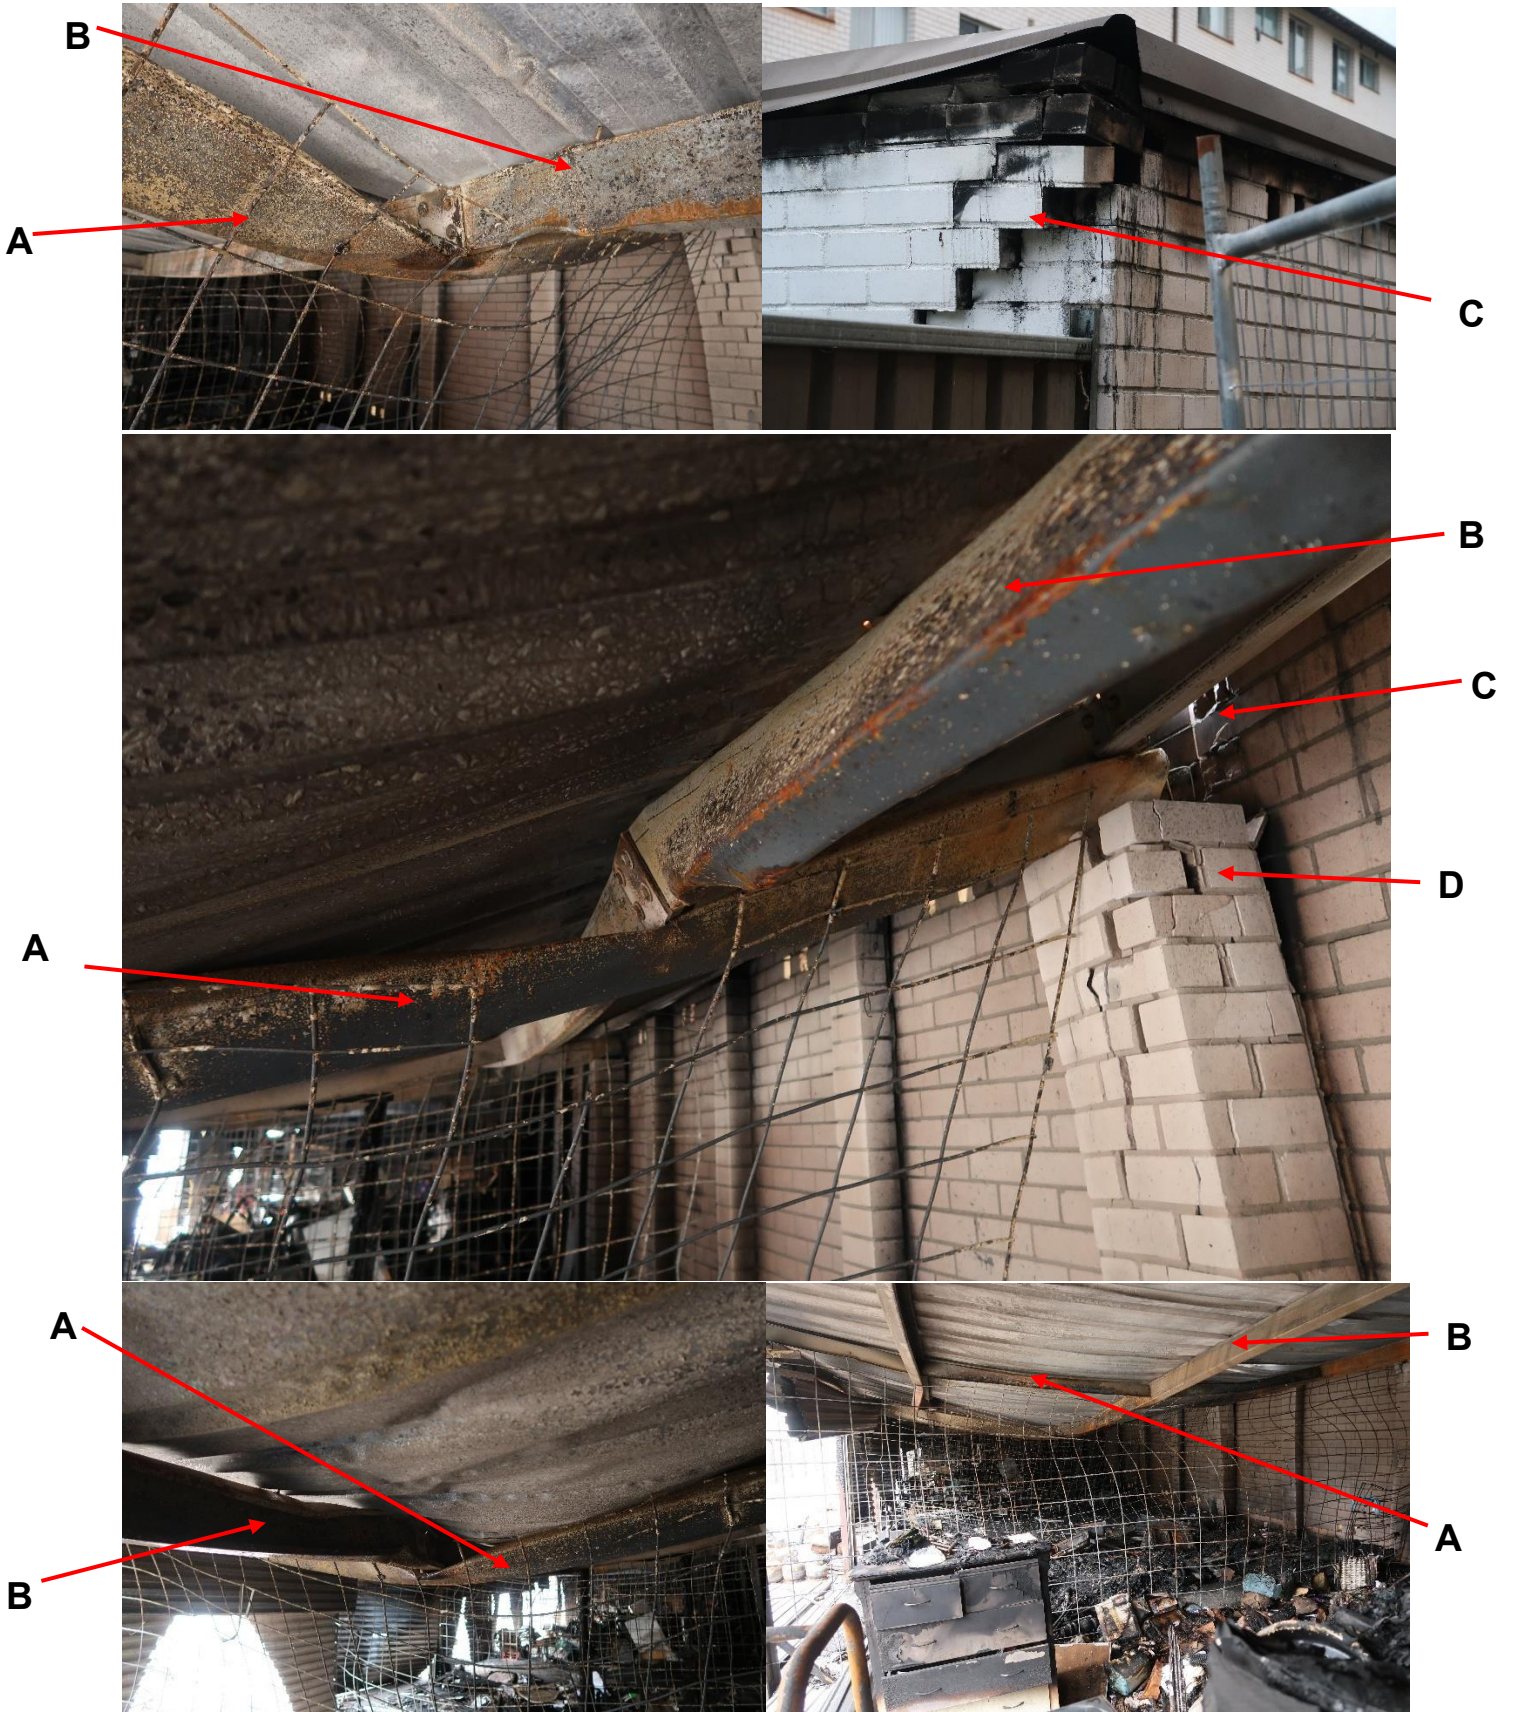
4. Fire intensity was causing the steel frame that supported the structure to begin sagging. As the frame began to distort, stability of the brick wall began to weaken. Large volumes of heavy superheated black hydrocarbon-laden smoke were venting from the garages. A danger existed that a wall breach on the Charlie side of the garages could result in intense flames impacting the glass windows of Exposure Charlie unit block less than two metres away, placing the unit block in significant danger.

As smoke began to clear, firefighters observed cracks and displacement of bricks on the Charlie Delta corner of the structure. The area was declared a collapse zone and secured with barrier tape. All firefighters working at the fireground were informed of the collapse zone via a general broadcast. Fire Communications were informed of the establishment of the collapse zone.

Extreme heat due to the involvement of volatile materials, including polyurethane foam-based furniture, caused structural steel to soften and weaken, becoming displaced. In the above views, the steel **A** beams and **B** purlins supporting the roof initially expanded (pushing outwards) then sagged, causing steel to pull in. Displacement of the steel caused movement of the **C** upper brick walls and **D** brick support columns, creating openings (that could potentially fire to vent) and causing the walls to crack become unstable, presenting a collapse risk.

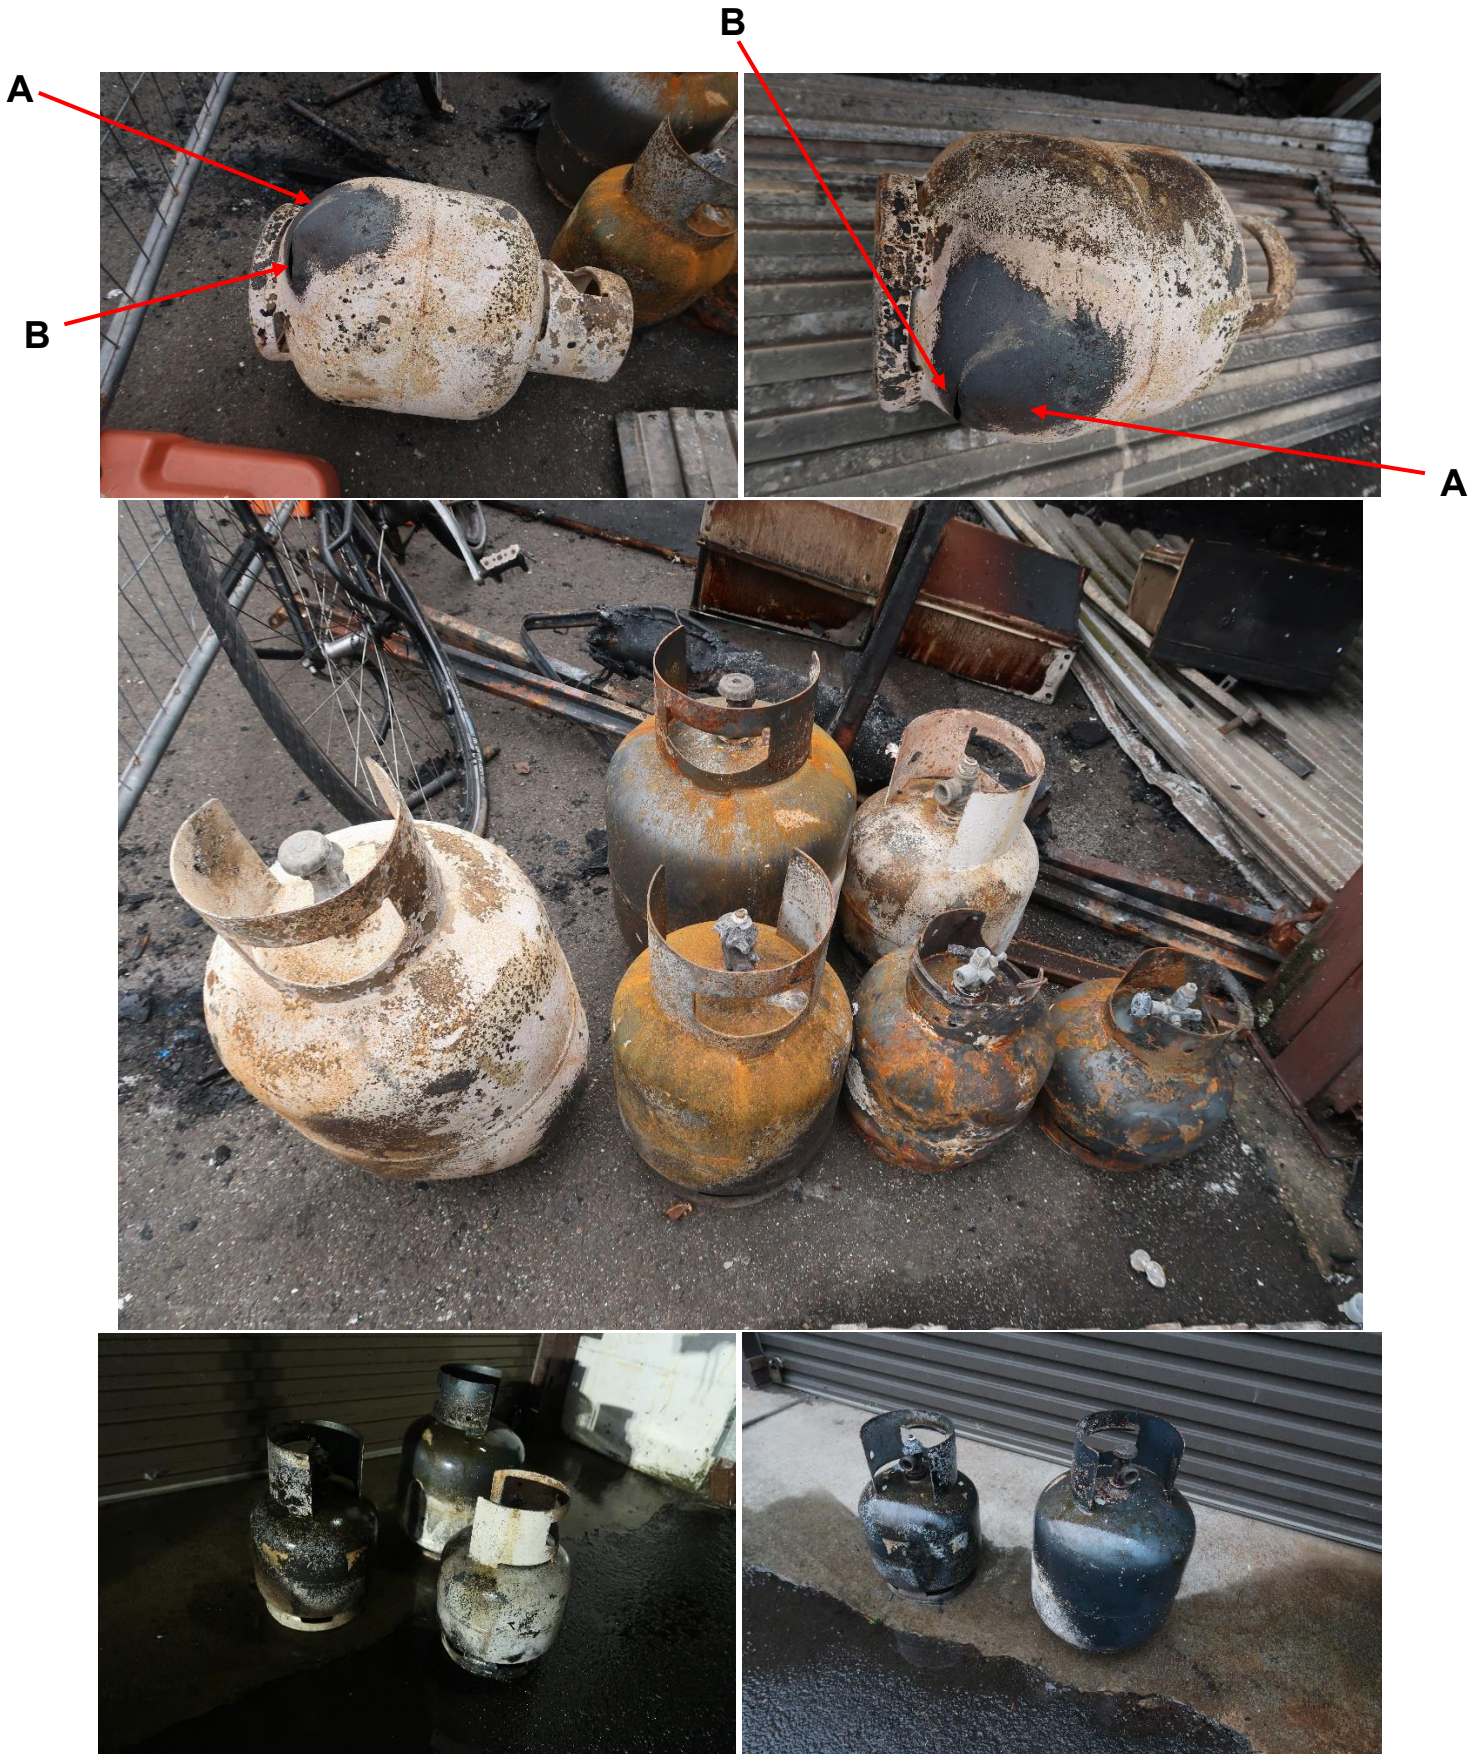
5. Numerous 9 kg LPG cylinders were located within the garages. Heat from the fire caused pressure to increase in a number of cylinders, resulting in operation of the pressure relief valves and venting of flame jets. At least one cylinder was the subject of a BLEVE (Boiling Liquid Expanding Vapour Explosion). The BLEVE occurred when the cylinder pressure relief valve was unable to release vapour pressure that had built up in the cylinder faster than the vapour pressure that was building up, resulting in the cylinder failing and an explosion occurring. A number of smaller explosions caused by aerosols also occurred within the garages.

A number of LPG cylinders of various sizes were located throughout the garages. The cylinder located in the top photographs was located next to a polyurethane foam mattress in garage number 2 and exposed to intense levels of heat, causing an overpressure of the cylinder that caused the cylinder to **A** bulge and ultimately fail when a **B** split in the cylinder casing occurred. The application of water streams by firefighters had an immediate effect on fire conditions, cooling the fire area and reducing cylinder internal pressures. All cylinders showed signs of venting.

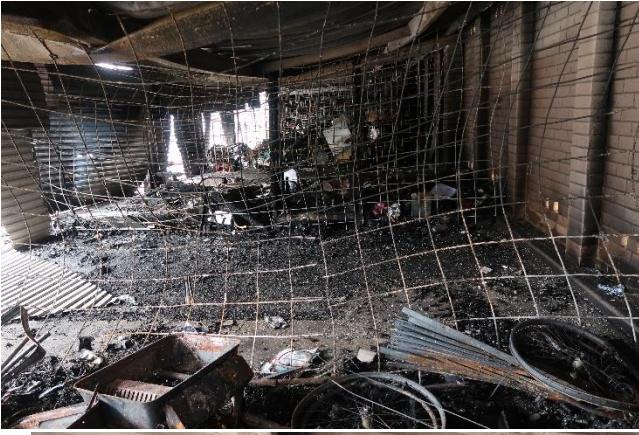
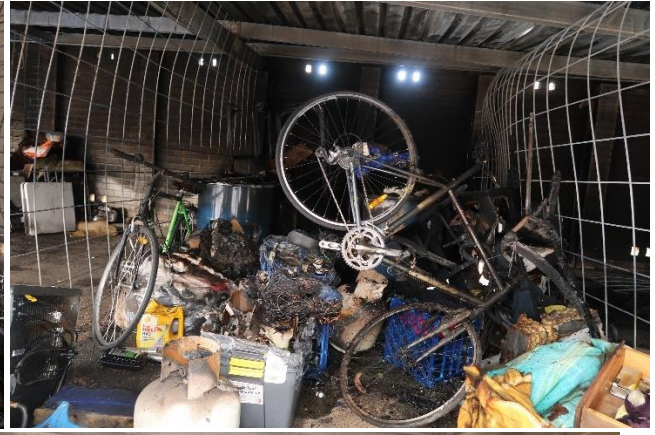
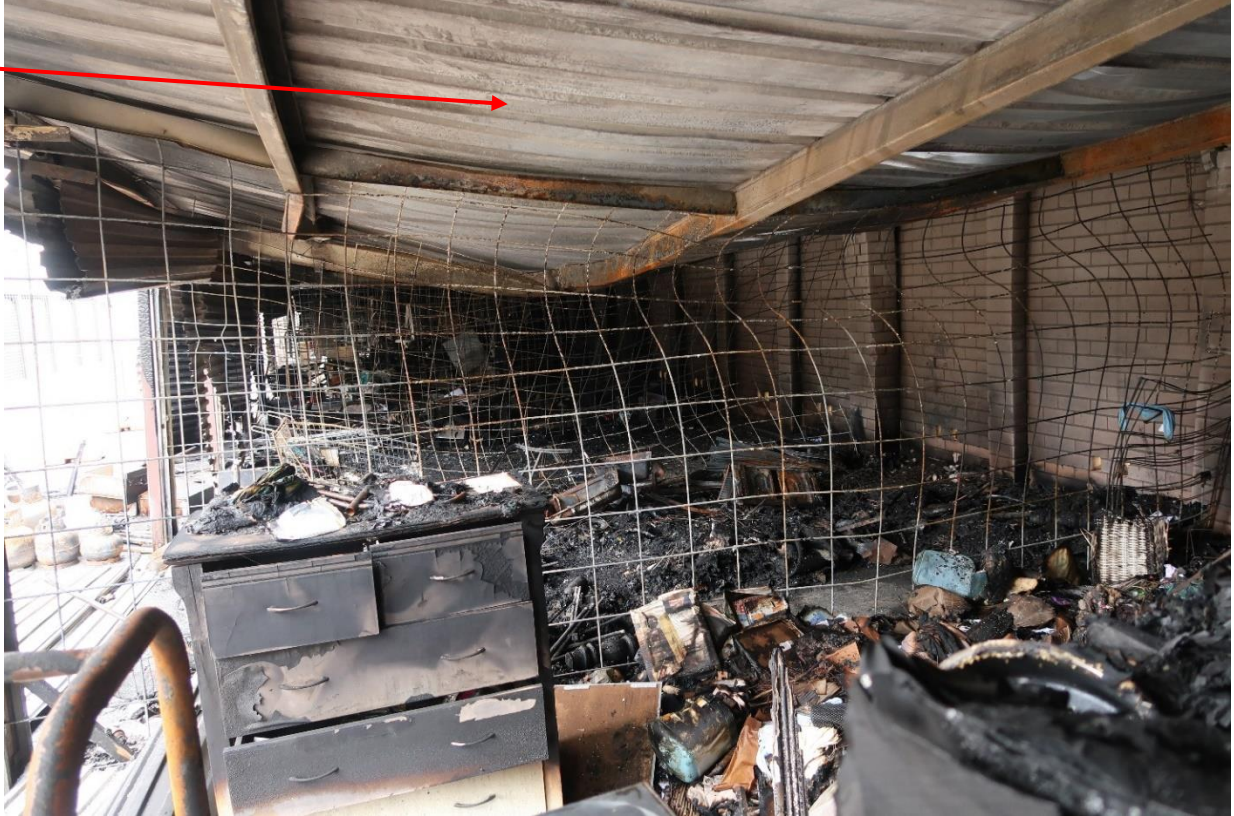
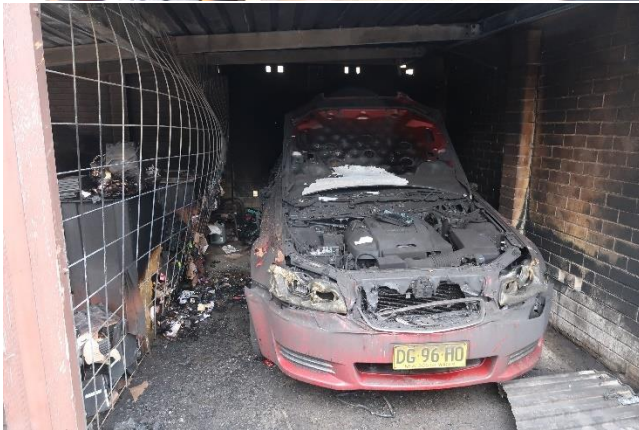
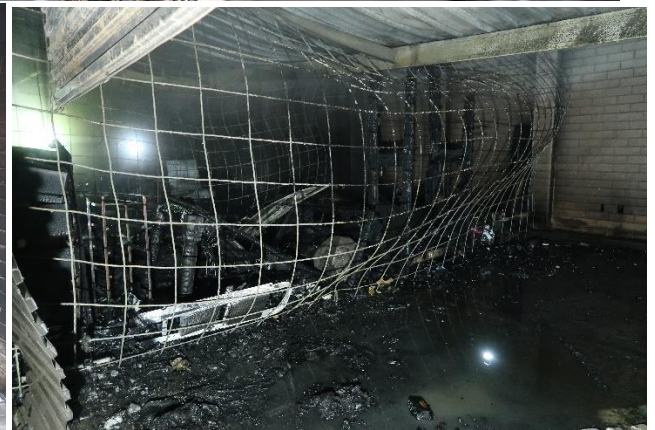
2. Heat, smoke, flames and superheated gases were contained within the garage and unable to vent. These products of combustion travelled laterally to the north and south. Separation between garages was non-existent, allowing unrestricted spread of heat, smoke, flames and superheated gases beneath the steel roof the entire length of the complex, from end to end.

3. Radiant heat from under-roof superheated gases was projected downwards, igniting combustible materials beneath gases. This process resulted in ignition of material within garages 21 metres to the north and 6 metres to the south (southern end of the garage complex). Direct fire spread was also occurring from garage to garage due to a lack of fire separation between the garages.

The individual garages were divided by steel wire square mesh with 20 cm spacing, allowing unrestricted fire spread. The roof was formed by steel sheets (indicated by arrow). Superheated fire gases spread beneath the roof from end to end through the complex. Radiant heat from the overhead fire gases ignited the surfaces of stored materials, facilitating rapid fire involvement remote from the garage of origin. The gases travelling beneath the roof were hydrocarbon laden, burning at temperatures that exceeded 800°C. Firefighters did an excellent job establishing an effective fire cut-off point.

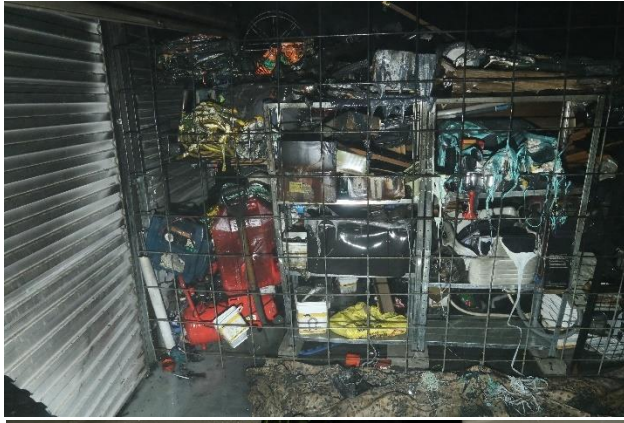
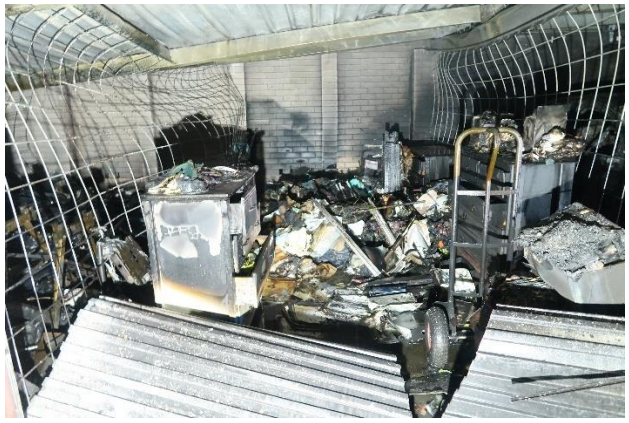
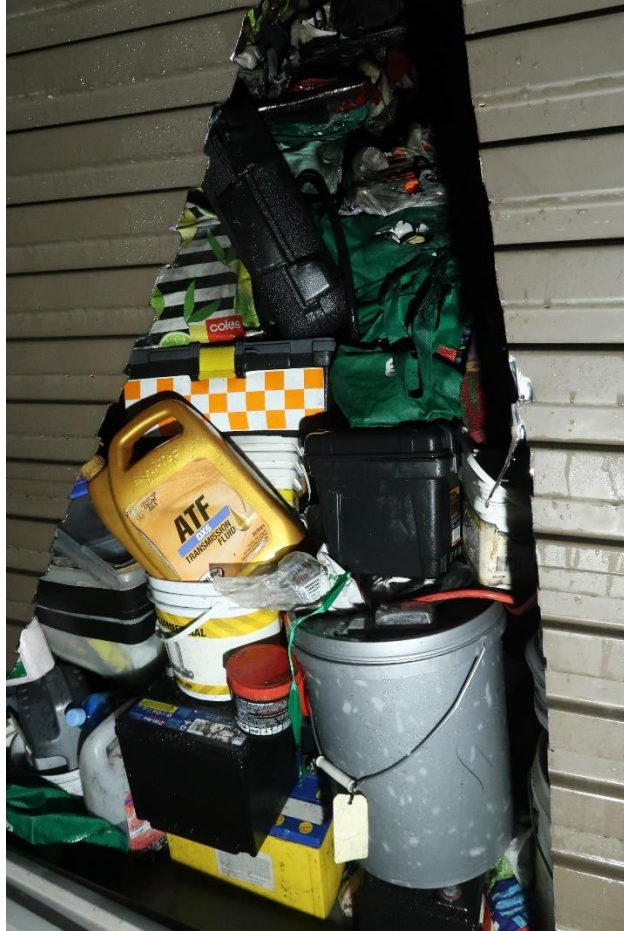
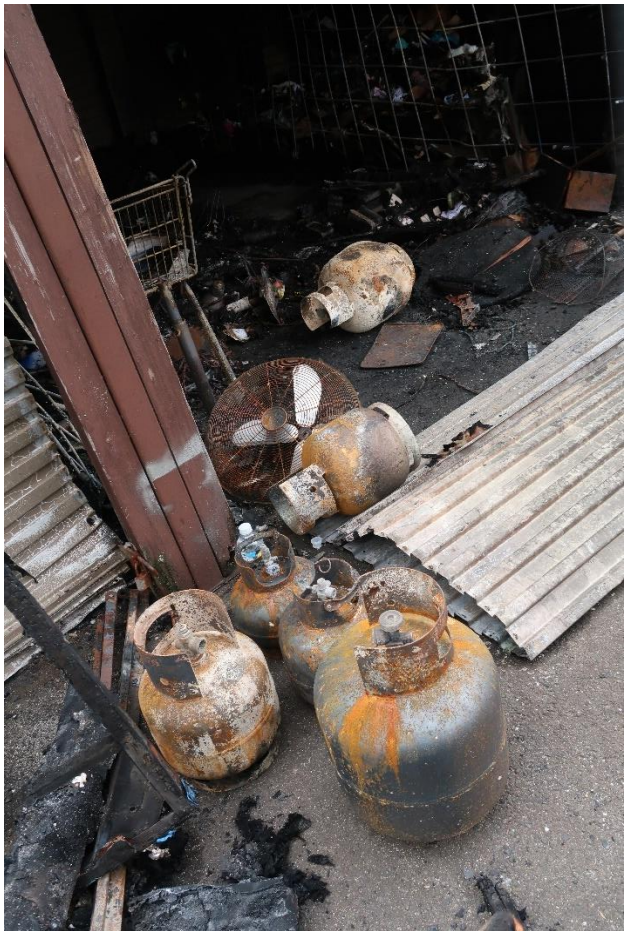
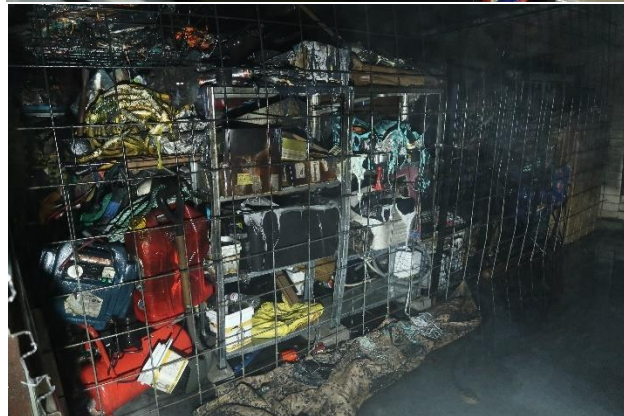
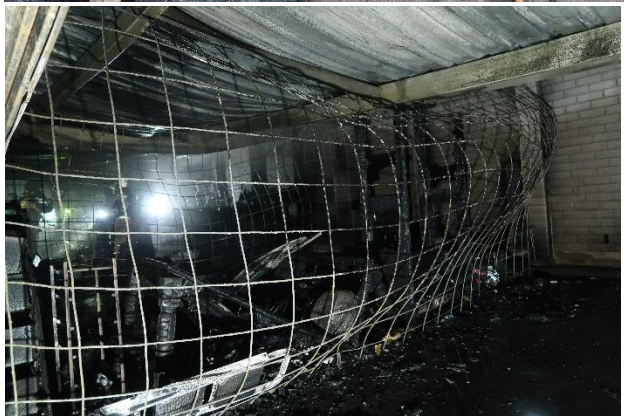
Garage contents consisted of a large variety of stored materials, representing a “witches brew” fuel load. Although some garages were lightly loaded, others were filled to capacity. Many contained hazardous materials including flammable liquids, LPG cylinders and aerosols.
