## **MW1 C STATION TRAINING AND INCIDENT CASE STUDIES**

**FILE NO. 2024 /07.**

**LEARNING FROM THE PAST: 14 PUMPERS  
AND 2 AERIALS CALLED TO SMITHFIELD  
PALLET FACTORY FIRE**

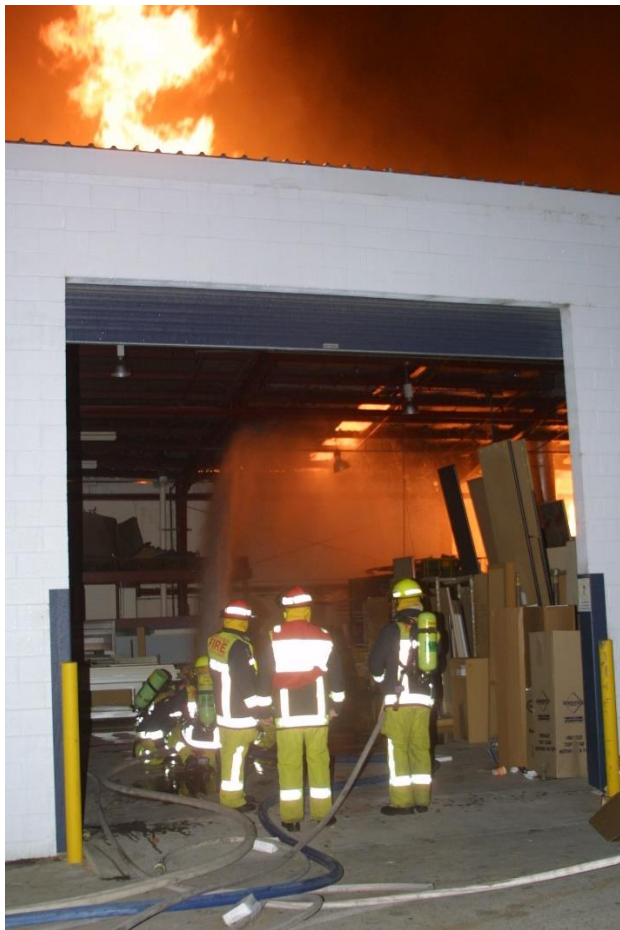
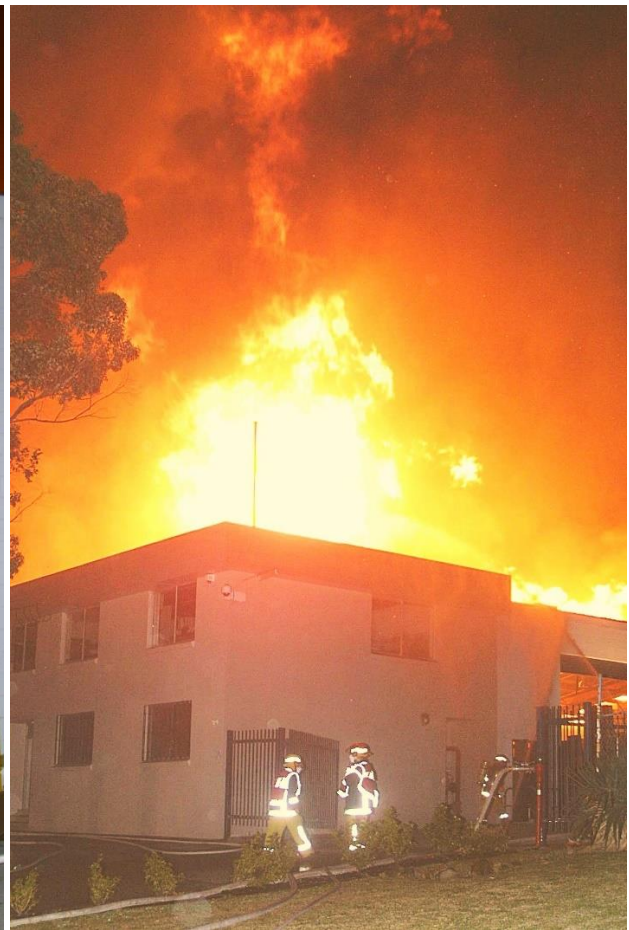
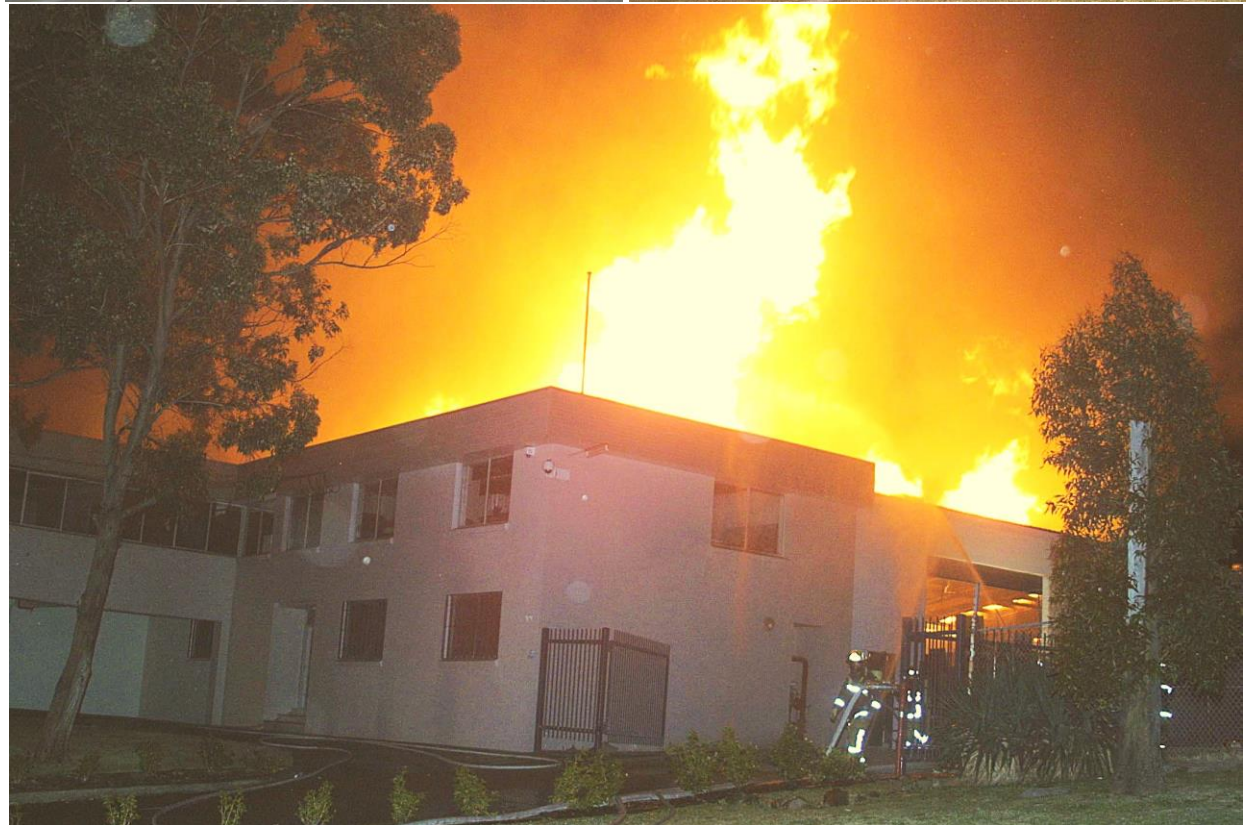
Flames at least 20 metres in height from the burning pallet stack vent into the night sky. Large flames roll across the roof of Exposure D factory, melting the roof skylights, allowing embers to enter. The factory wall has collapsed and firefighters are setting up a ground monitor to stop fire entering the factory.

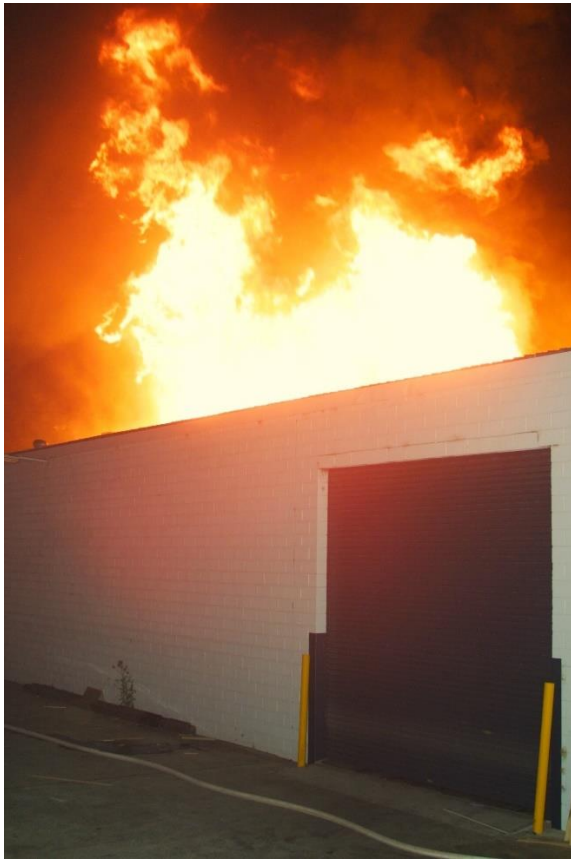
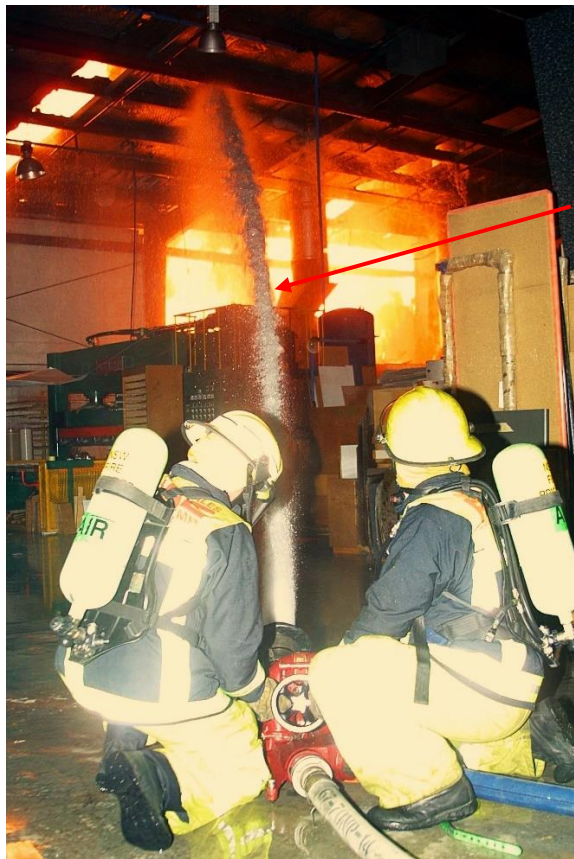
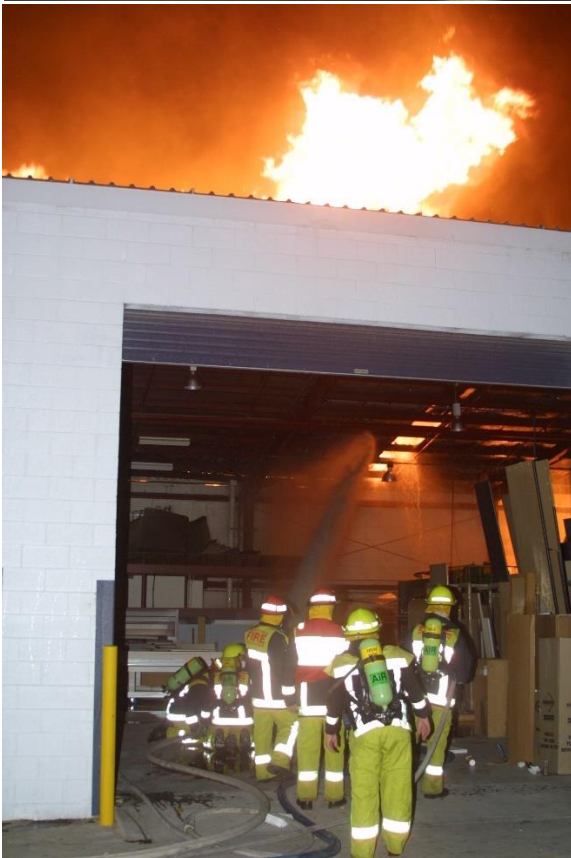
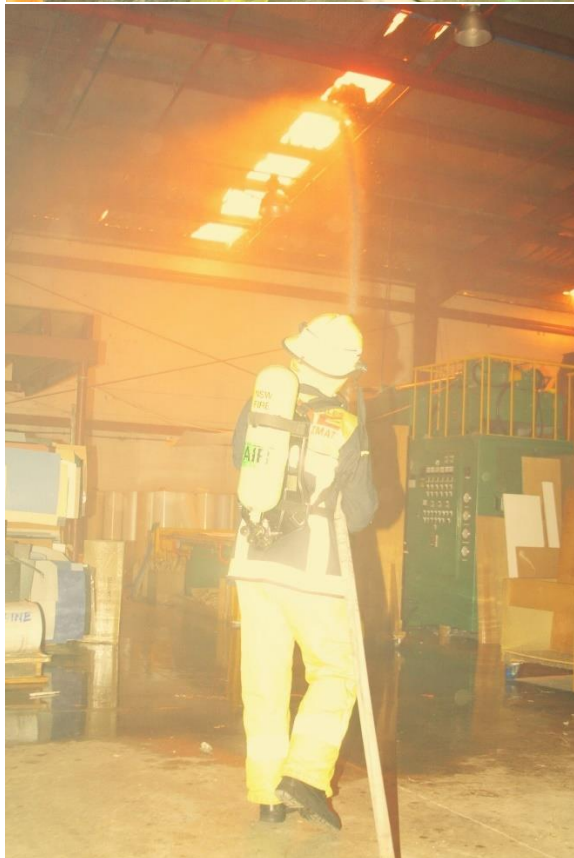
Large flames produced by the burning pallet stack fire roll across the roof of the Exposure D kitchen manufacturing factory. The intensity of the fire has caused the Exposure D wall to collapse (indicated by arrow). Firefighters Peter Watson and John Lewis (top right) are positioning a ground monitor inside the factory, to stop fire from entering. Operations are being carried under the direction of Sector Commander Pumper 67 S.O. Craig Easy.

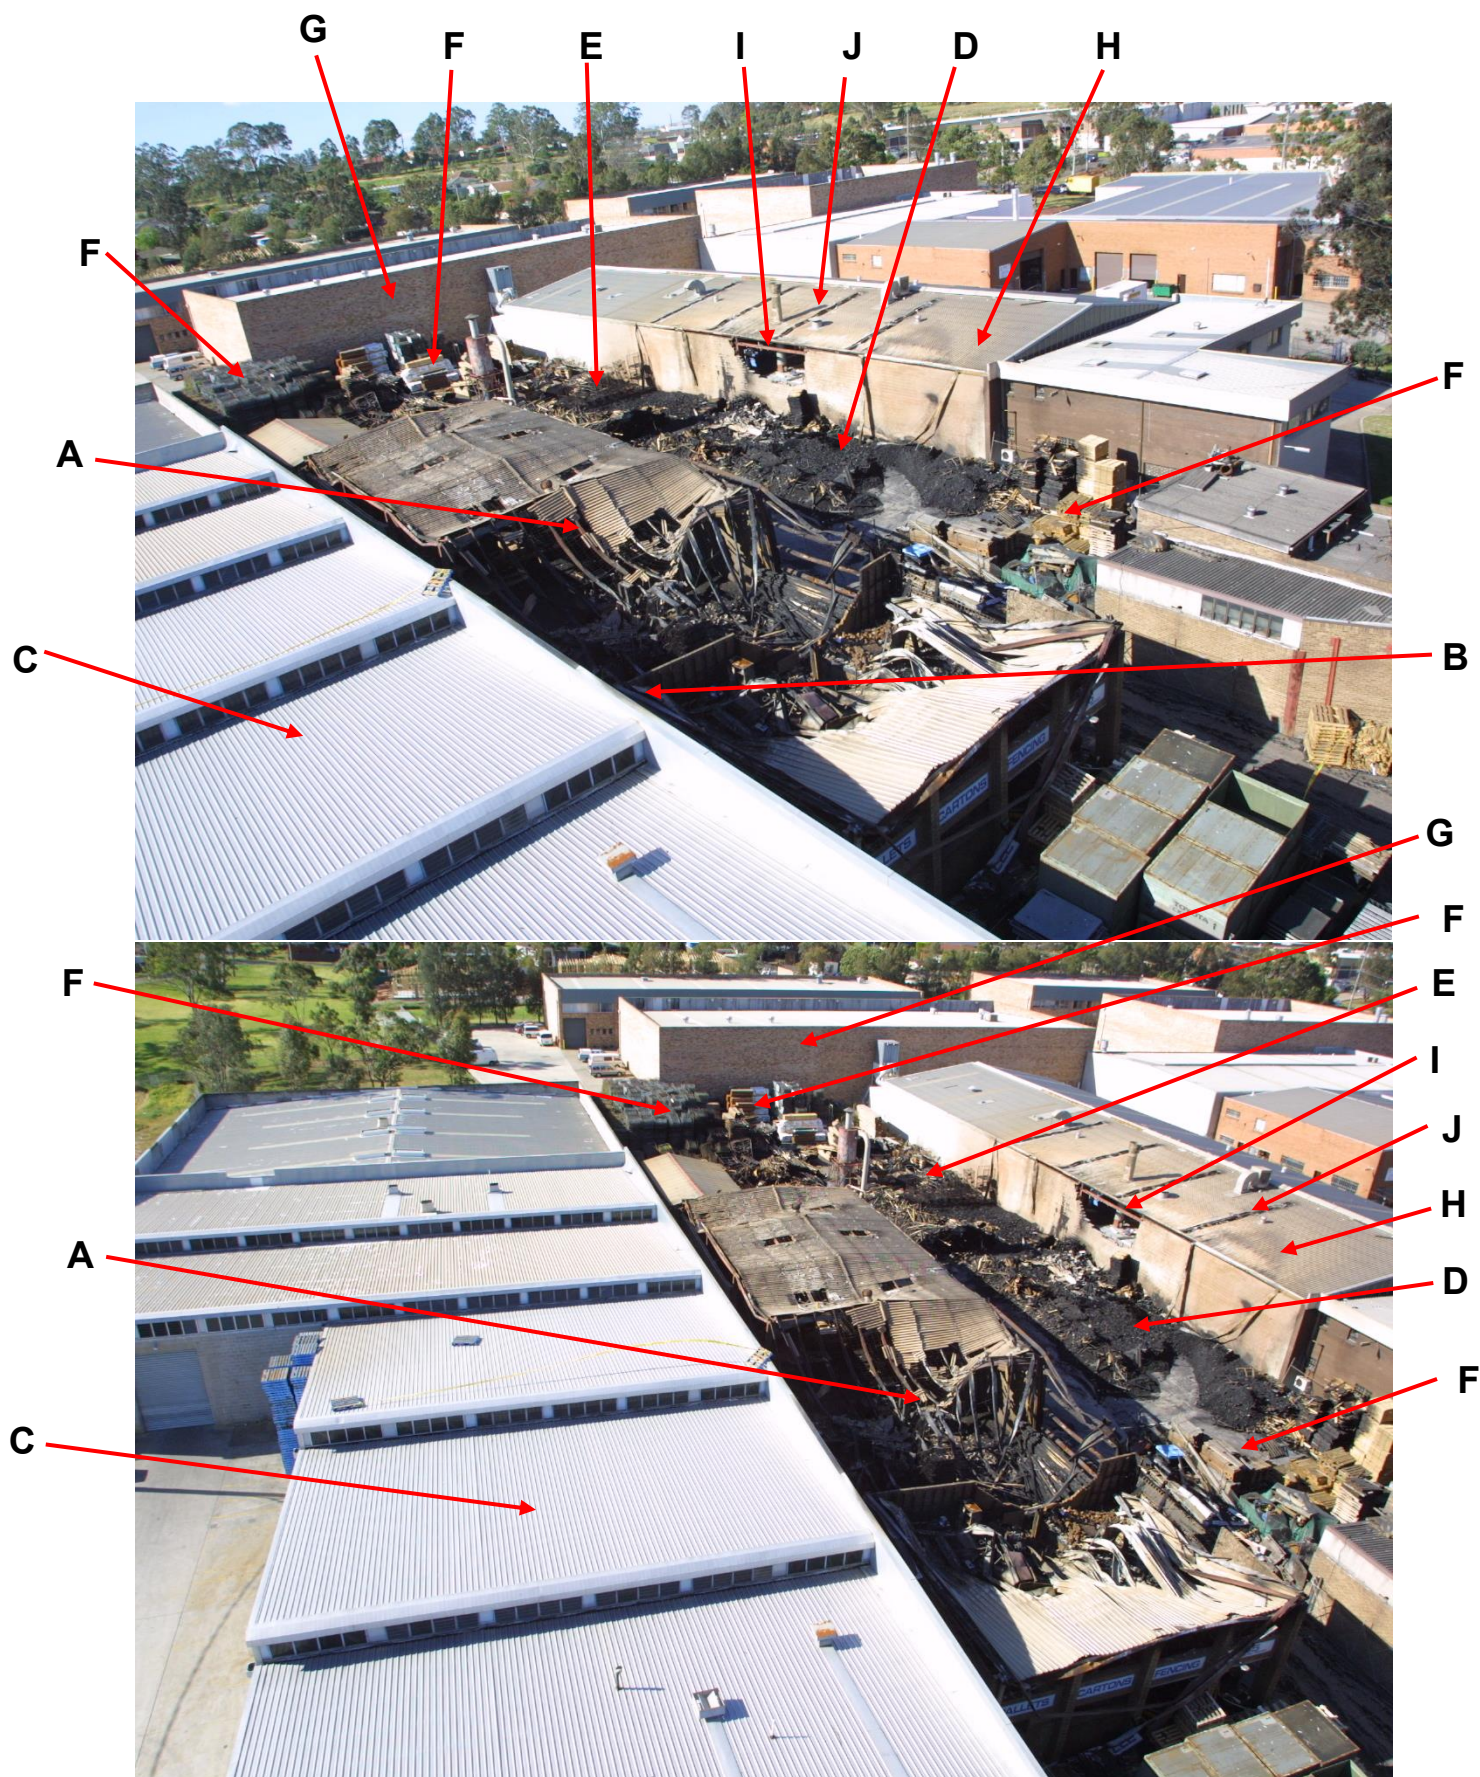
Aerial view of the fireground, indicating the intensity of the fire and the close proximity of exposures.

**A** - Involved factory. **B**- Collapse wall of fire building allowing fire to impact Exposure B. **C** – Exposure B warehouse. **D** - Remains of pallet stack. **E** – Timber stacks involved in fire. **F** - Timber stacks saved. **G**- exposure C. **H** - Exposure D. **I** - Breach in Exposure D wall. **J** – Burnt out roof skylight panels above Exposure D.

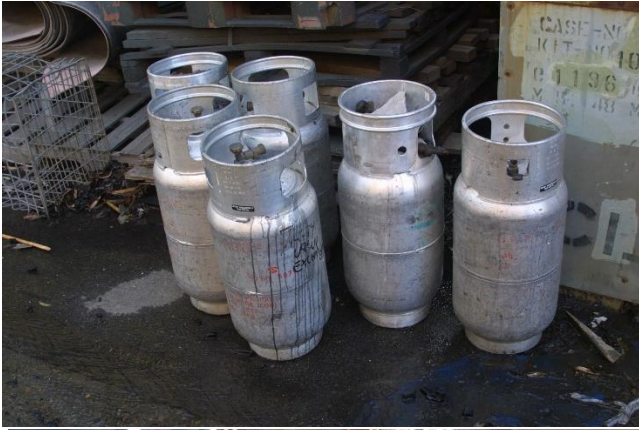
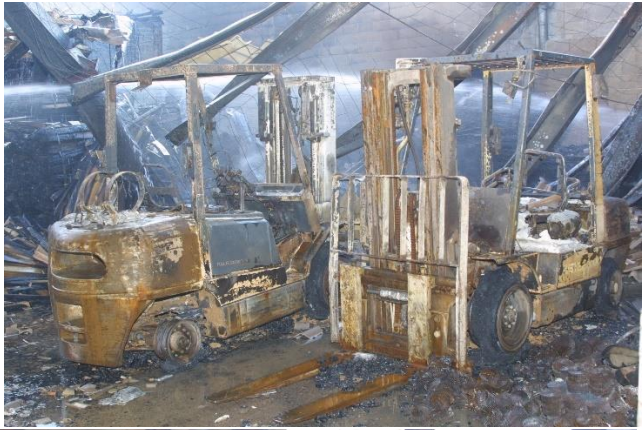
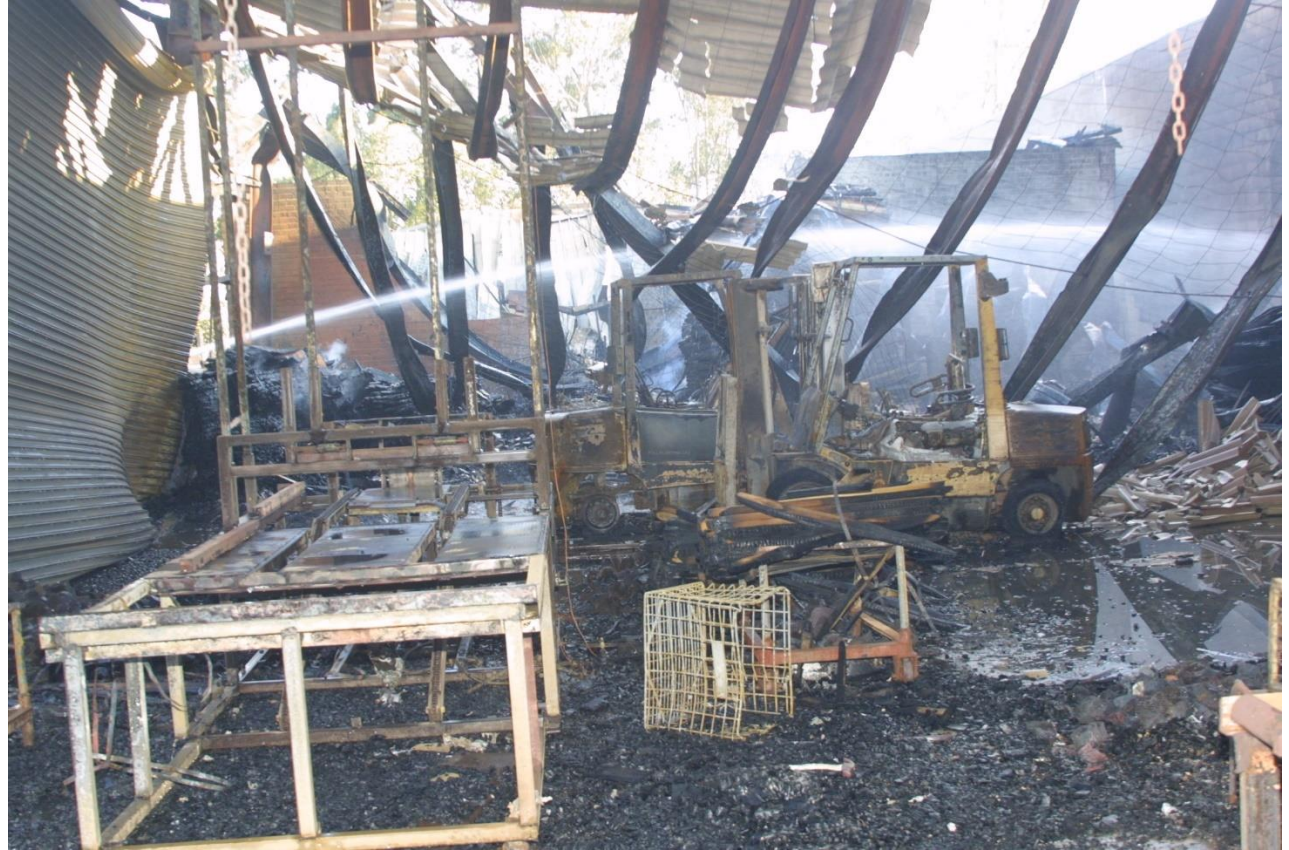
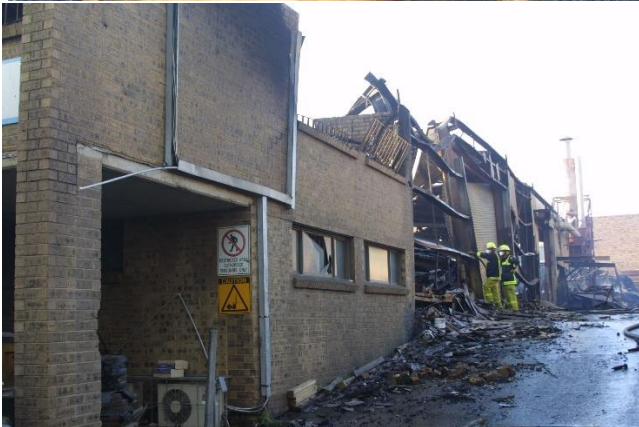
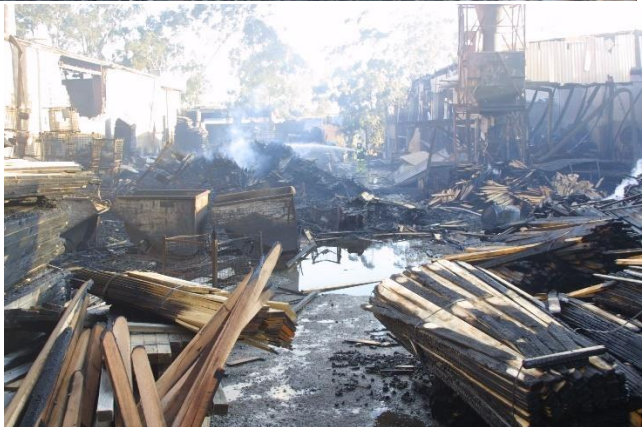
Top left: 15 kg LPG cylinders located in the factory yard. Top right: Two LPG powered forklifts inside the factory  
Both LPG cylinders were involved in BLEVEs. Middle: Interior view of factory. Structural steel has been destroyed. Lower left: View of the driveway into the factory yard. Lower right: Post fire view of the timber stacks in the factory yard.

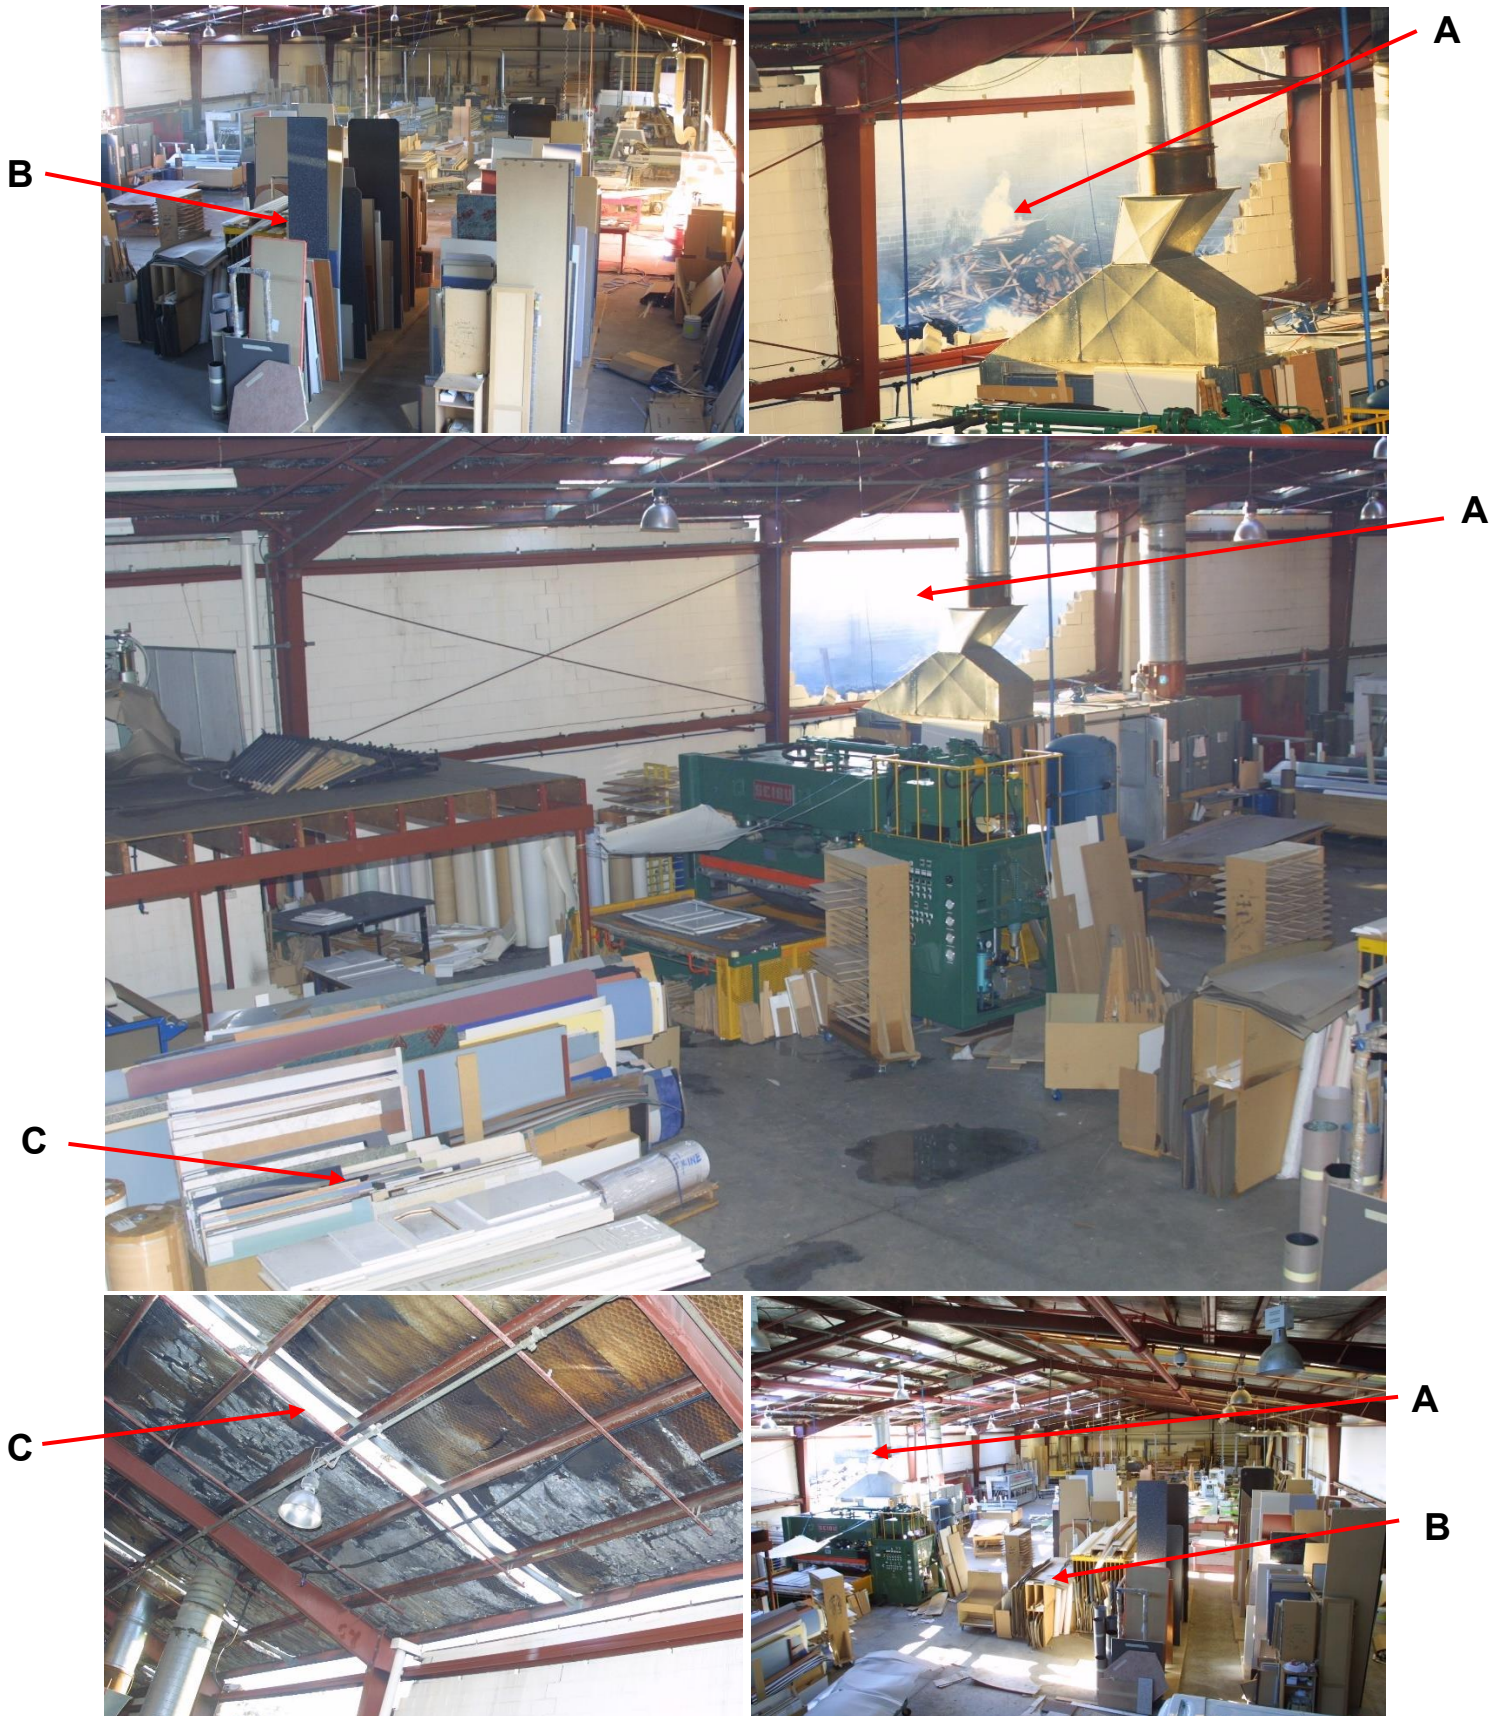
The intensity of fire from the burning pallet stack was so severe, a 10-metre section of "Besser" block wall along the western side of the Exposure D wall collapsed into the fire, allowing the fire to directly impact the interior contents of the factory. Pumper 67 firefighters Peter Watson and John Lewis positioned a ground monitor inside the factory and directed the monitor stream onto the opening created by the wall collapse, stopping fire from entering the factory through the breached wall. Two 70 mm lines from Pumper 72 supplied water to the ground monitor. Pumper 72 Captain Fitzhenry was operating a forklift inside the factory, moving timber stacks away from the wall breach out of danger.

**Exposure D:** Fire intensity caused (A) a large section of the western wall to collapse, allowing fire to enter factory. Firefighters fought a determined battle to stop the fire spreading into the exposure, which contained (B) large quantities of combustible materials. Intense radiant heat also caused the (C) roof skylights to melt, creating large openings that allowed embers to enter the factory. Due to the efforts of firefighters, the factory was saved.

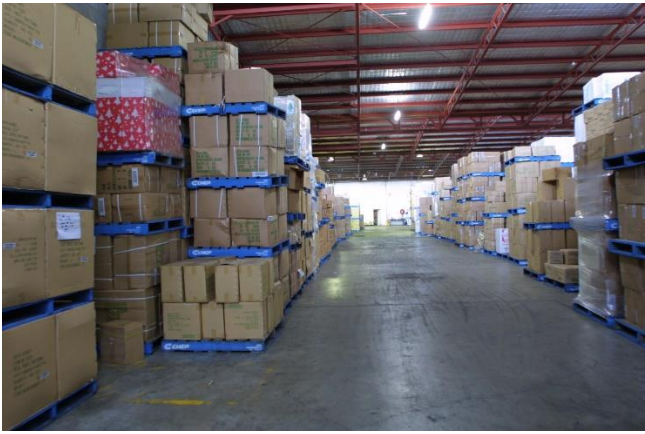
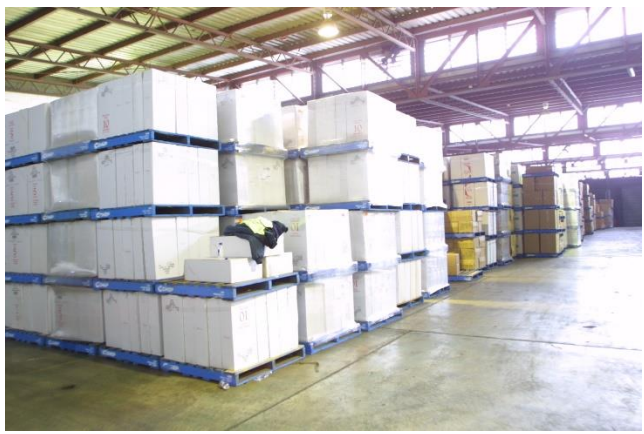
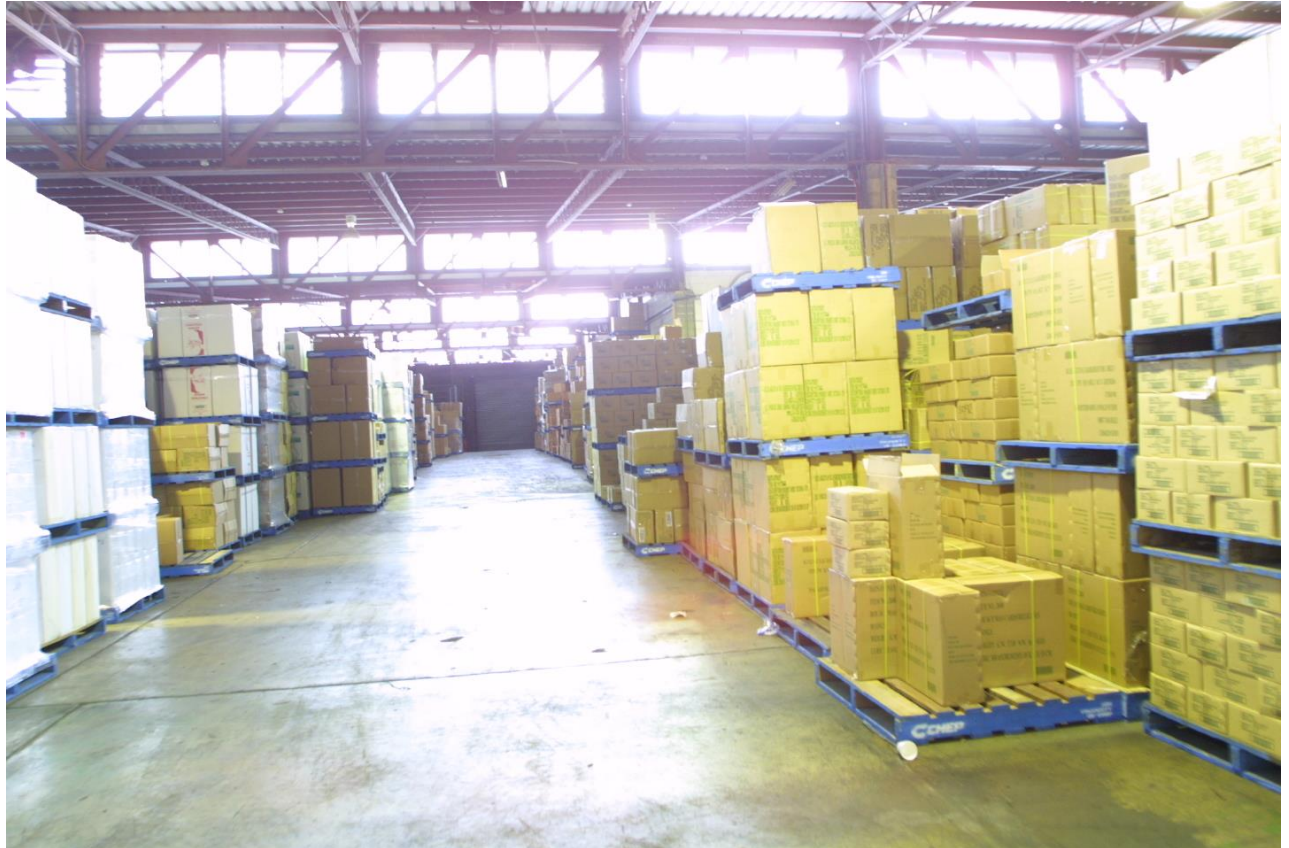
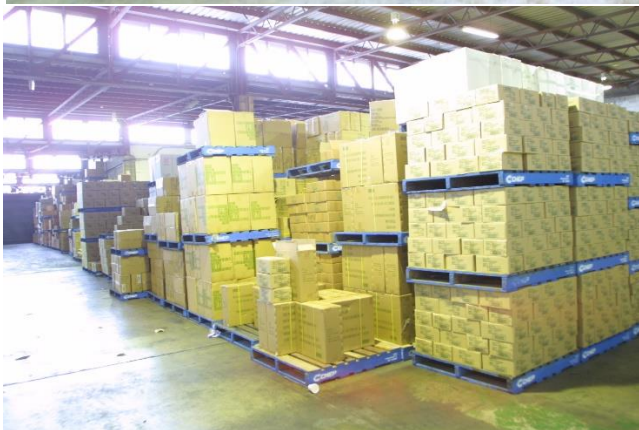
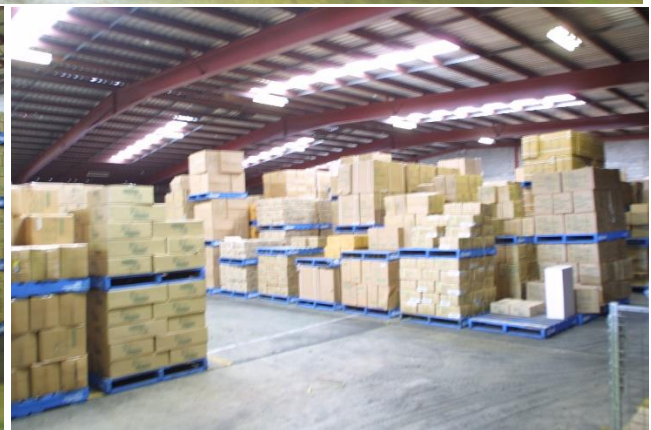
Fire was now burning so fiercely within the fire building, the western wall of the factory had collapsed, allowing flames to directly impinge onto the Exposure B walls. Exposure B was a large warehouse, 100 m x 40 m, completely full of stock, stacked in cardboard boxes on pallets, from floor to ceiling; this stock mainly consisted of plastic Christmas trees and decorations. Exposure B was separated from the fire building by a gap of thirty centimetres. The vertical aspects of the sawtooth roof were formed from glass panels, which were now being heavily impacted by heavy flames and intense radiant heat.

**Exposure B:** Exposure D was under severe attack for a number of hours. The wall of the involved factory collapsed, allowing flames to impact the eastern wall of the Exposure B warehouse. Ladder Platform 27 protected the eastern wall of the warehouse. Firefighters located inside the warehouse operating forklifts moved approximately 60 pallets of stock away from the wall closest to the heavily involved factory. The warehouse and all stock were saved.
