MW1 C STATION TRAINING AND INCIDENT CASE STUDIES

FILE NO. 2024 /02.

MILPERRA 6th ALARM TIMBER JOINERY FIRE

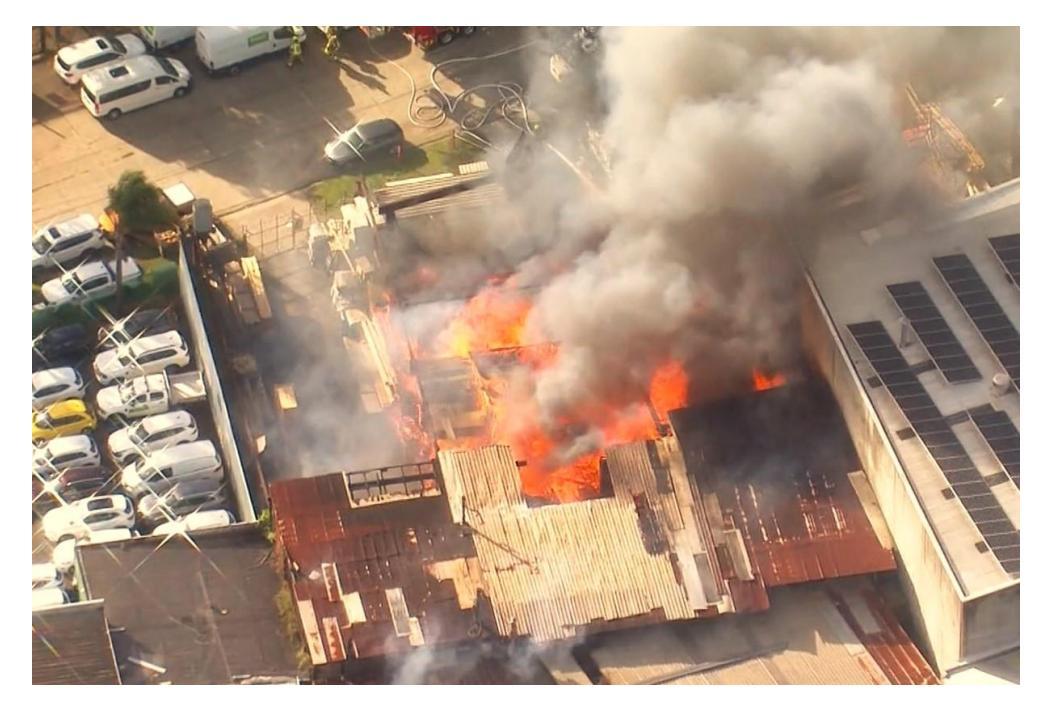
When firefighters first arrived on scene, they found the middle of the timber yard burning fiercely.

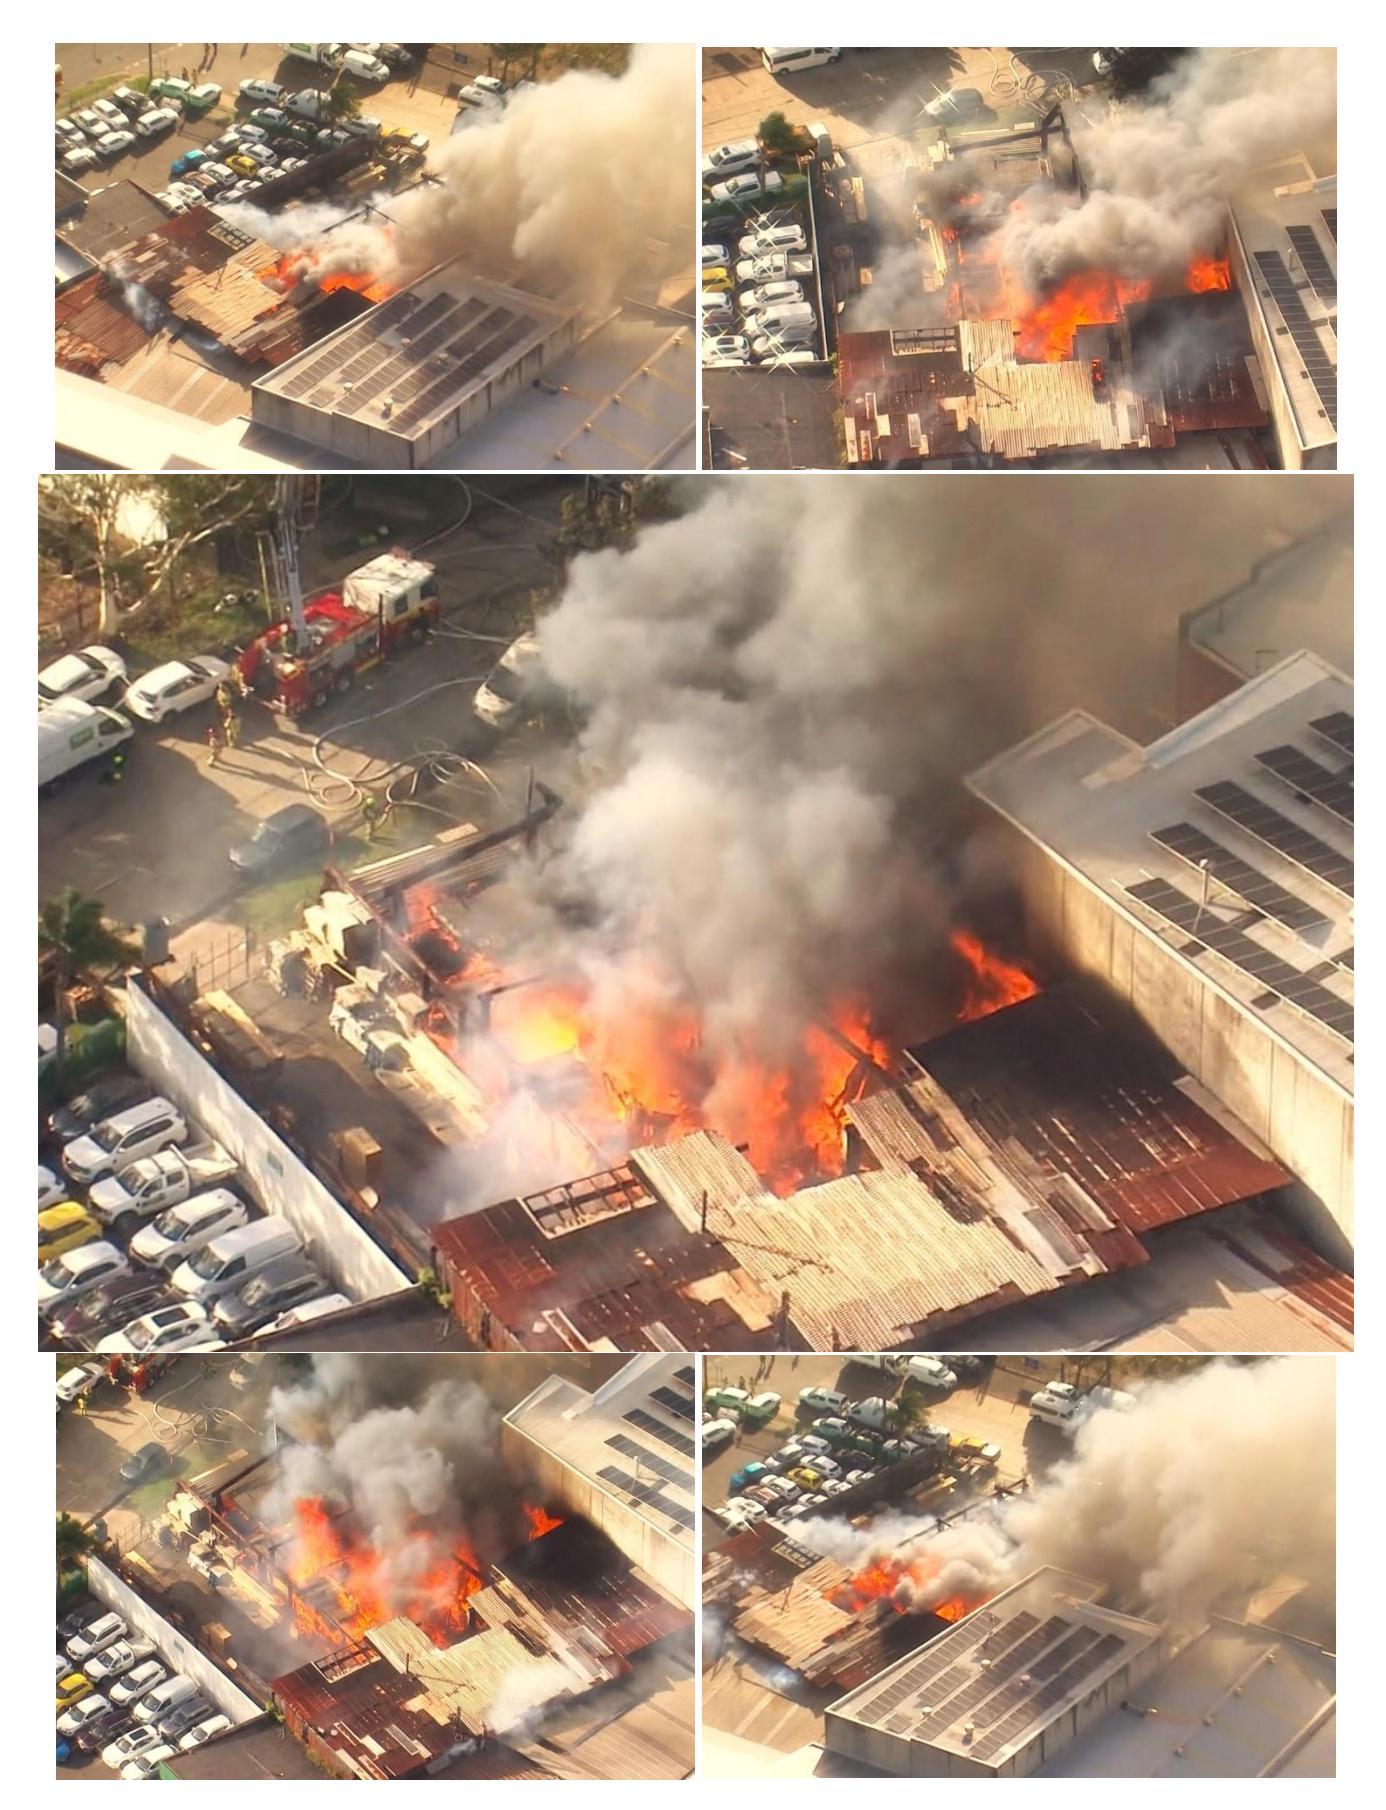
The Main Fire Occupancy shortly after firefighters arrived on scene. The fire is already at an advanced stage and has breached through the roof above the middle of the yard.

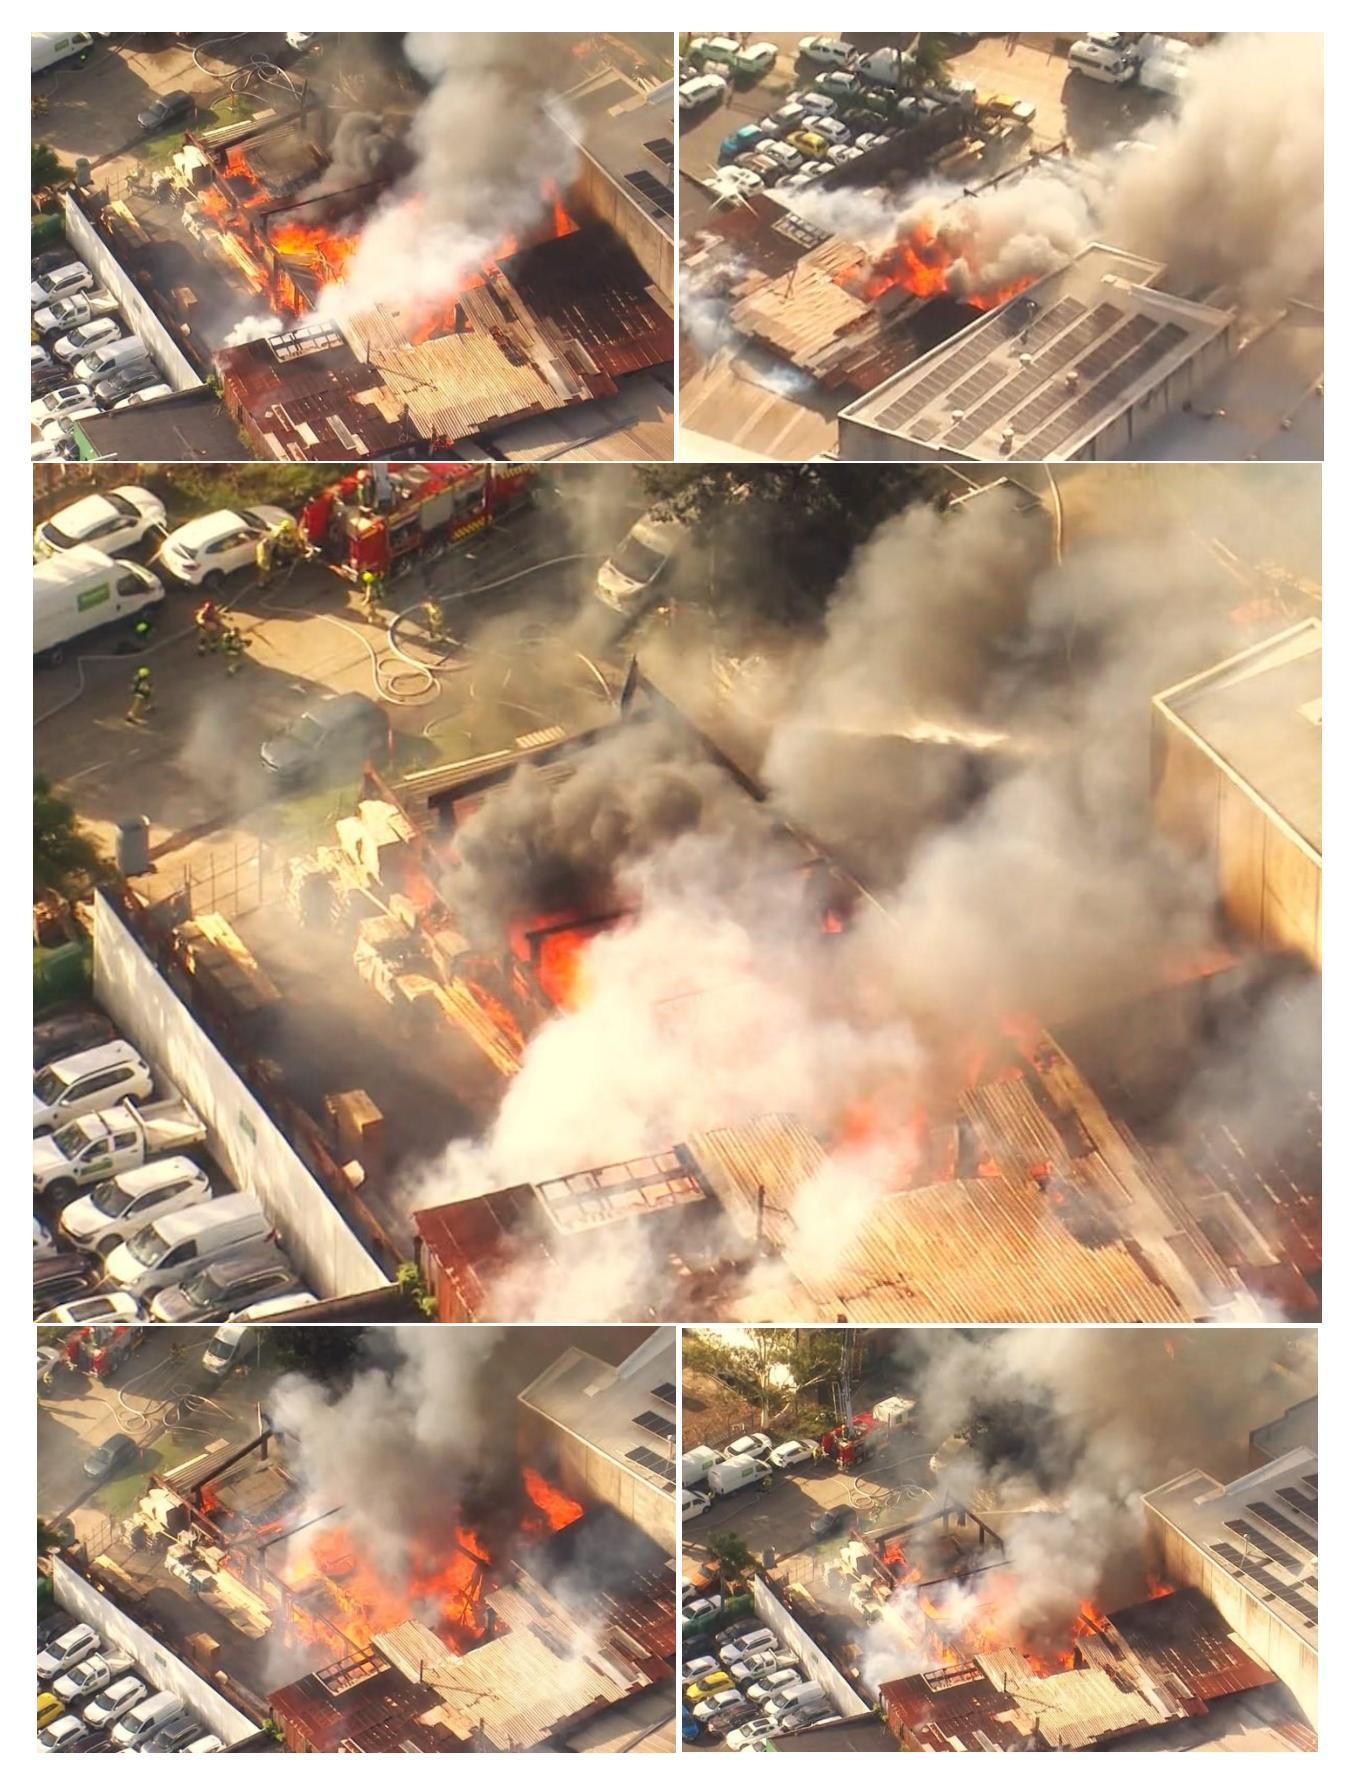
Fanned by strong winds, the fire burns intensely within the timber stacks. Dark coloured smoke is indicative of hydrocarbon-based products stored at the site, including various fuels, cleaning products and lubricants for the numerous machines at the site. Firefighters have established protection of Exposure Bravo which is being impacted by fire.

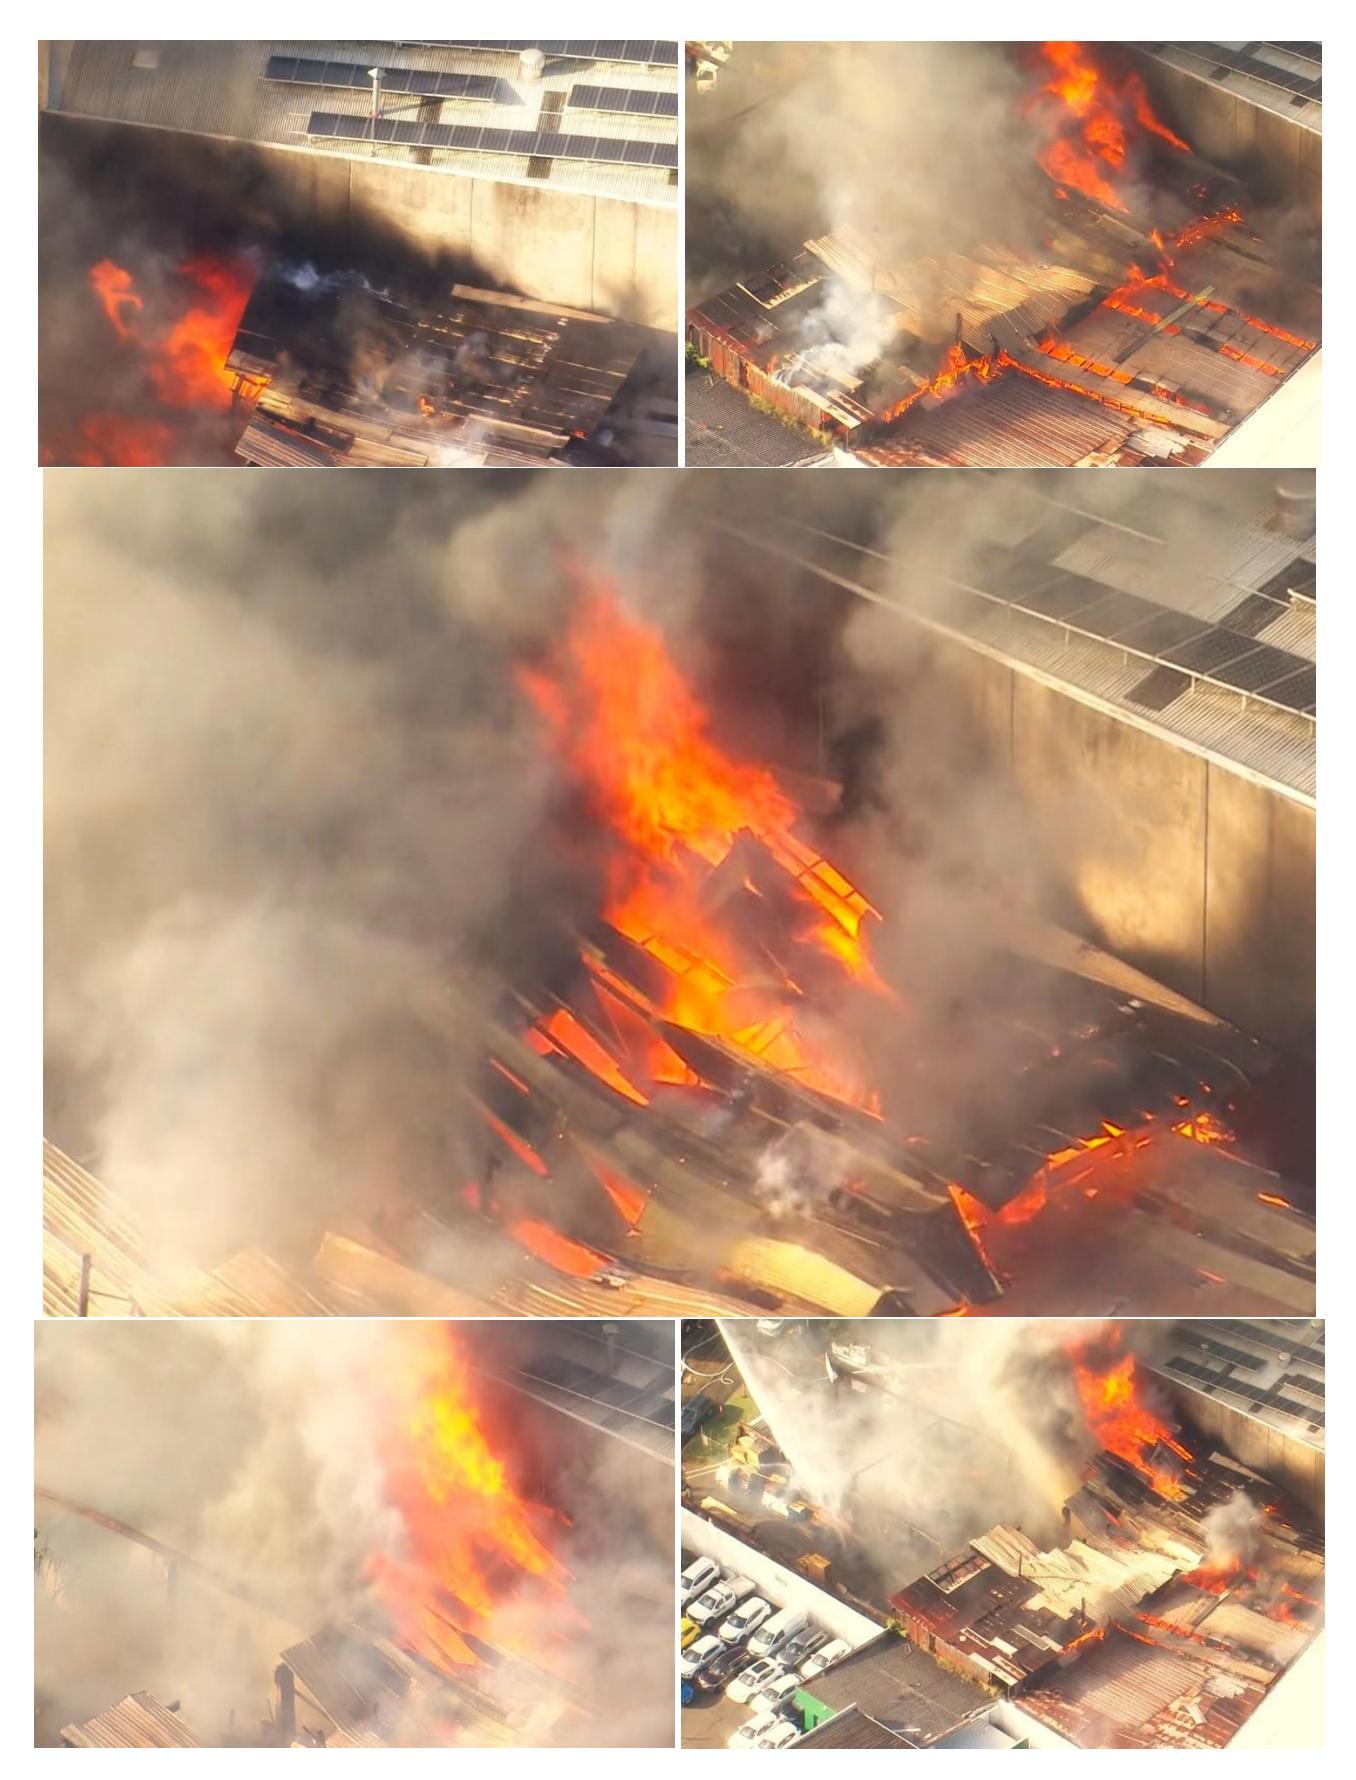
Conditions resulted in the formation of a wind driven fire. Winds were gusting at almost 50 km/h. A wind entry point existed on the open sided southern end of the structure. Flames vent at the north western corner of the structure, producing a characteristic superheated gas exhaust. The presence of oil-based products in the yard allowed a hydrocarbon-enriched atmosphere to develop in the fire combustion zone, greatly increasing fire intensity. Firefighters encountered ferocious fire conditions.

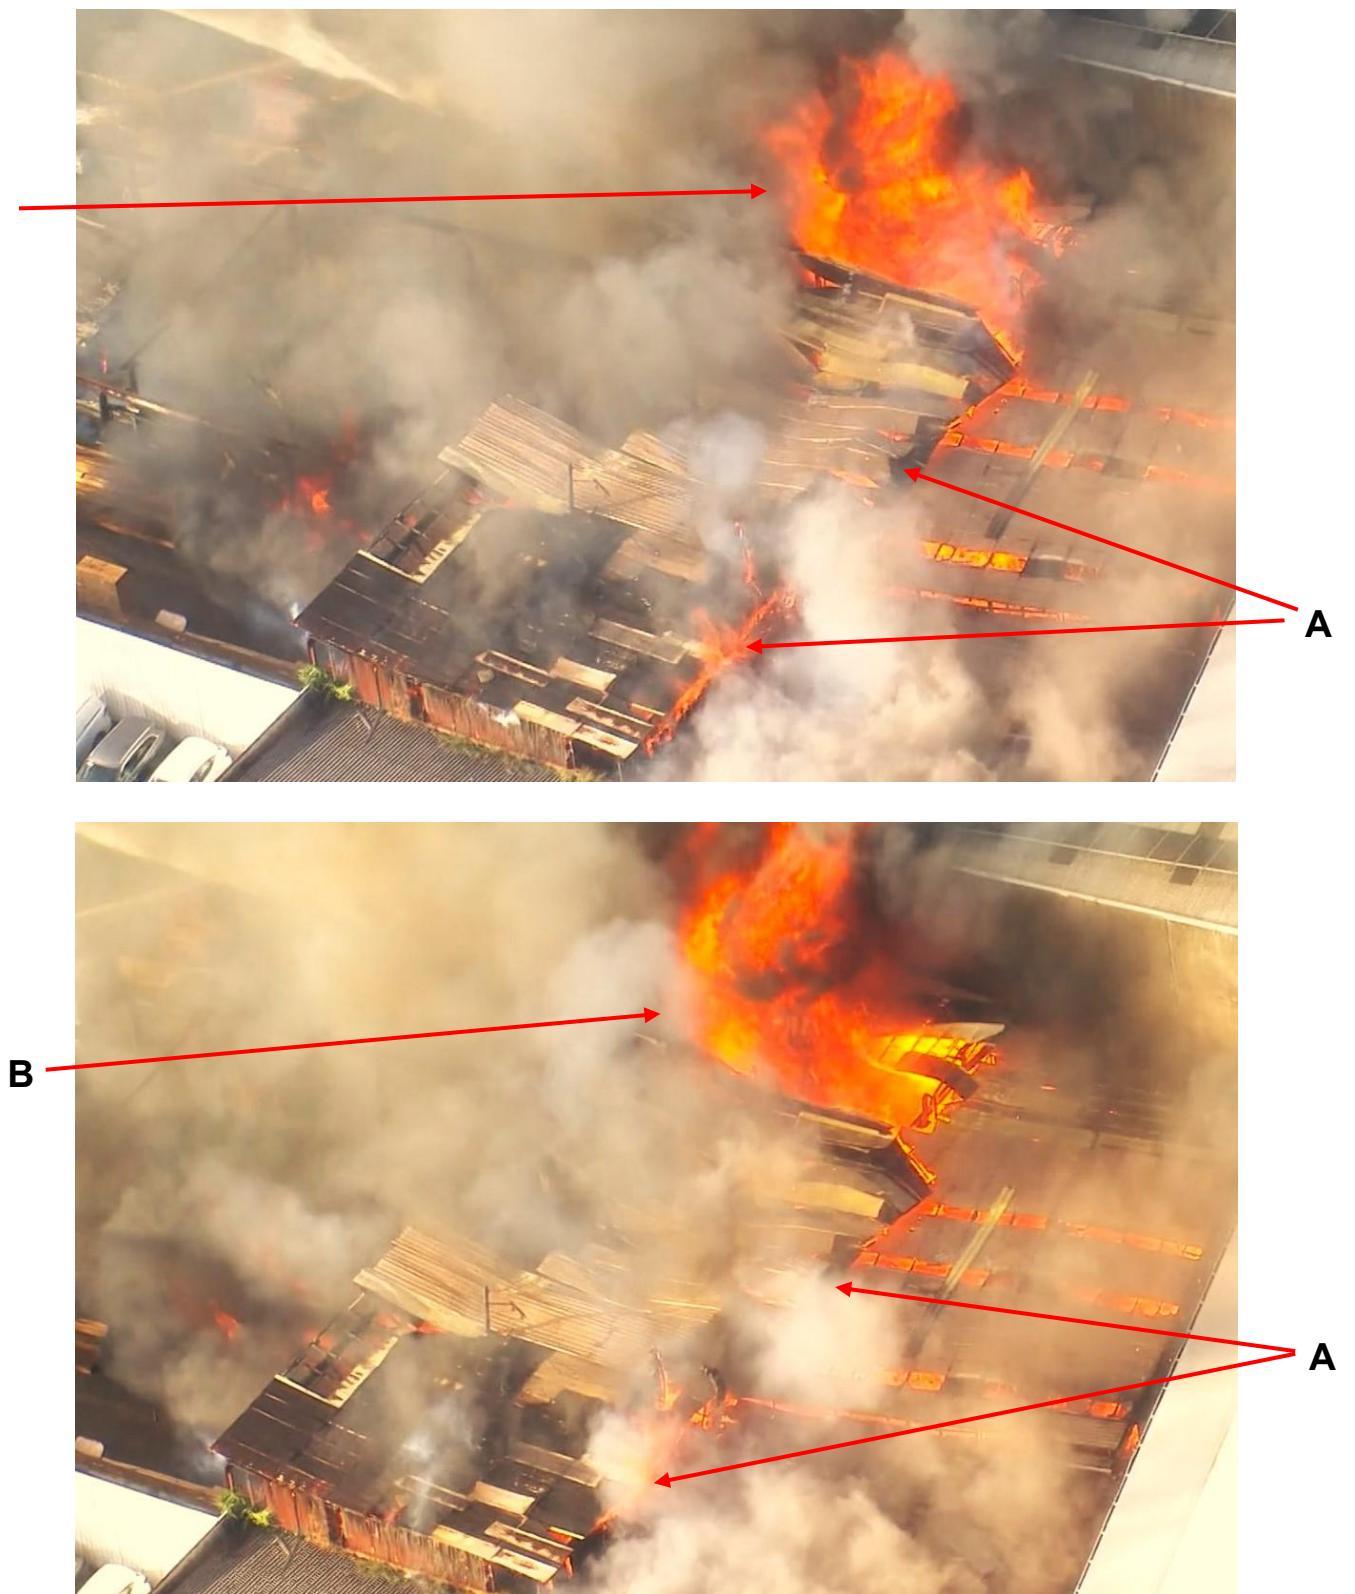
Key elements of a wind driven fire: **A** Wind Entry Point, on the up-wind side of the structure. Although flame is visible, it is not venting from this opening (being held in by wind pressure). **B.** Fire Vent Point. Large flames are being released from the fire vent point, on the down-wind opening of the structure. Within the structure, extreme levels of combustion take place, due to the pressurised and oxygenated air flow mixing with the hydrocarbon enriched atmosphere. Fire intensity is much greater than would ordinarily be encountered due to these factors. This type of extreme fire behaviour is not common, however can occur on windy days. The flames venting in the bottom photograph are more consistent with flammable vapour ignitions, indicative of the "hydrocarbon-rich" nature of the venting un-burnt pyrolysis gases.

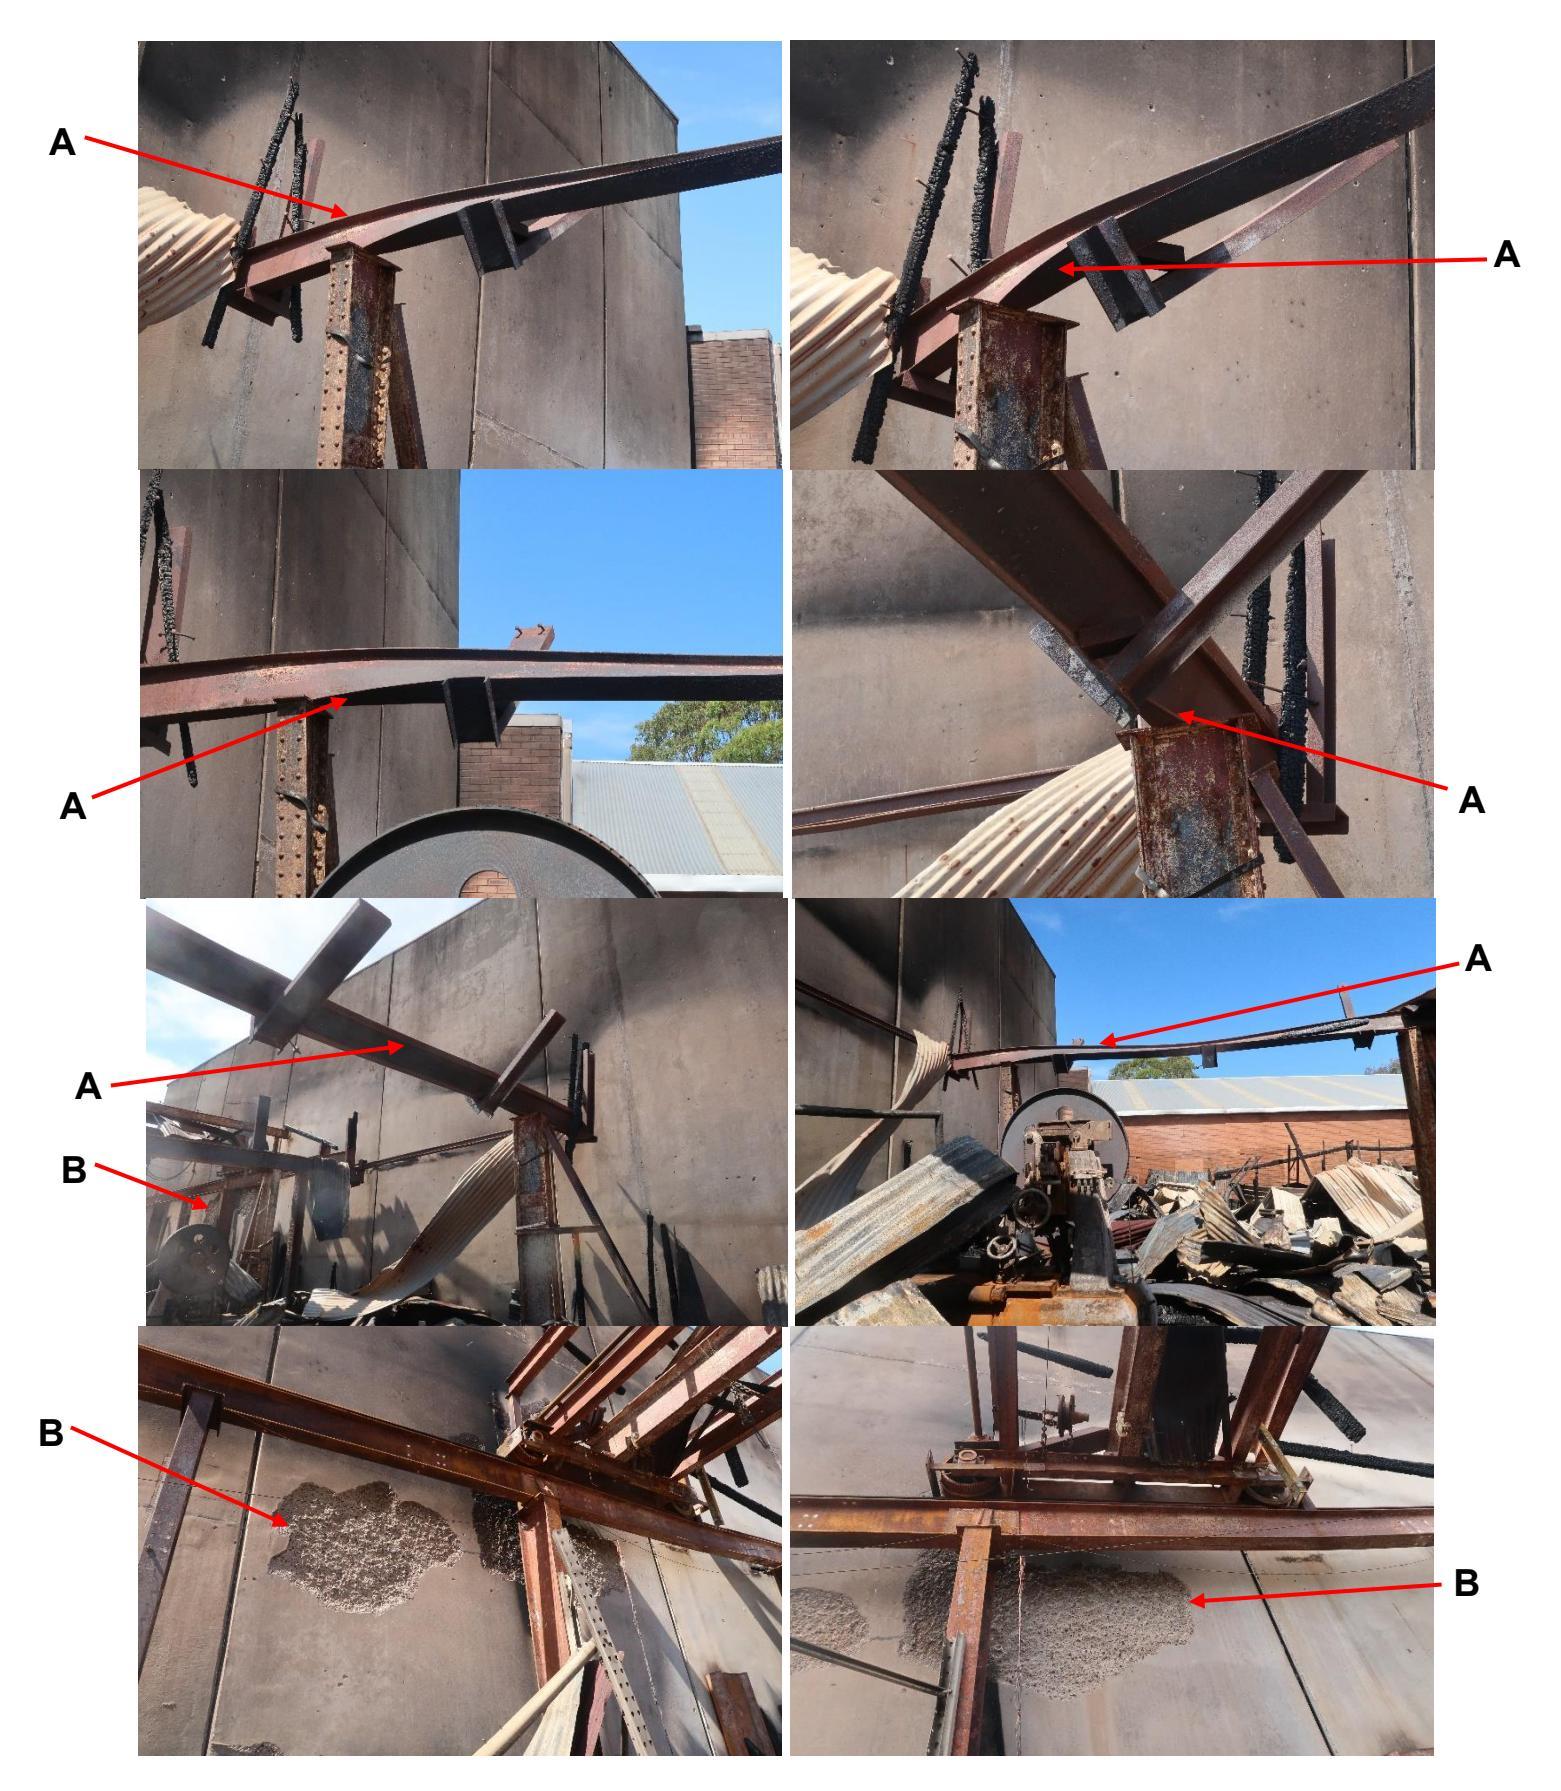
Fire impact was so fierce, that post fire examinations would reveal severe concrete spalling due to the intense nature of fire impact. The cooling stream from the single inlet monitor was having a significant impact protecting this exposure. Venting flames continued to heavily impact the second level glass frontage of Exposure Bravo. Firefighters used a 70 mm protection line to direct a cooling stream onto the glass frontage, providing sufficient protection to prevent the glass from failing.

The wind driven fire produced intense venting superheated gases, causing the steel to lose tensile strength and twist (**A**) and severe spalling of a pre-cast concrete slab panel (**B**). This damage is indicative of the elevated heat associated with the venting superheated gases produced by a wind driven fire. No where else on the fireground did this level of fire damage occur. Photopgraphs on previous pages 27-30 depict the ferocity of the venting flames.

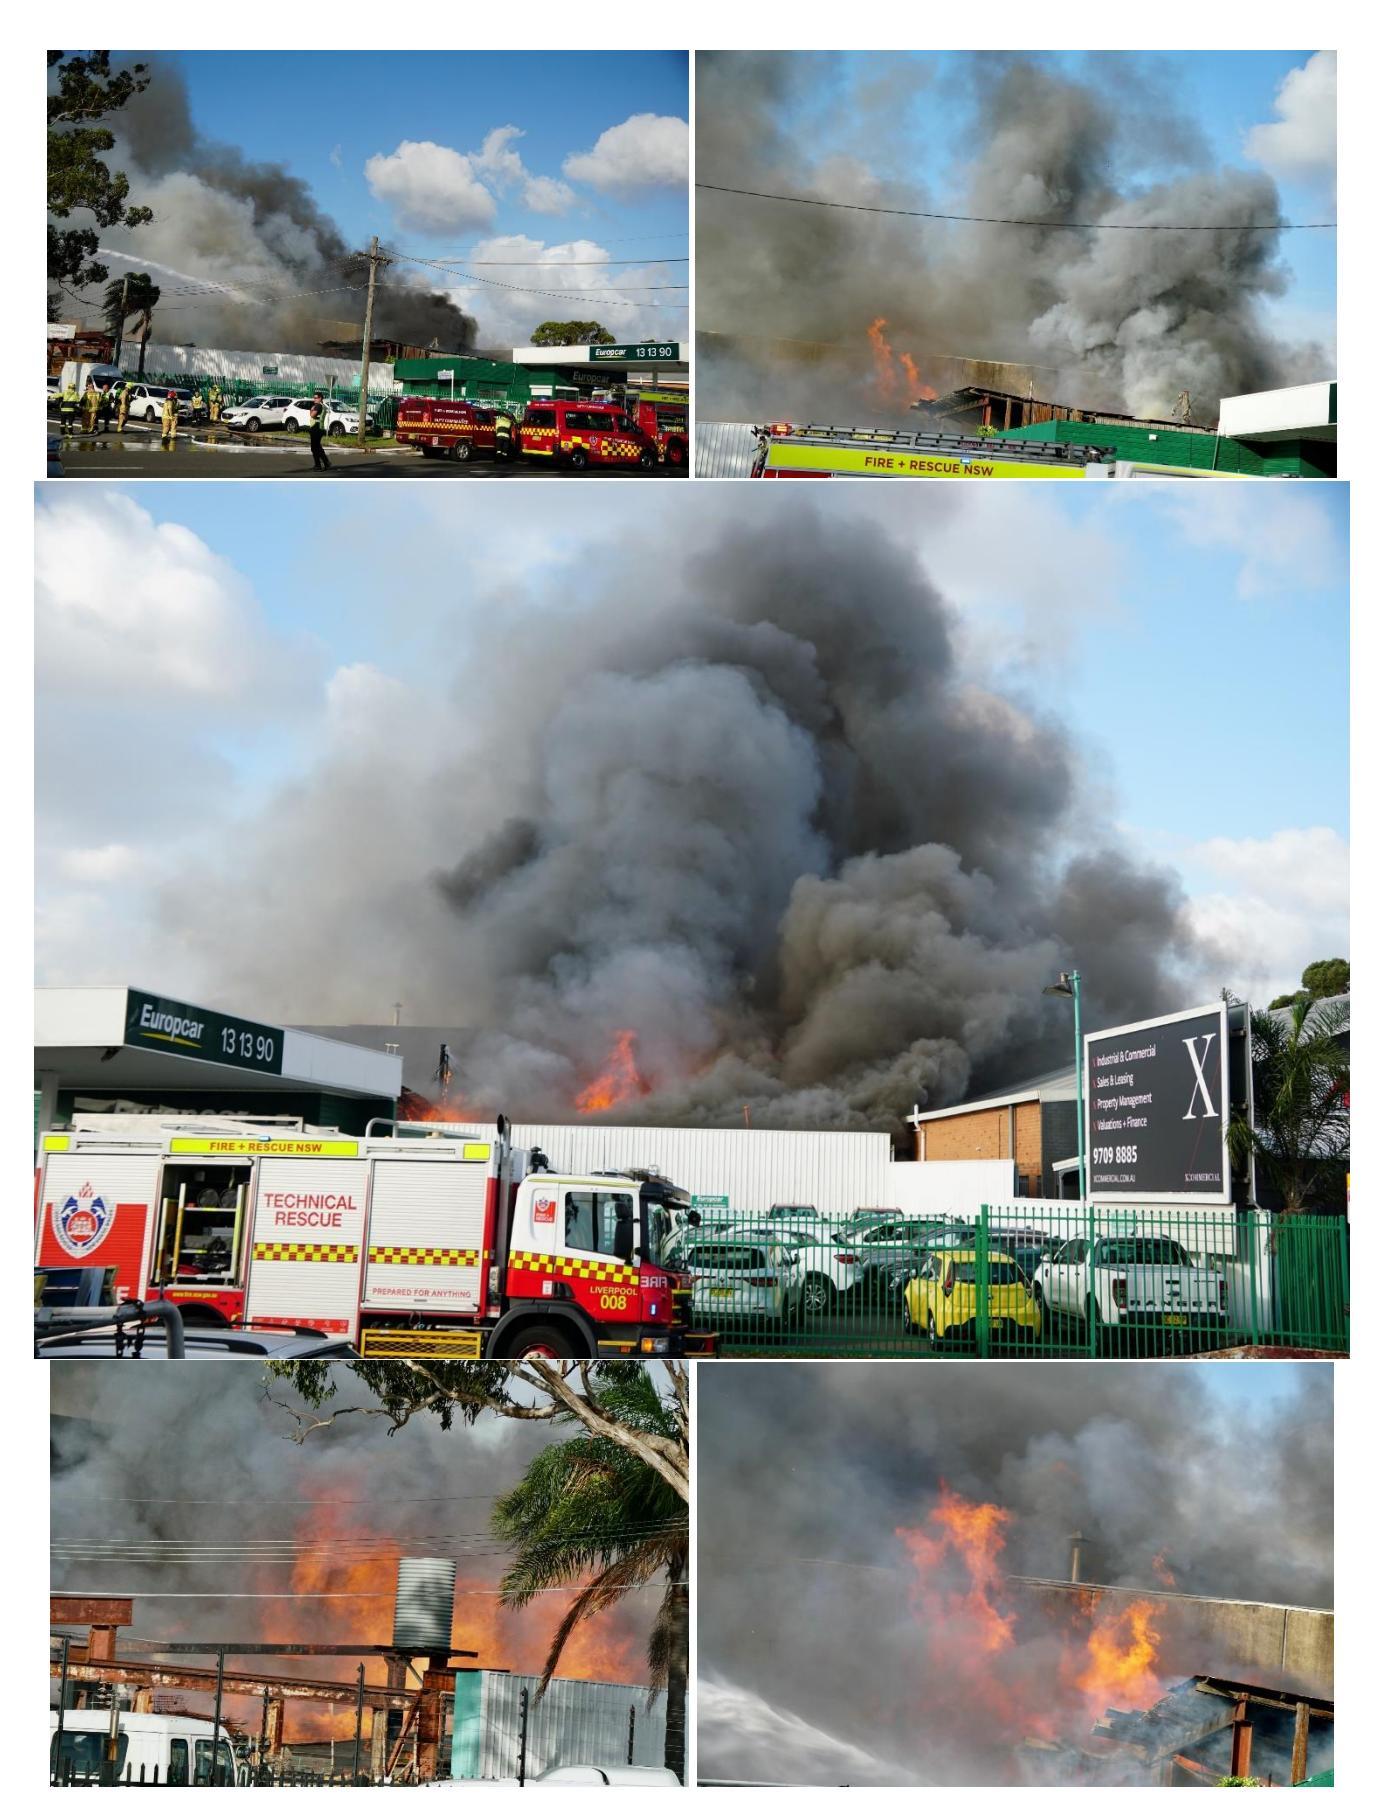
Dark coloured smoke venting from the timber yard is indicative of the hydrocarbon-based materials present at the site, including fuels, lubricants, cleaning products, etc. Fire activity is intense and multiple exposures are under threat simultaneously. Firefighters are systematically establishing protection on all sides of the main fire occupancy.

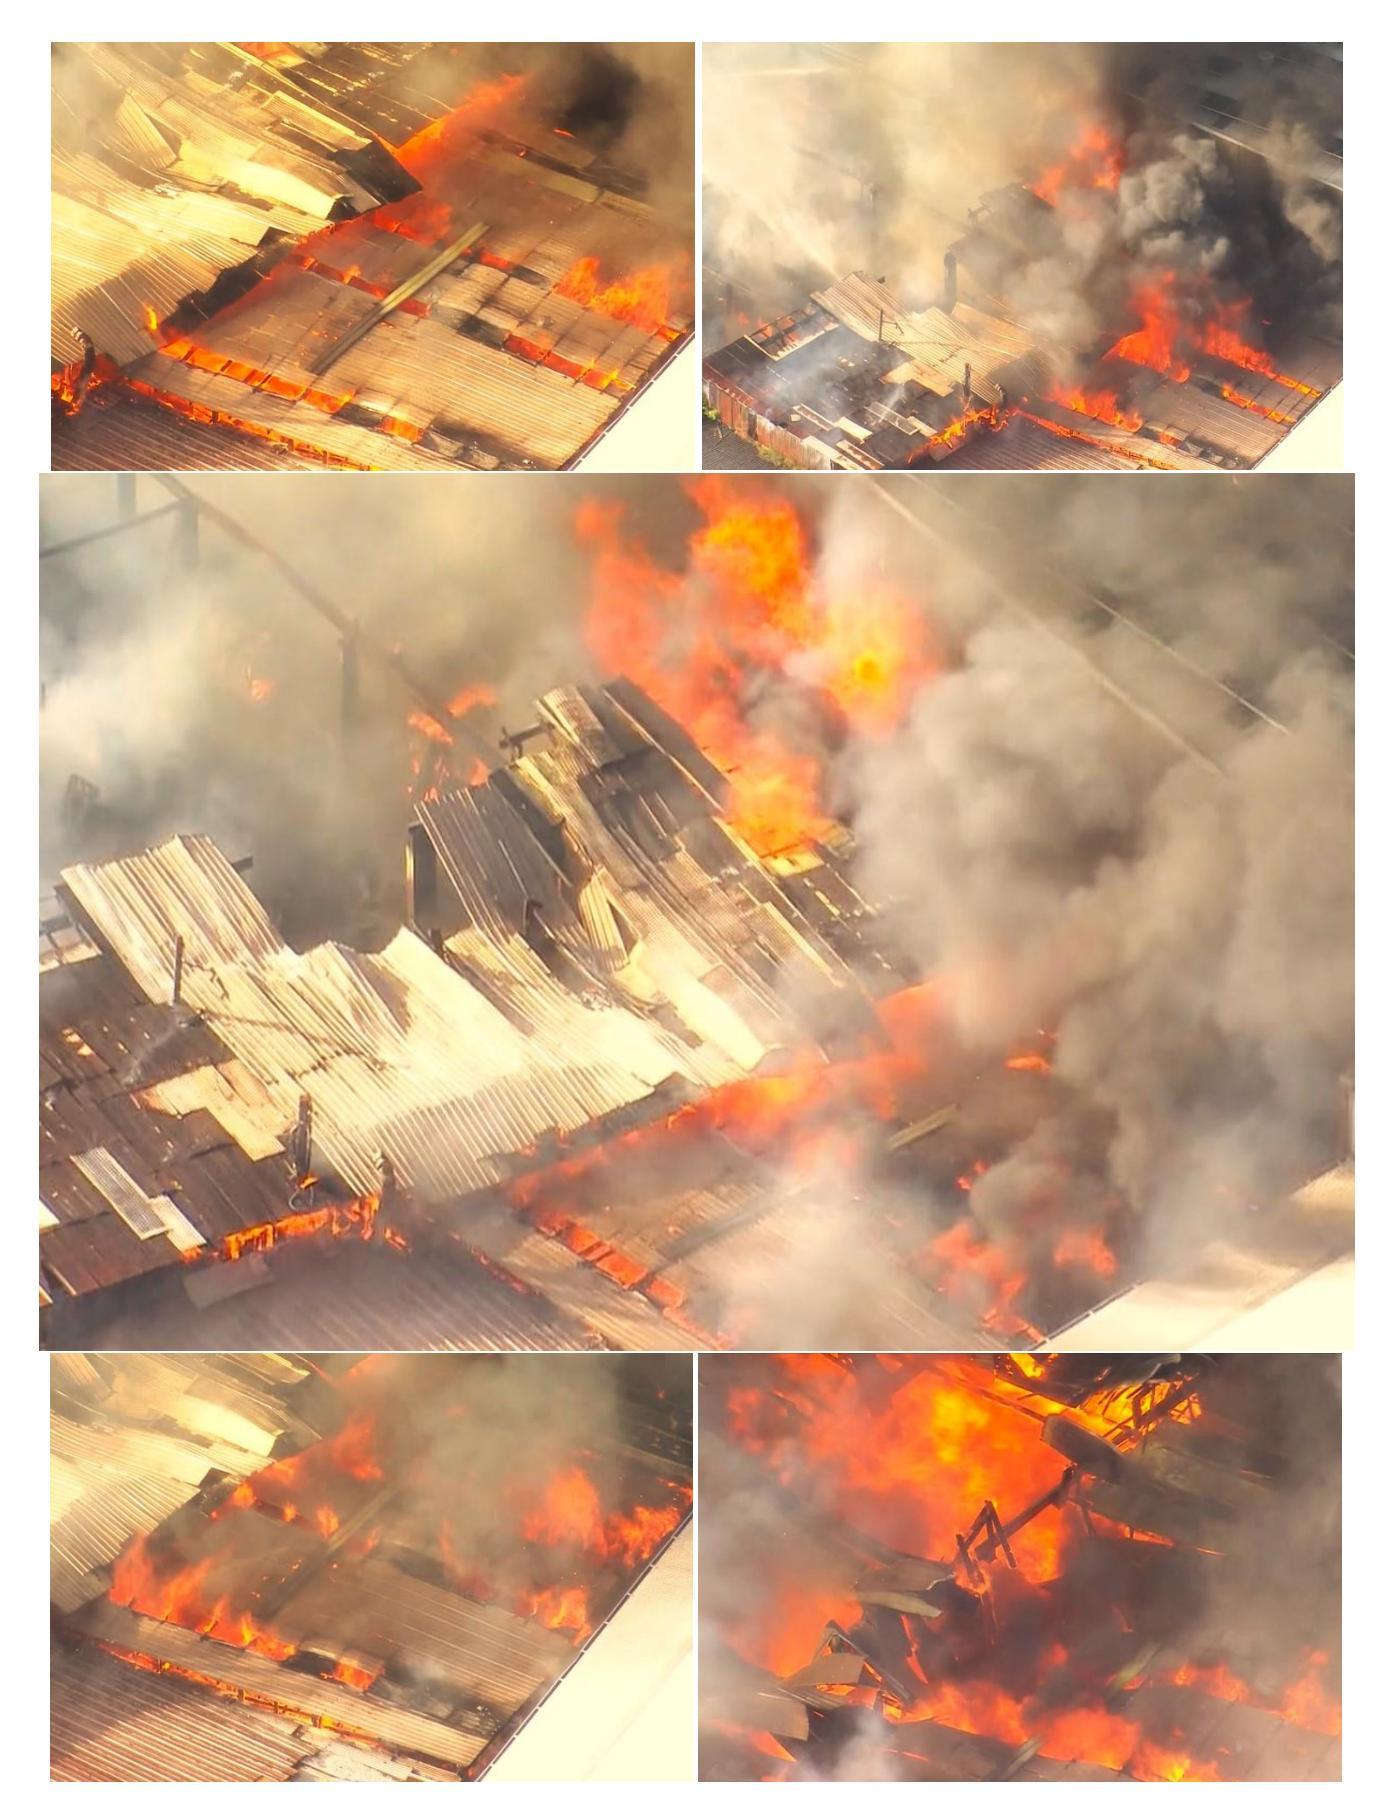
Fire activity is ferocious. The iron-sheet roof held a large amount of heat in the fire combustion area, increasing fire intensity. The iron roof sheets acted as a barrier to the application of firefighting water streams.

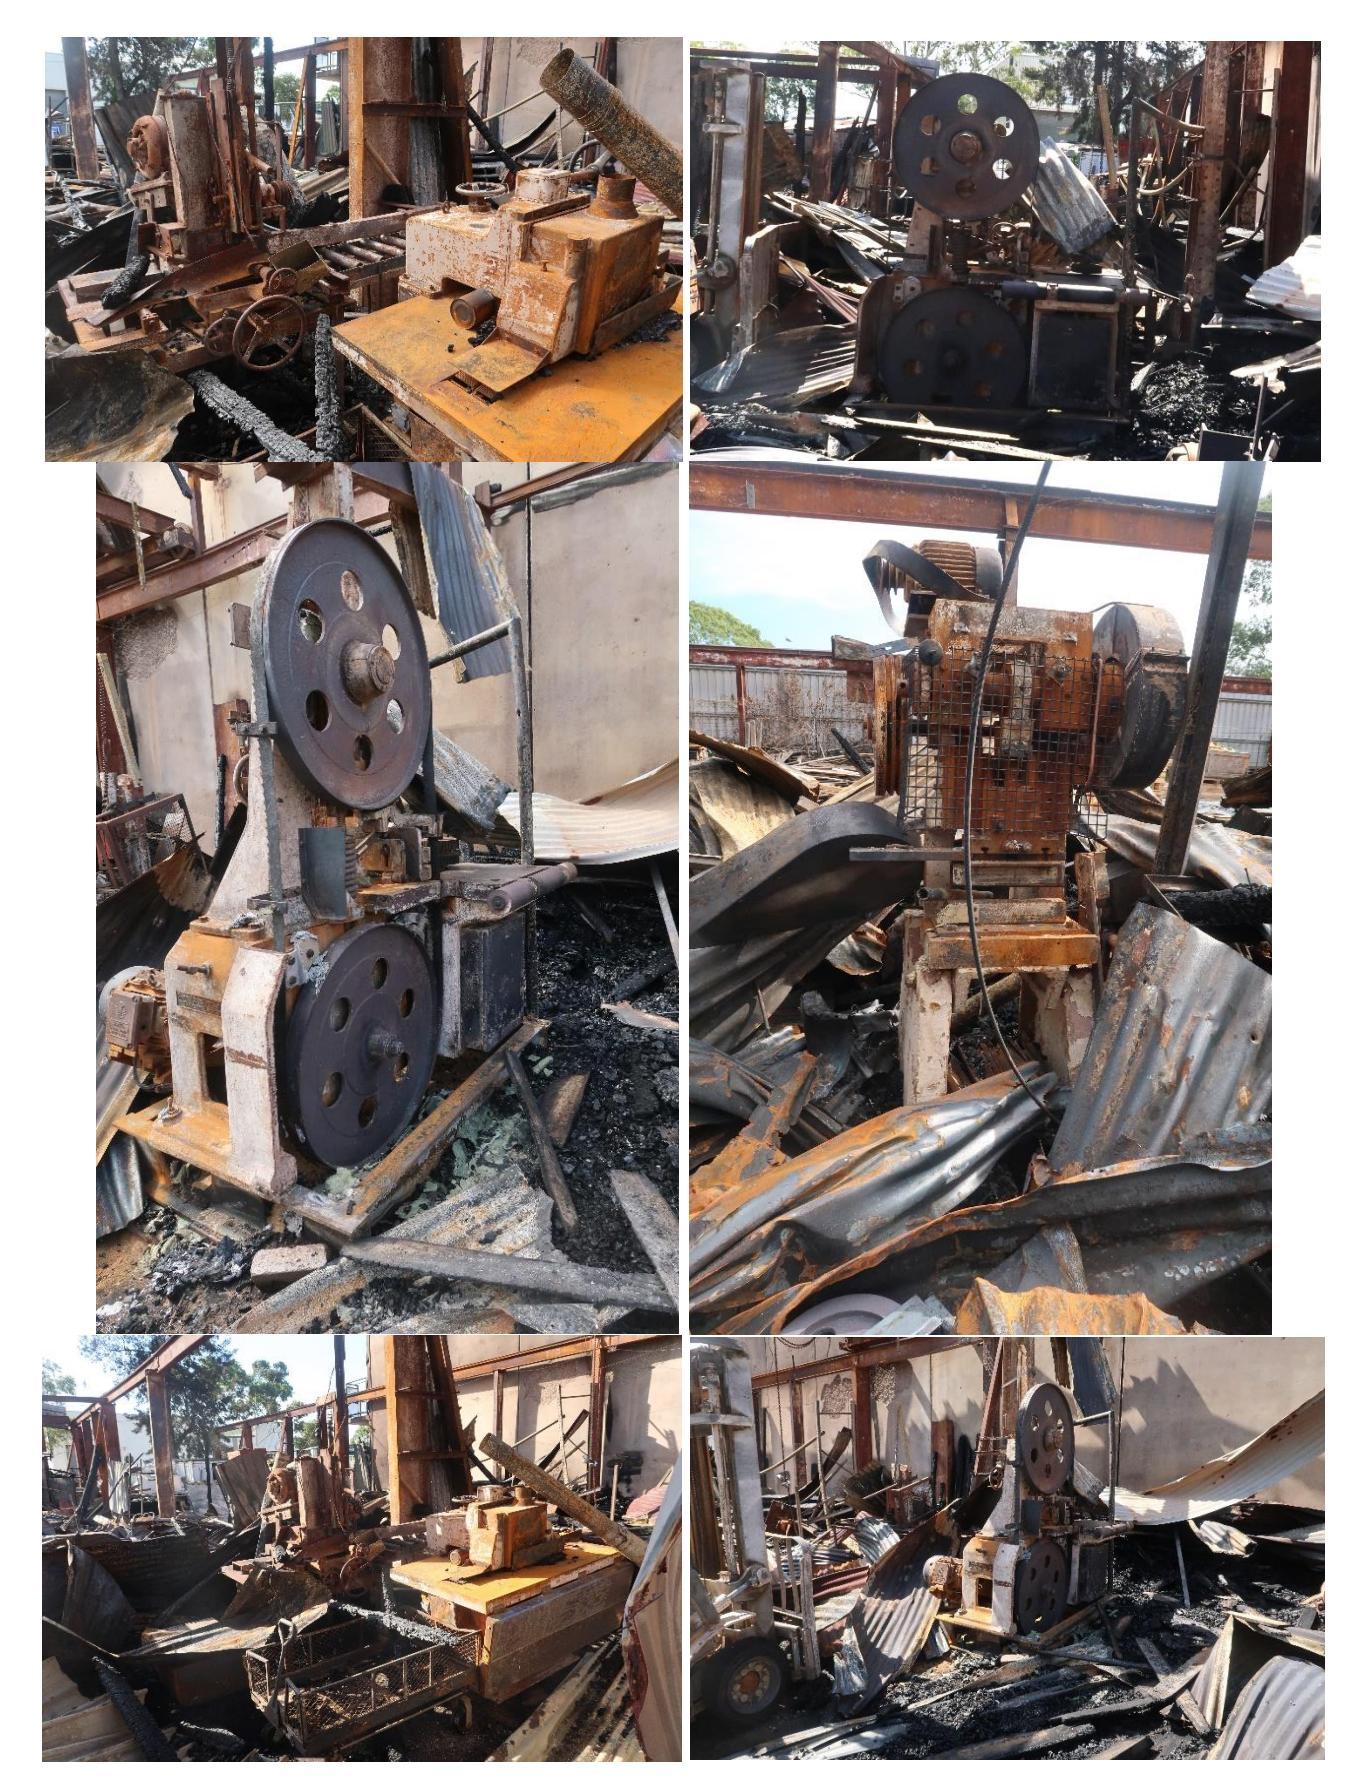
The site contained machinery used in the manufacturing process. The machinery did not contribute directly to fire behaviour, however fuels, lubricants, degreasers, cleaning products and solvents associated with the manufacturing process resulted in conditions of severe fire behaviour.
