MW1 C STATION TRAINING AND INCIDENT CASE STUDIES

FILE NO. 2024 /02.

MILPERRA 6th ALARM TIMBER JOINERY FIRE

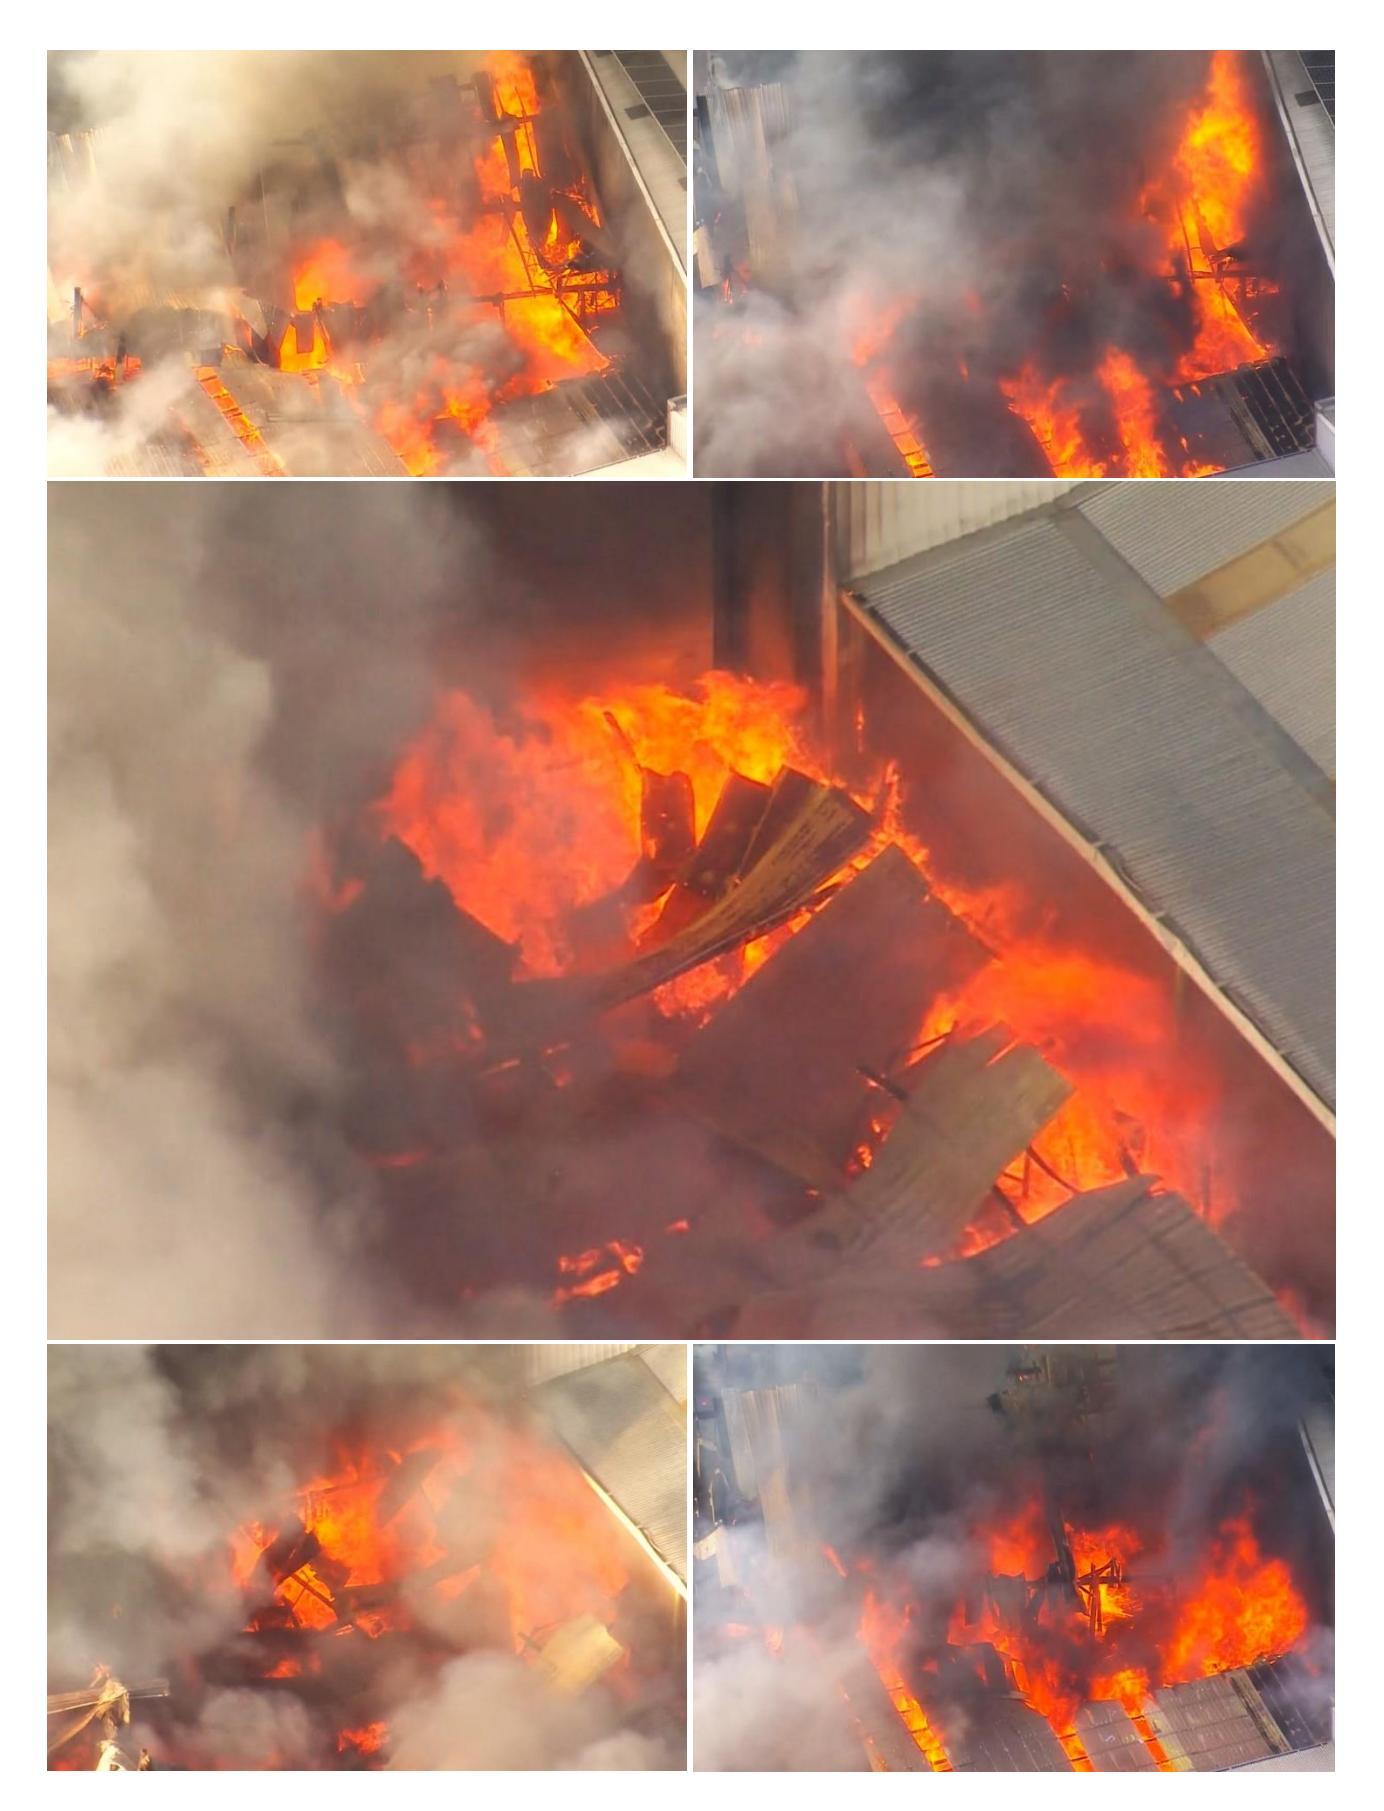
Intense fire is impacting the Exposure Charlie wall. Firefighting operations to protect Exposure Charlie were disciplined and coordinated, involving aerial streams, external protection lines and internal firefighting crews. Despite the ferocity of the fire impact, Exposure Charlie was saved.

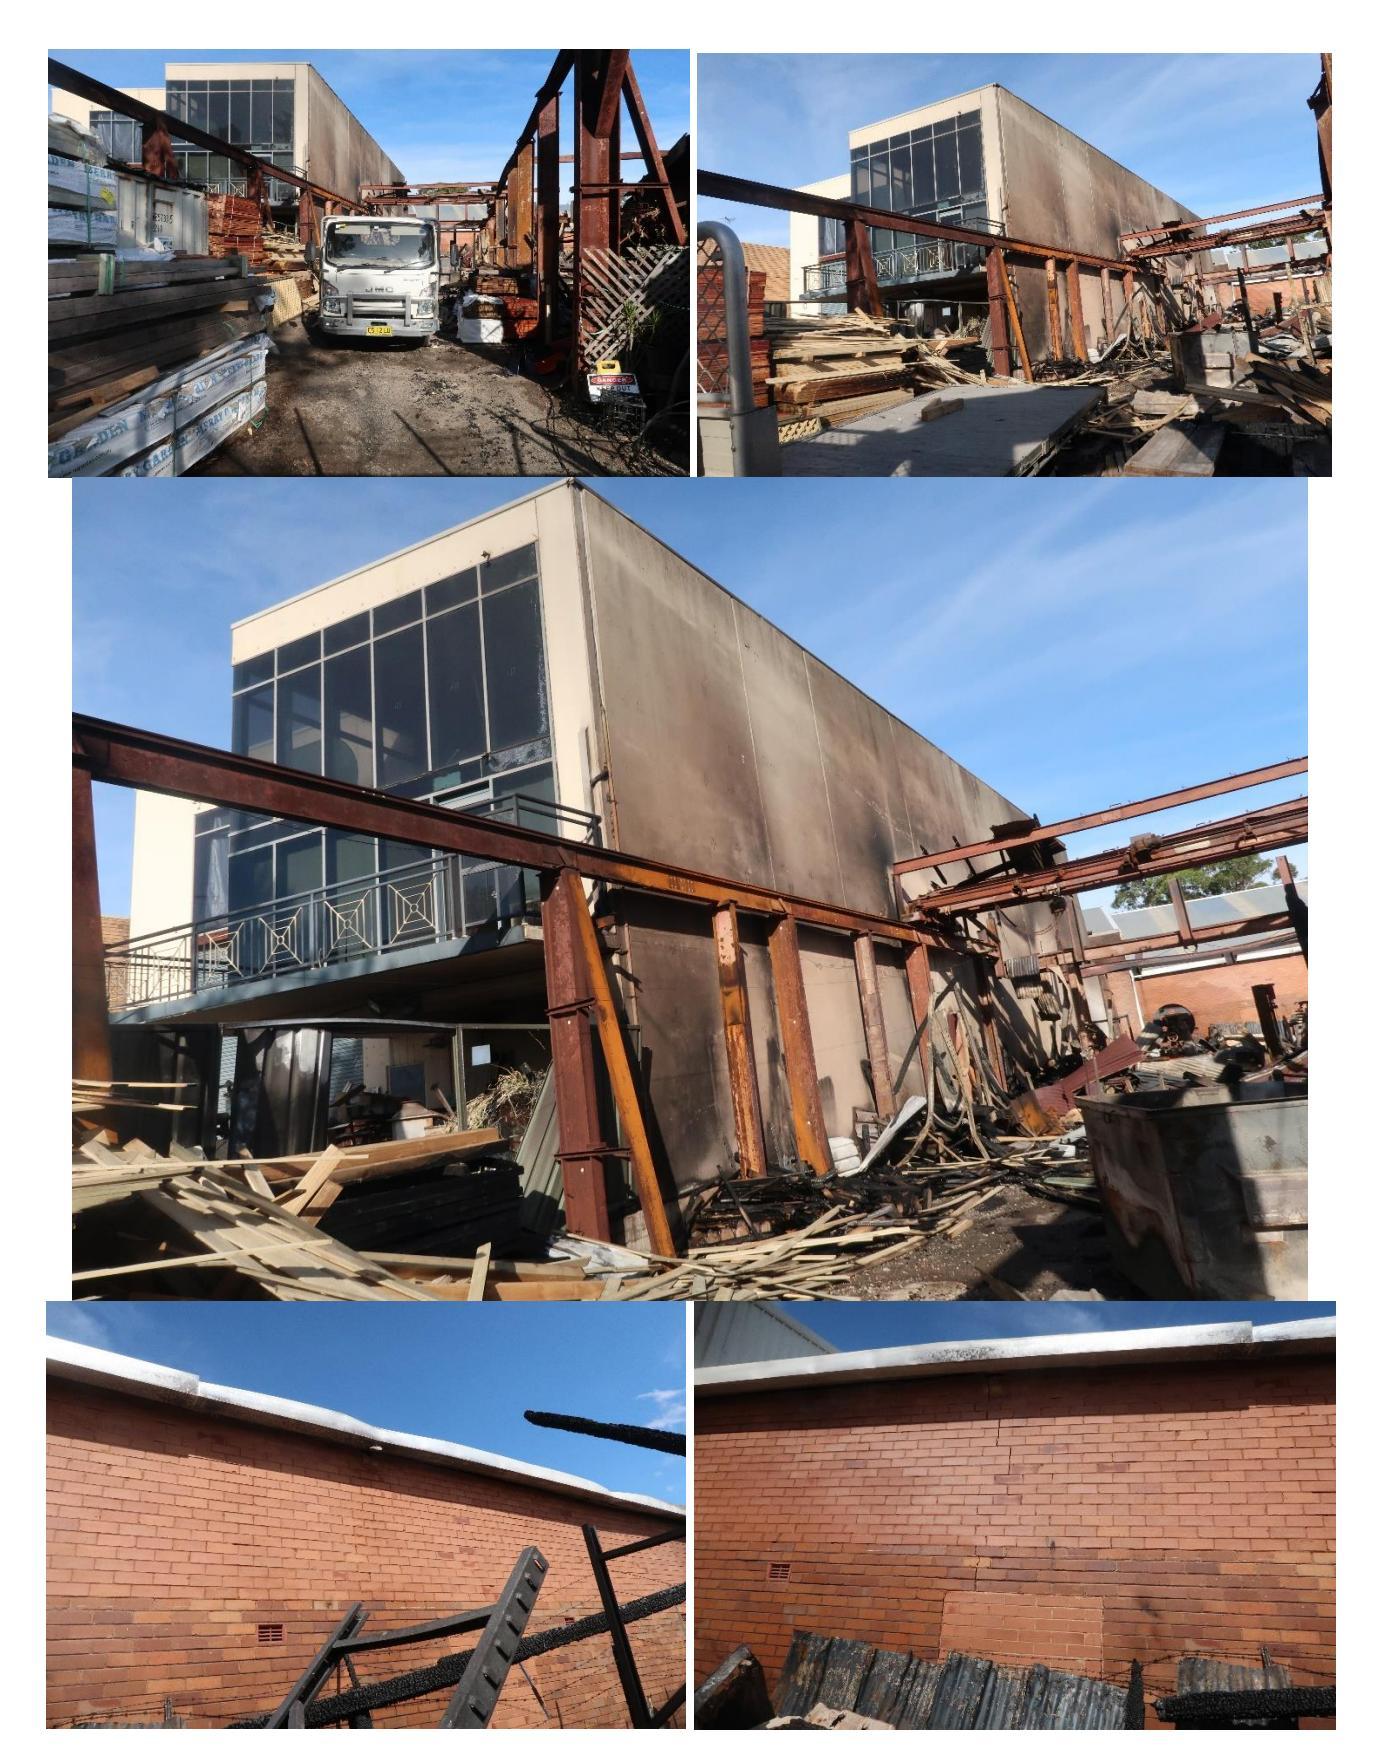
Exposures Bravo (top and middle) and Charlie were heavily impacted by fire. An important element of firefighting operations was the protection of these exposures. Shortly afer arriving on scene, firefighters established a protection stream onto the second level glass windows of Exposure Bravo. A combination of tactics, including hand line, internal firefighting and aerial streams was used to protected Charlie Exposure. This was extremely professional firefighting. Incredibly, despite the intensity of fire impact, no exposures were

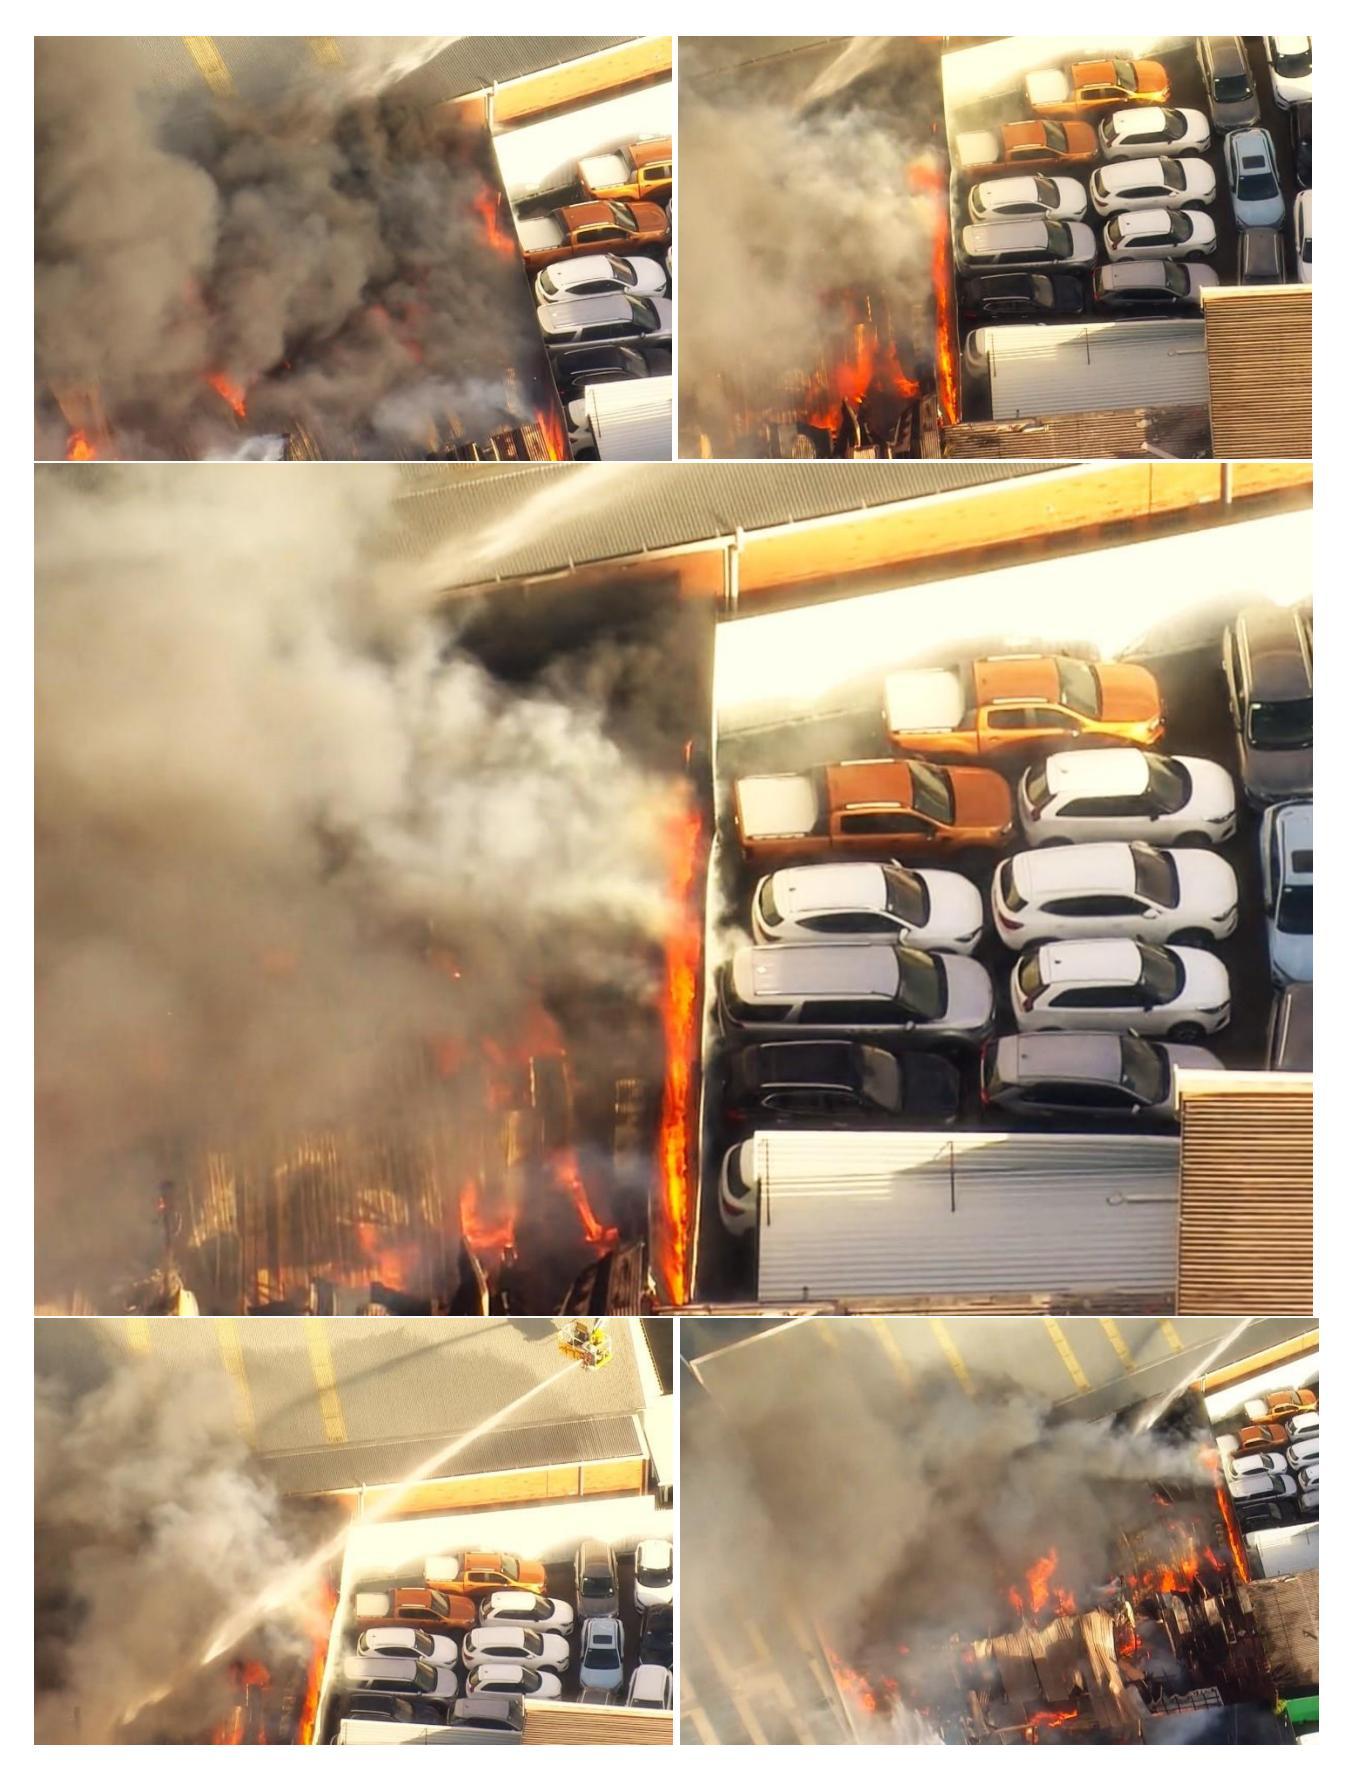
Exposure Delta came under heavy threat from impacting fire. The combined efforts of the Ladder Platform 21 aerial crew and firefighters operating hose lines from inside Exposure Delta protected the car rental yard containing almost 80 vehicles. Despite the intensity of the fire impact, Exposure Delta was saved and the business was trading the following day.

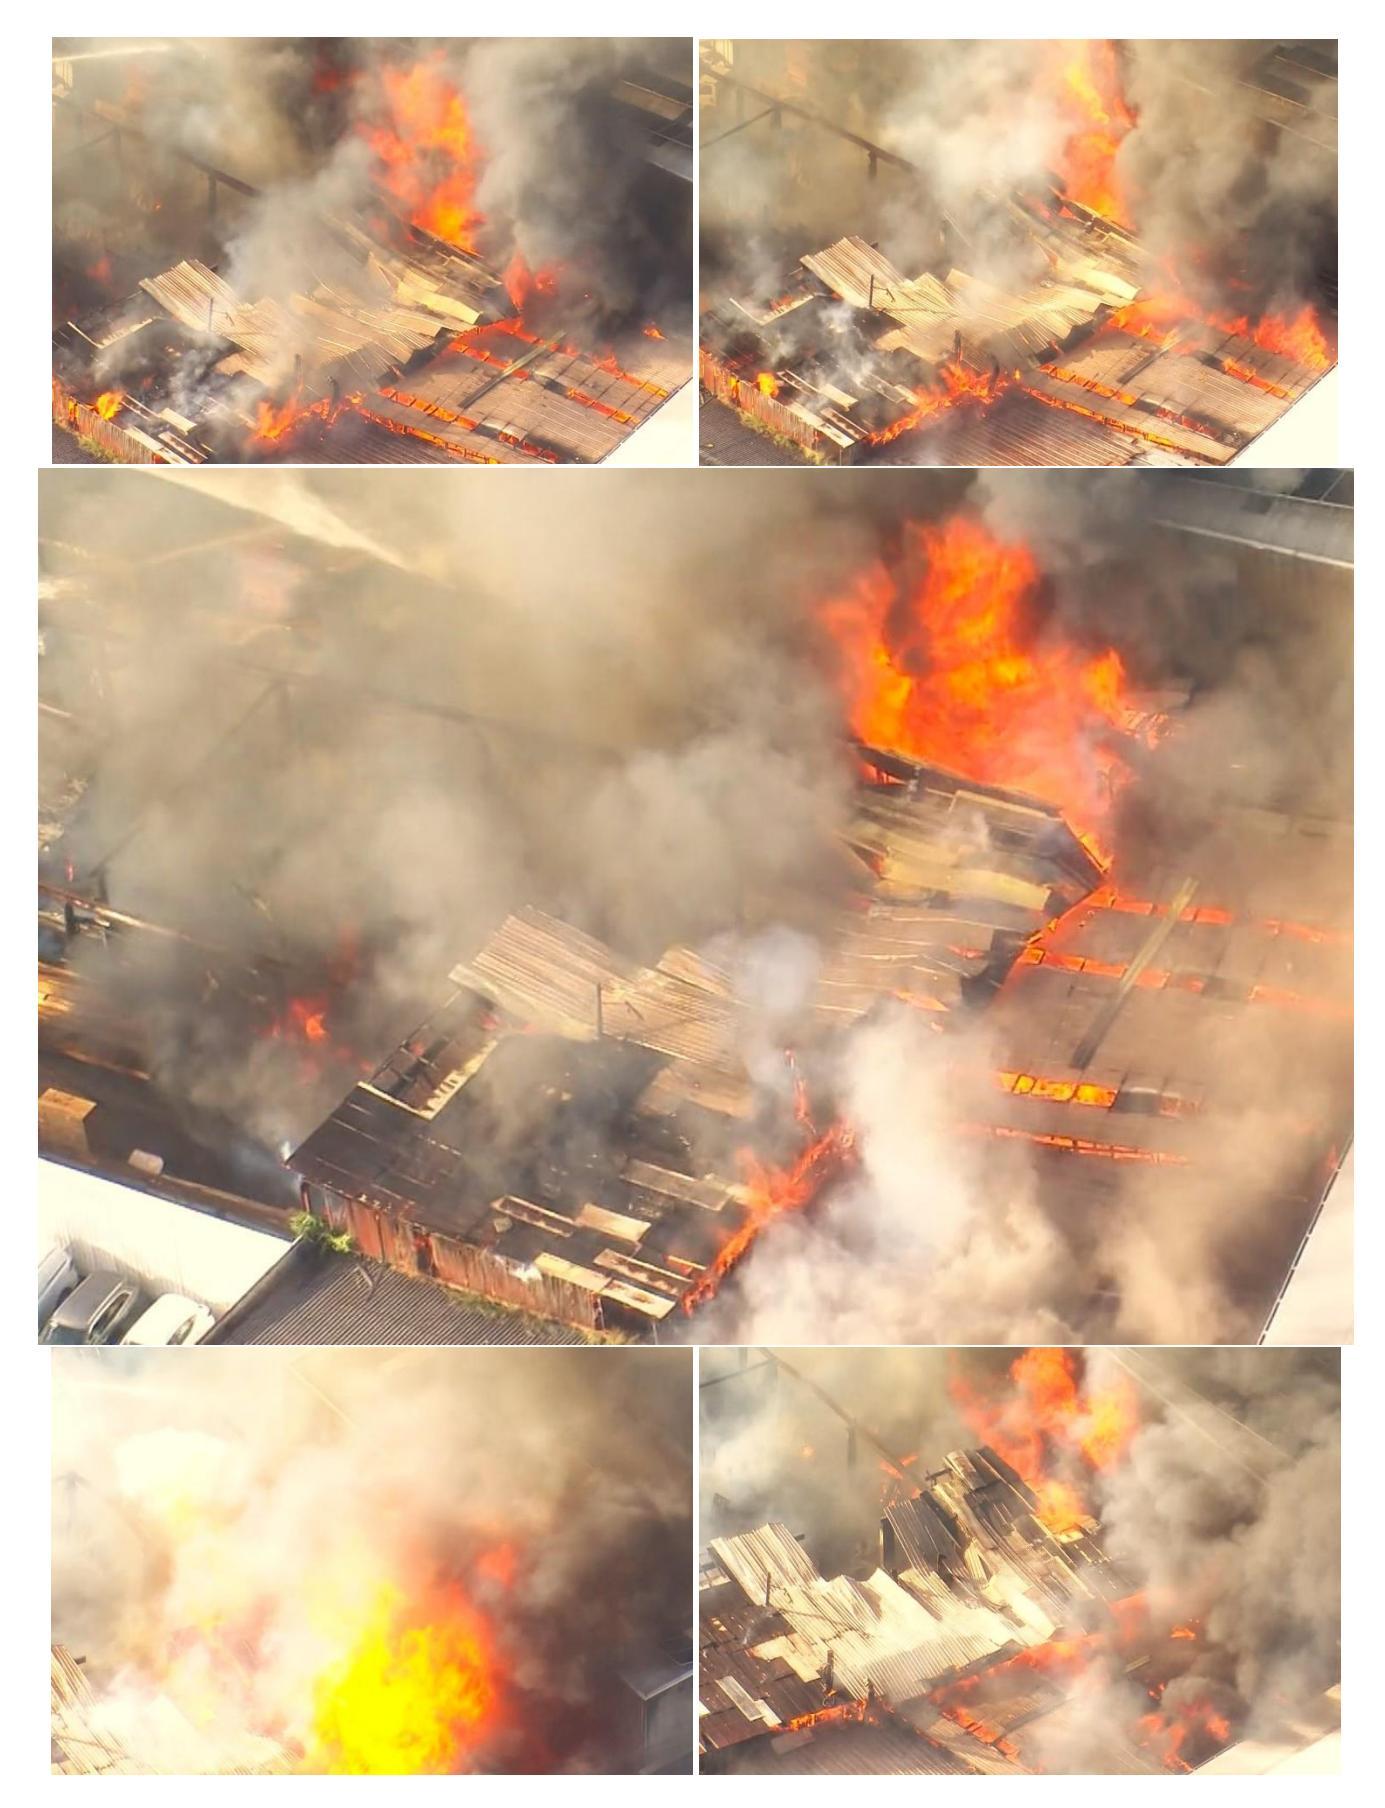
Firefighters begin battled ferocious fire conditions. From the moment the first appliance arrived on scene, firefighters began to establish operations that were coordinated, systematic and disciplined, determined by incident priorities. Firefighters were confronted with an expanding, fast moving and intense fire, threatening multiple exposures. Forklift LPG cylinder explosion (bottom left).

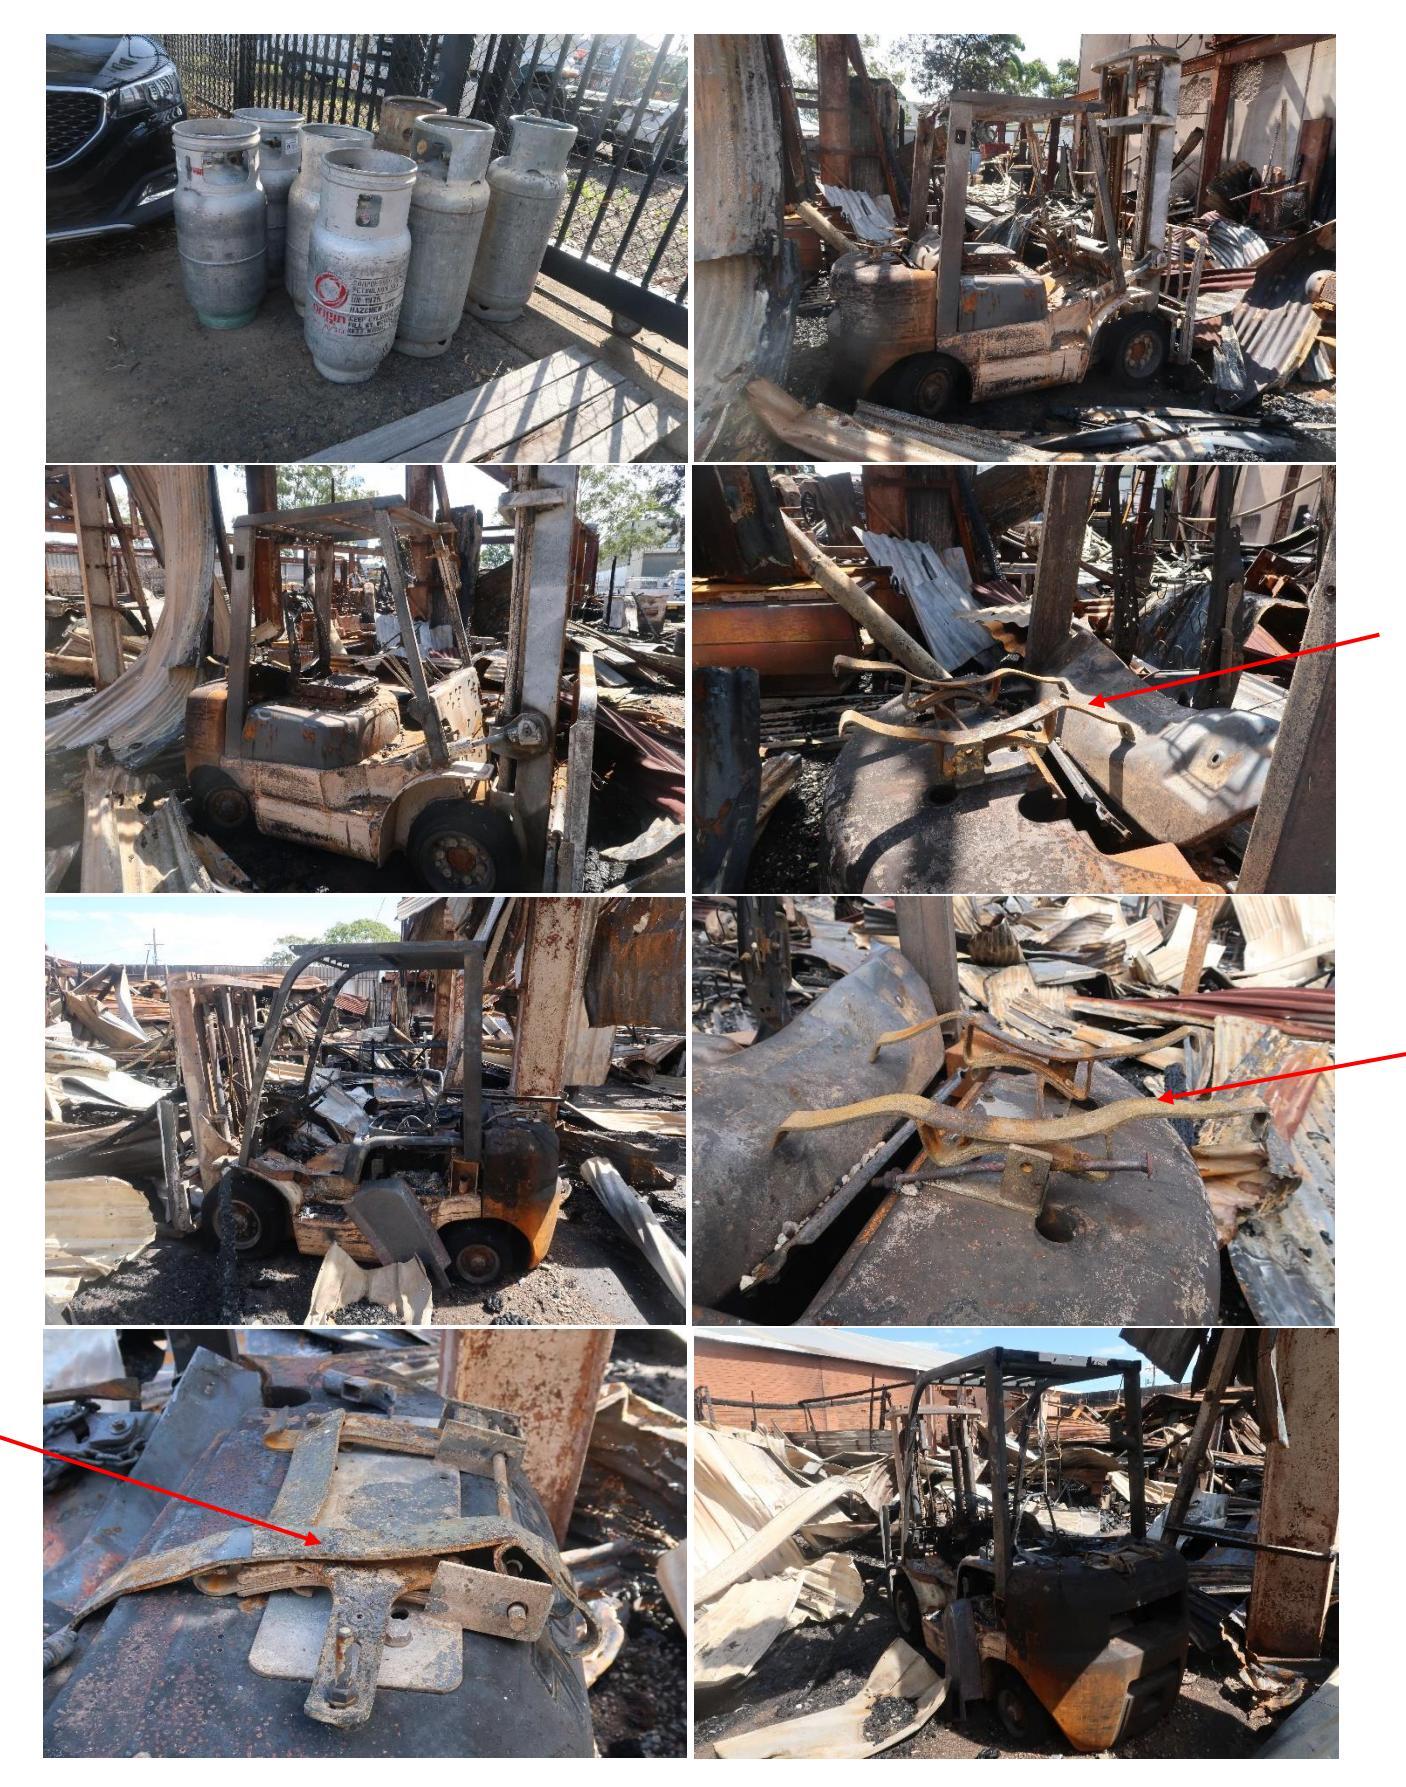
Top left: Firefighters removed a number LPG cylinders out of the fire's path. Several BLEVE (Boiling Liquid Expanding Vapour Explosion) events occurred involving LPG cylinders attached to forklifts. The steel brackets (indicated by arrows) used to secure the cylinders have been severely bent due to the force of the explosion from the LPG cylinders.

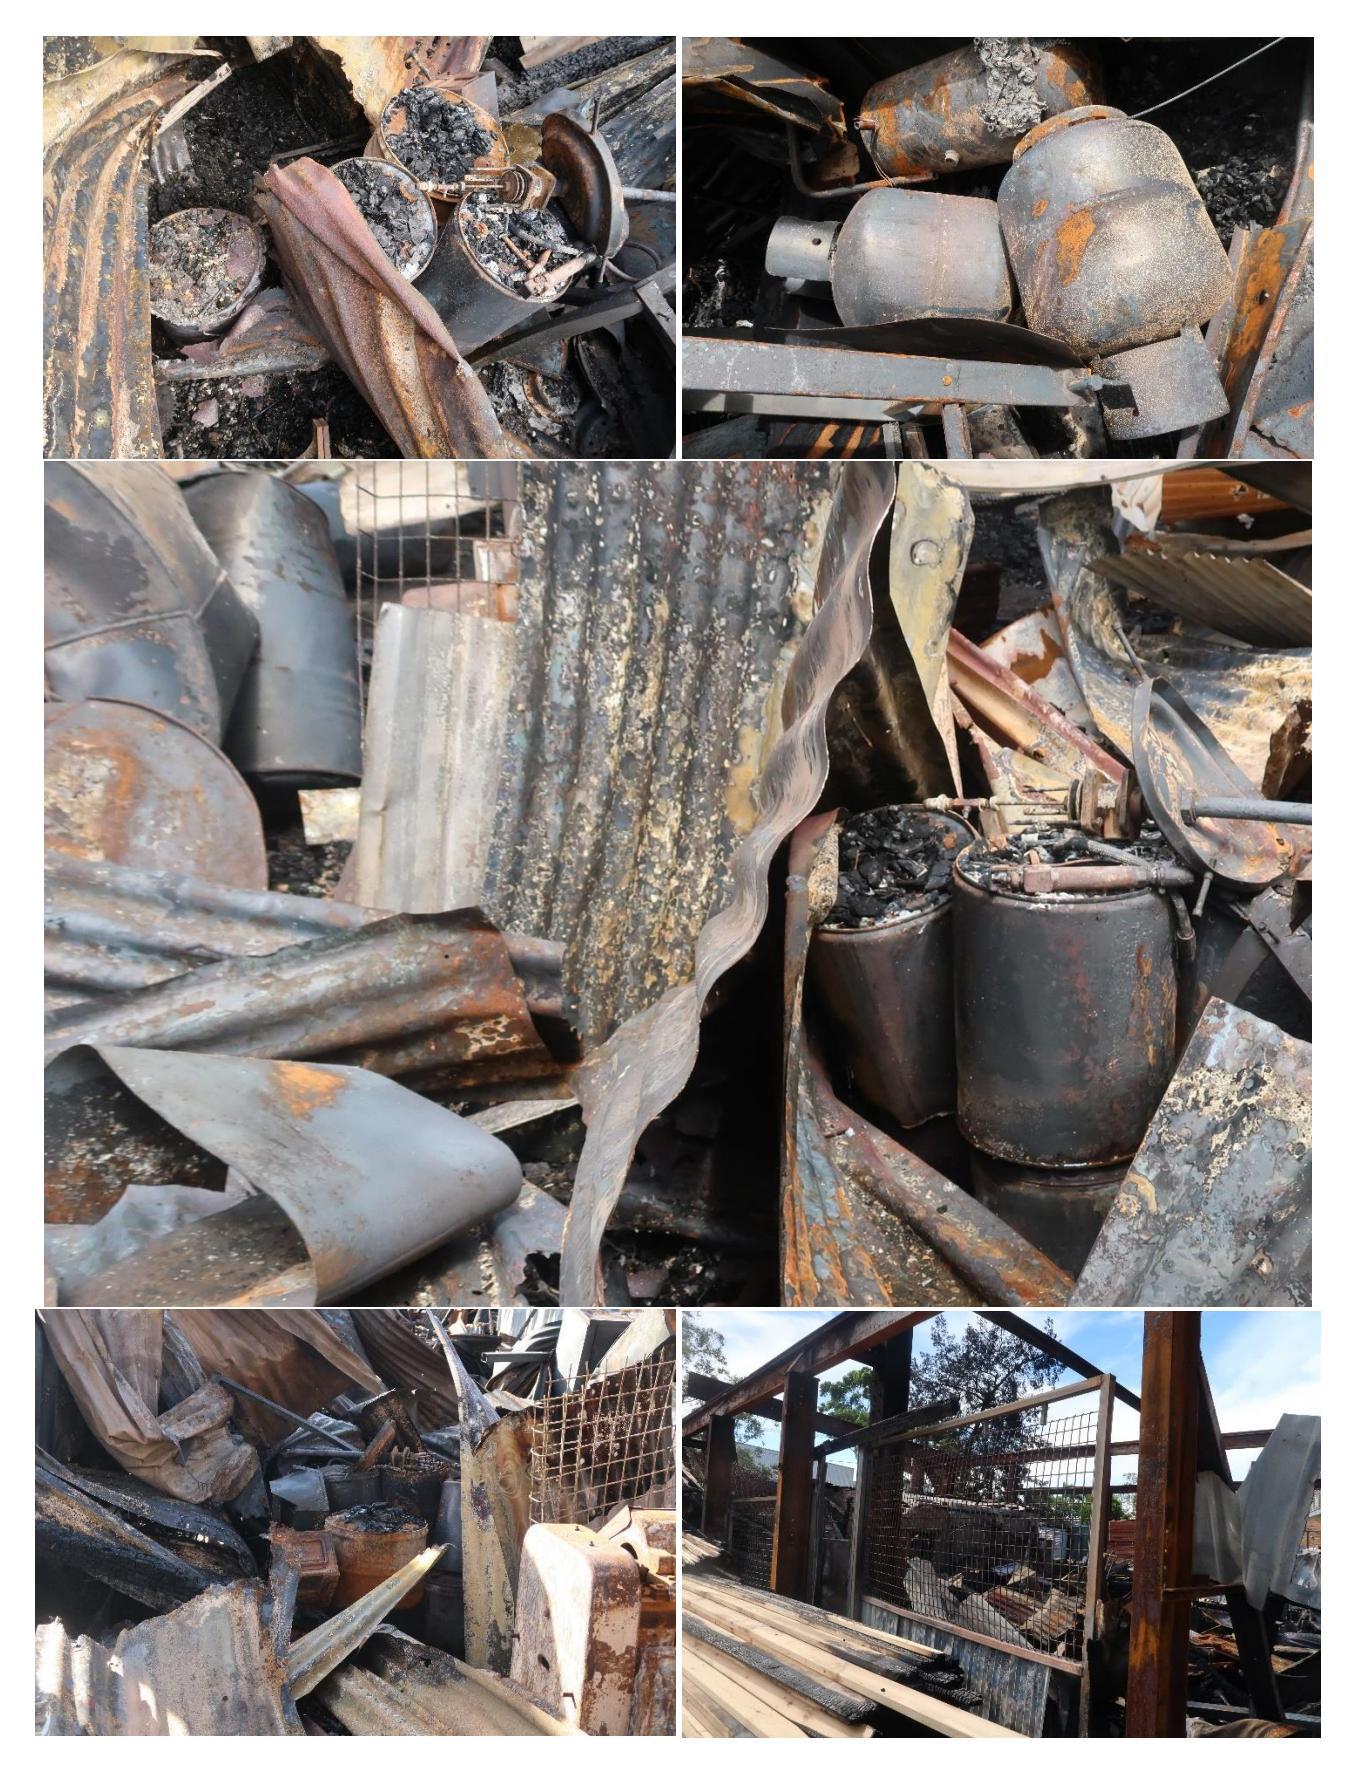
The yard, including the caged area, contained significant quantities of hydrocarbon-based materials used for day-to-day operations of the business, including fuels, lubricants and cleaning products. Under fire conditions these materials produce intense and extreme fire conditions.

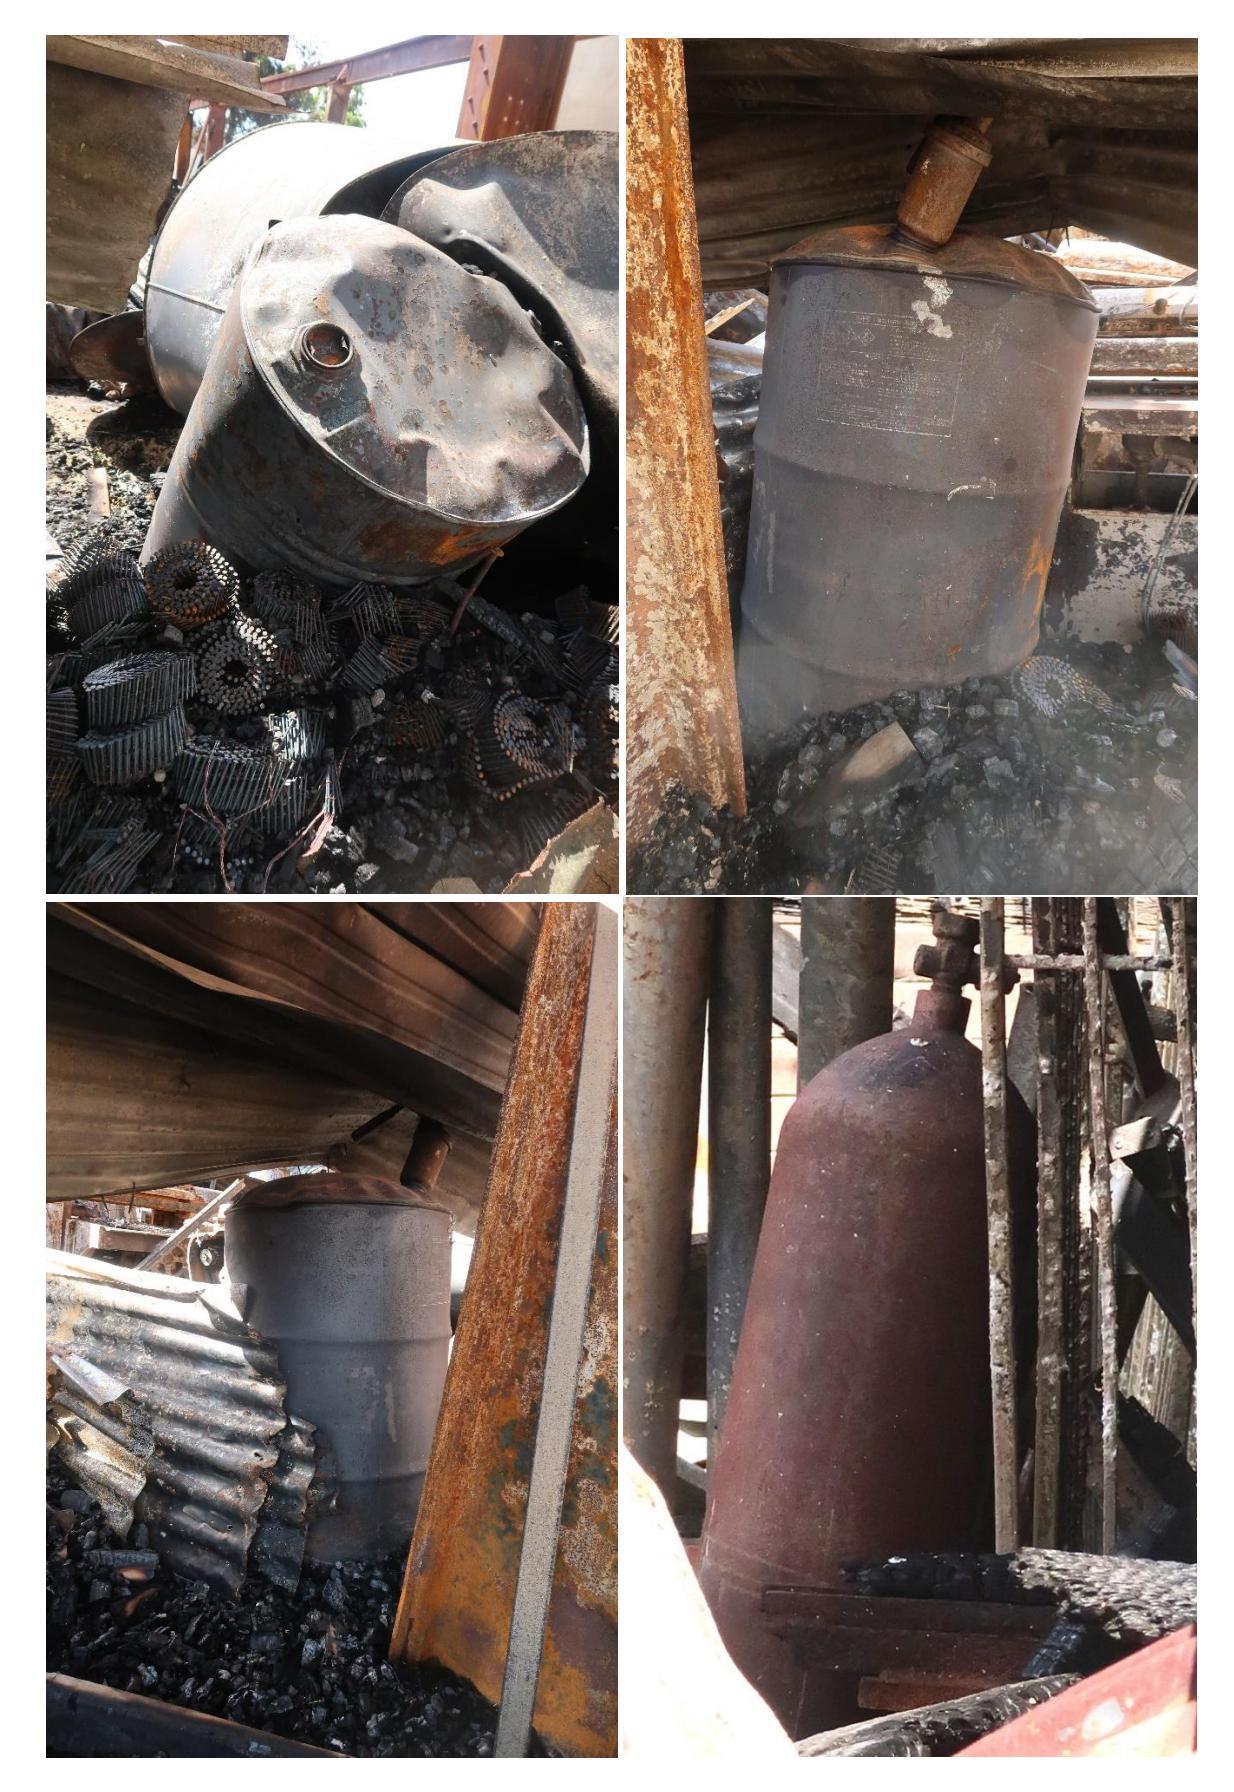
The yard contained significant quantities of hydrocarbon-based materials used for day-to-day operations of the business, including fuels, lubricants and cleaning products. Under fire conditions these materials produce intense and extreme fire behaviour. In these views, products including 200 litre drums of isopropyl alcohol and gas cylinders containing acetylene.

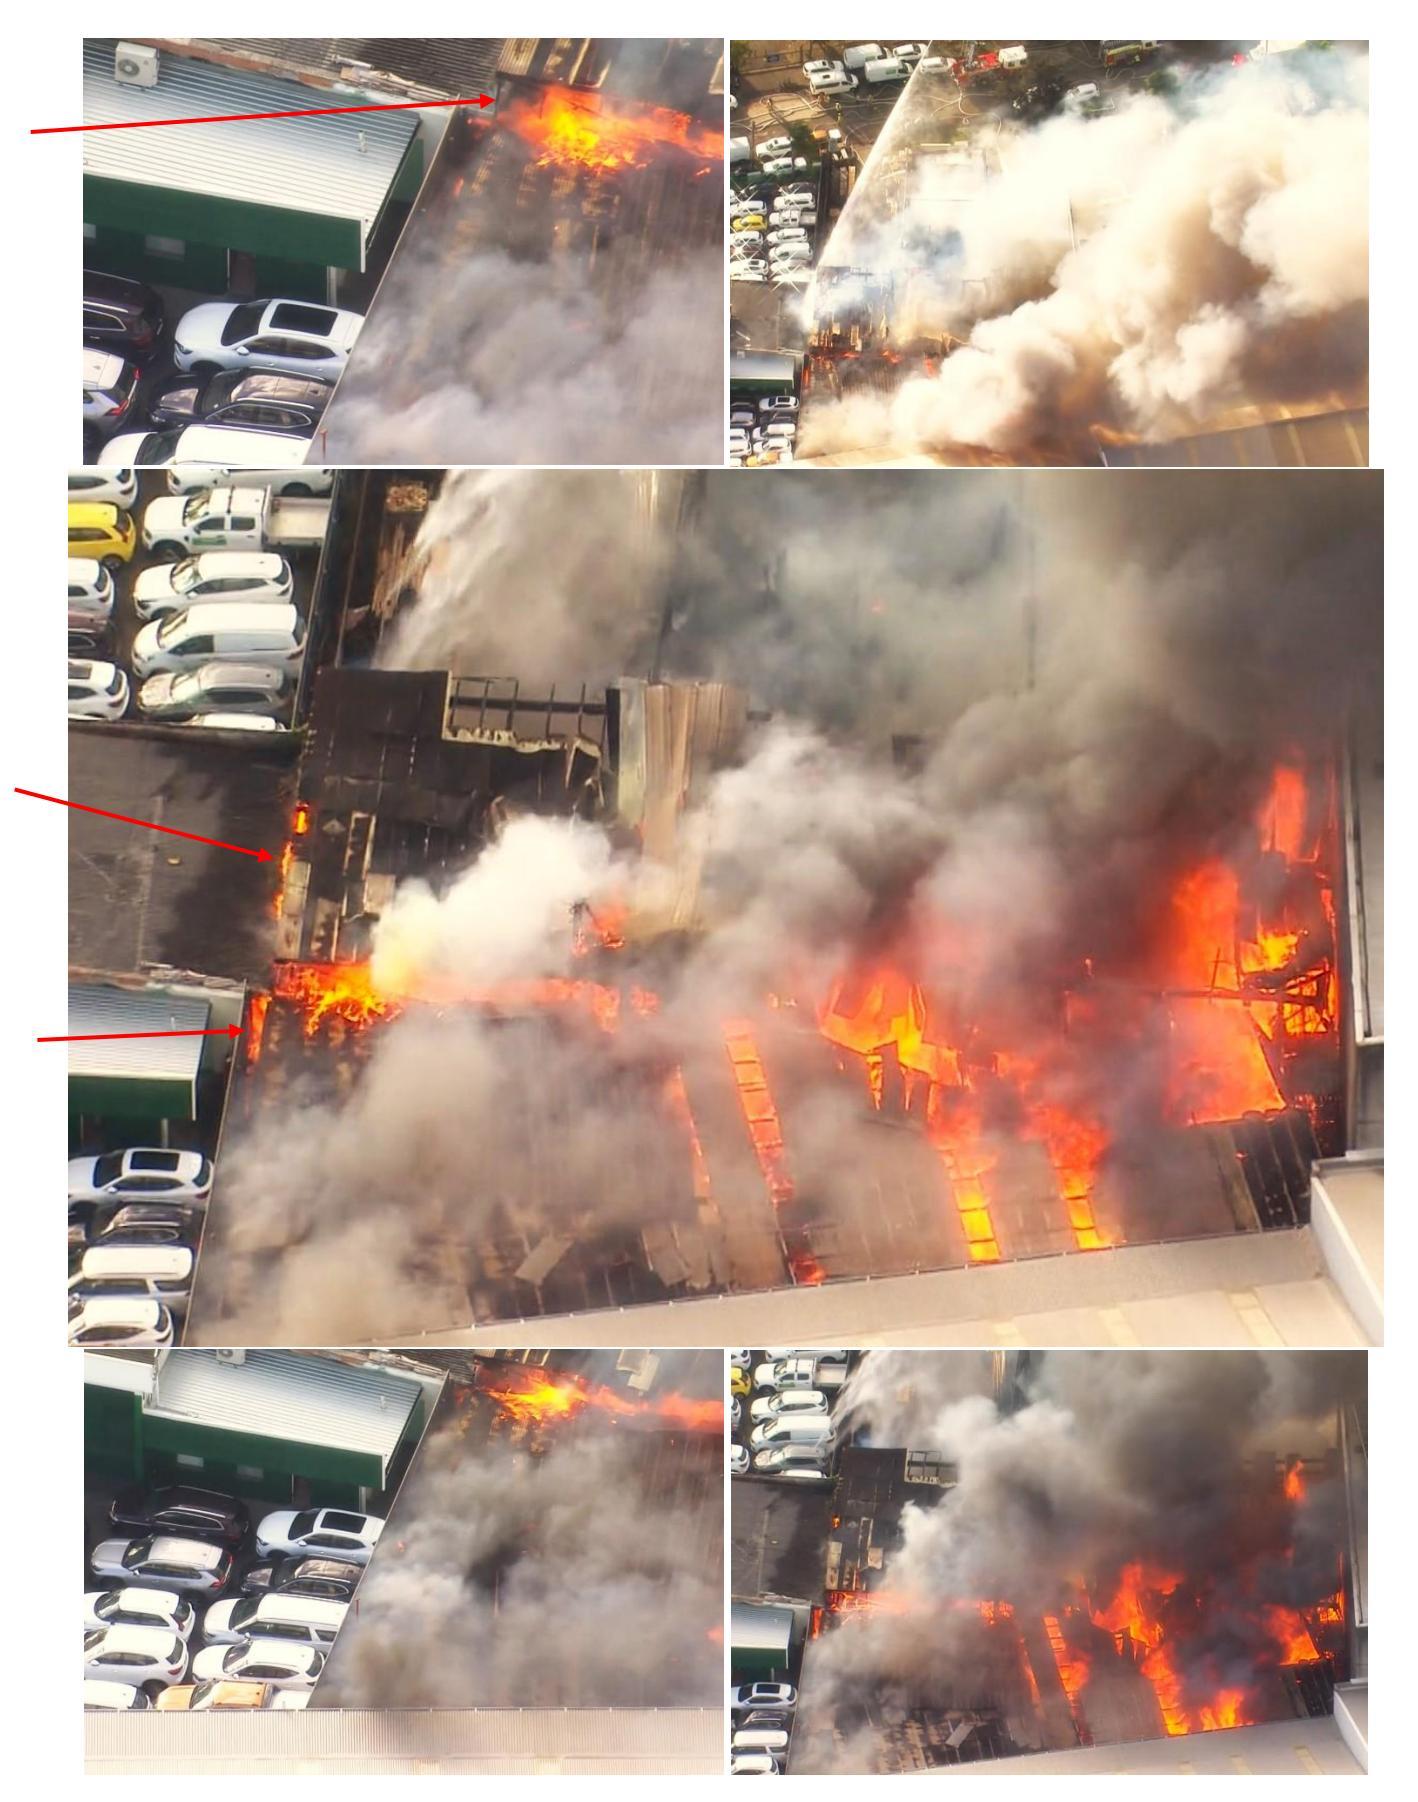
Heavy fire impacts the Exposure Delta office/workshop. Firefighters inside the exposure building extinguished fire as it entered the roof space (initially using a high pressure cleaning spray gun). The aerial stream of CAP 47 sweeps down the wall, extinguishing the fire externally.

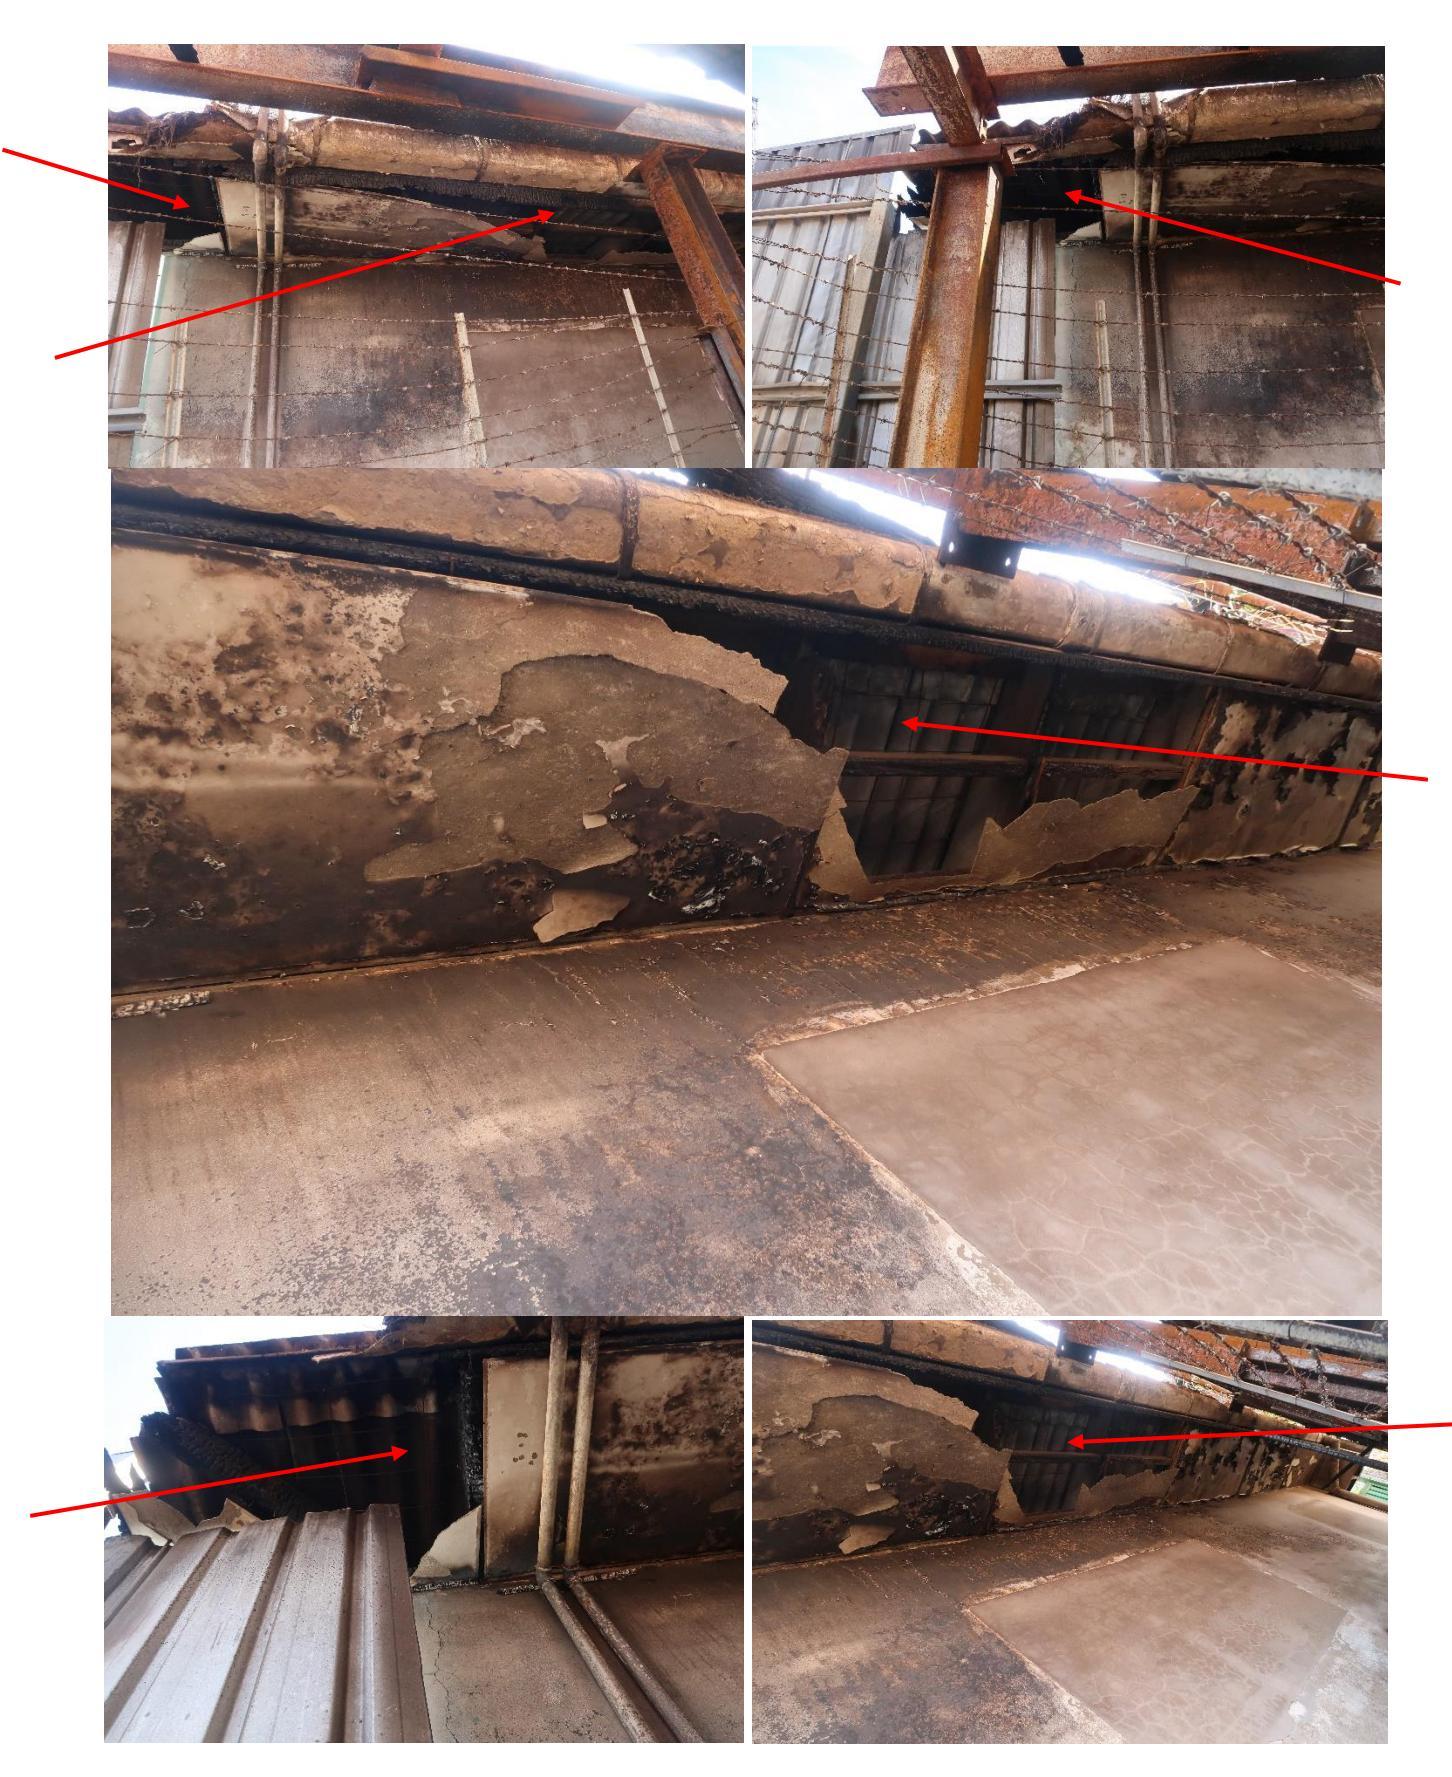
Severe fire impact to the roof eaves and fire entry to the roof space of Exposure Delta (indicated by arrows). Firefighters located inside Exposure Delta extinguished the fire as it entered the roof space, stopping fire spread and saving the exposure.
