MW1 C STATION TRAINING AND INCIDENT CASE STUDIES

FILE NO. 2024 /02.

MILPERRA 6th ALARM TIMBER JOINERY FIRE

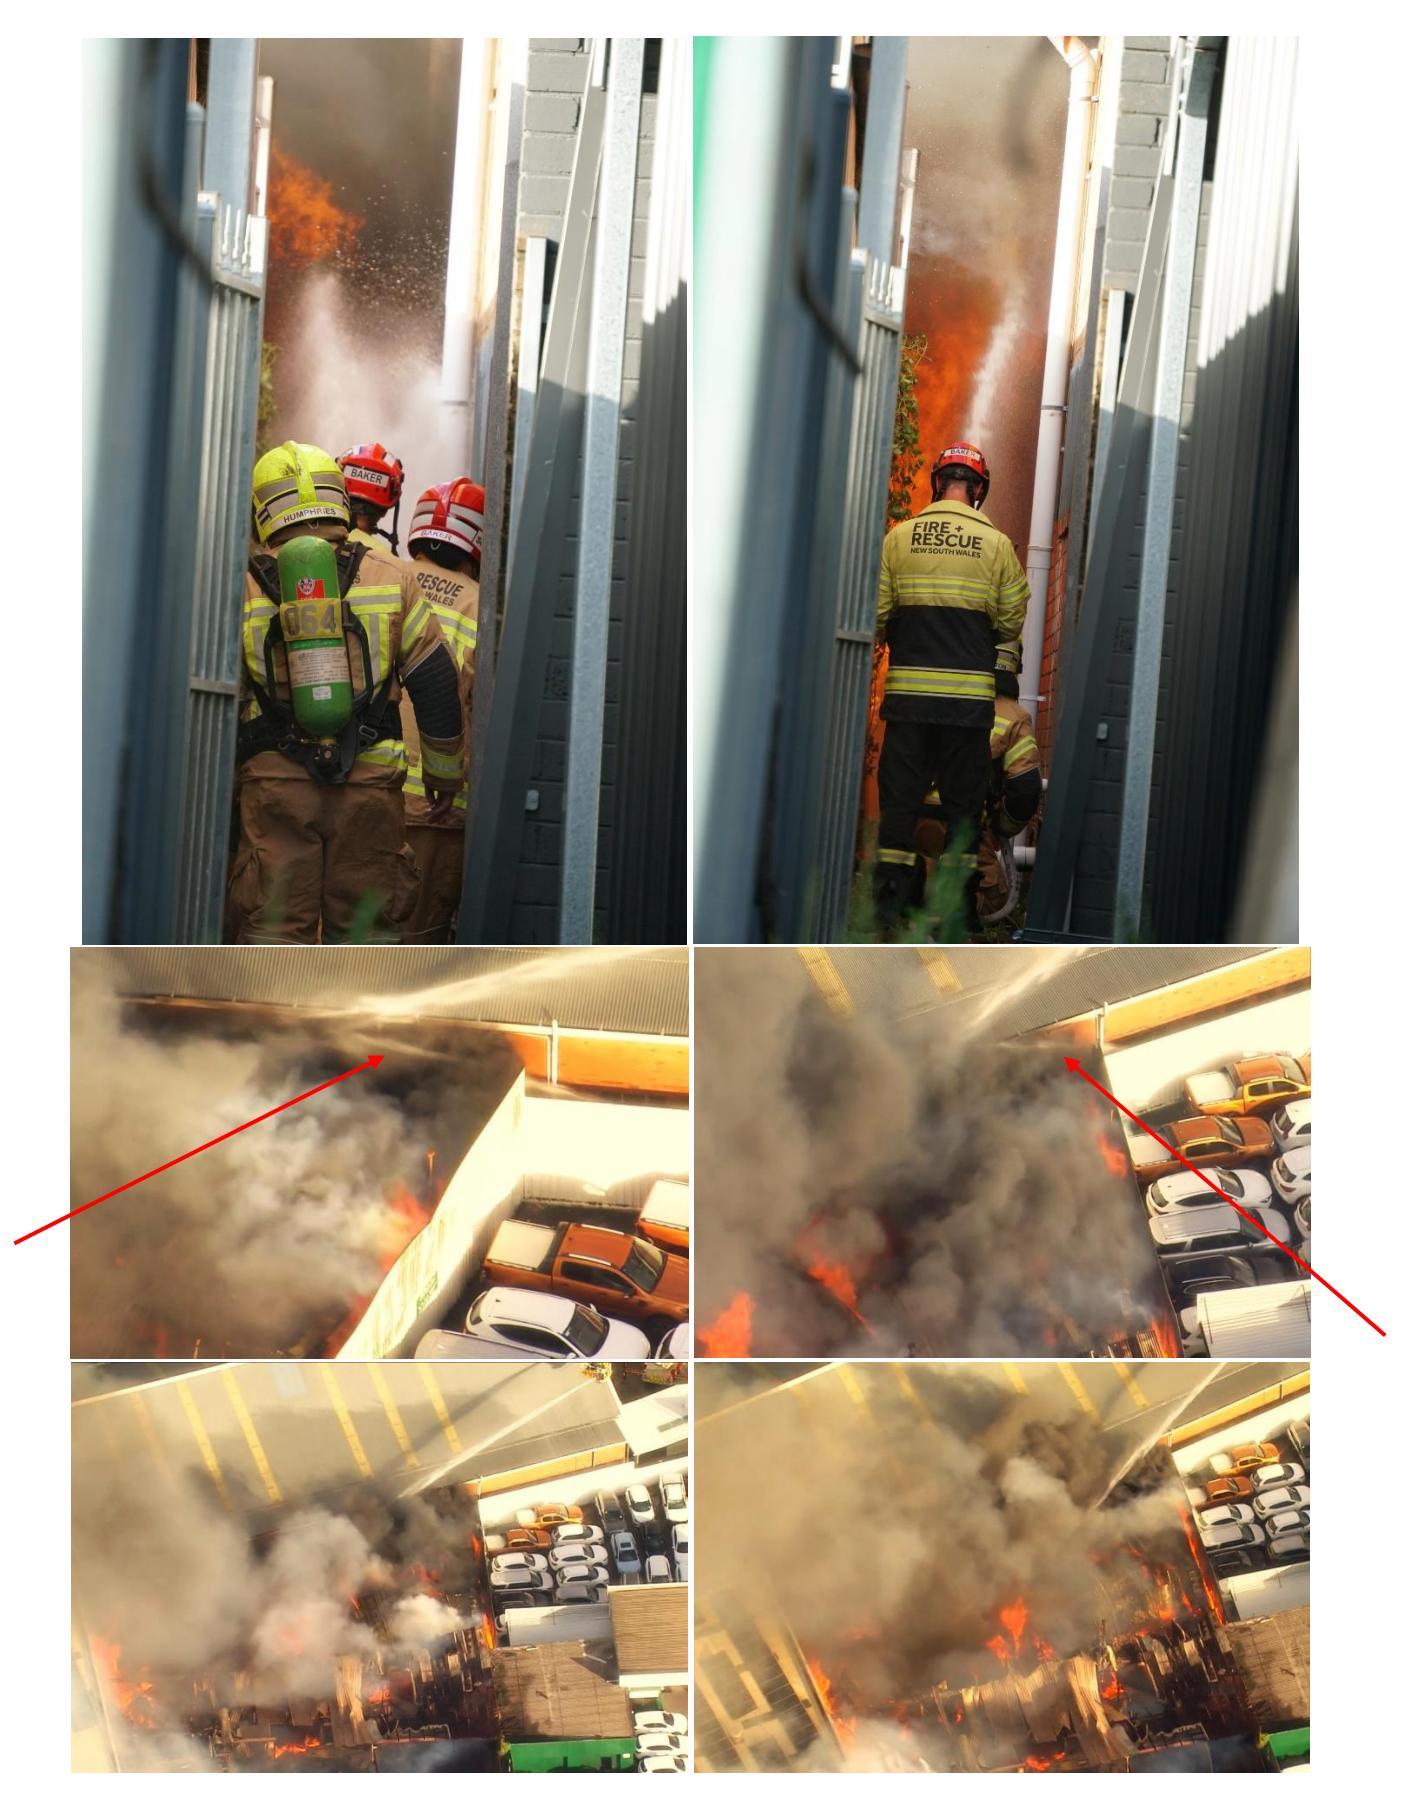
Exposure Charlie is under severe threat from fiercely impacting flames. Firefighters located in a one metre gap between Exposure Delta and Exposure Charlie direct a protective cooling stream onto the wall of Exposure Charlie. This stream is indicated by the arrows. Hose crews worked in conjunction with the aerial crew to protect Exposure Charlie.

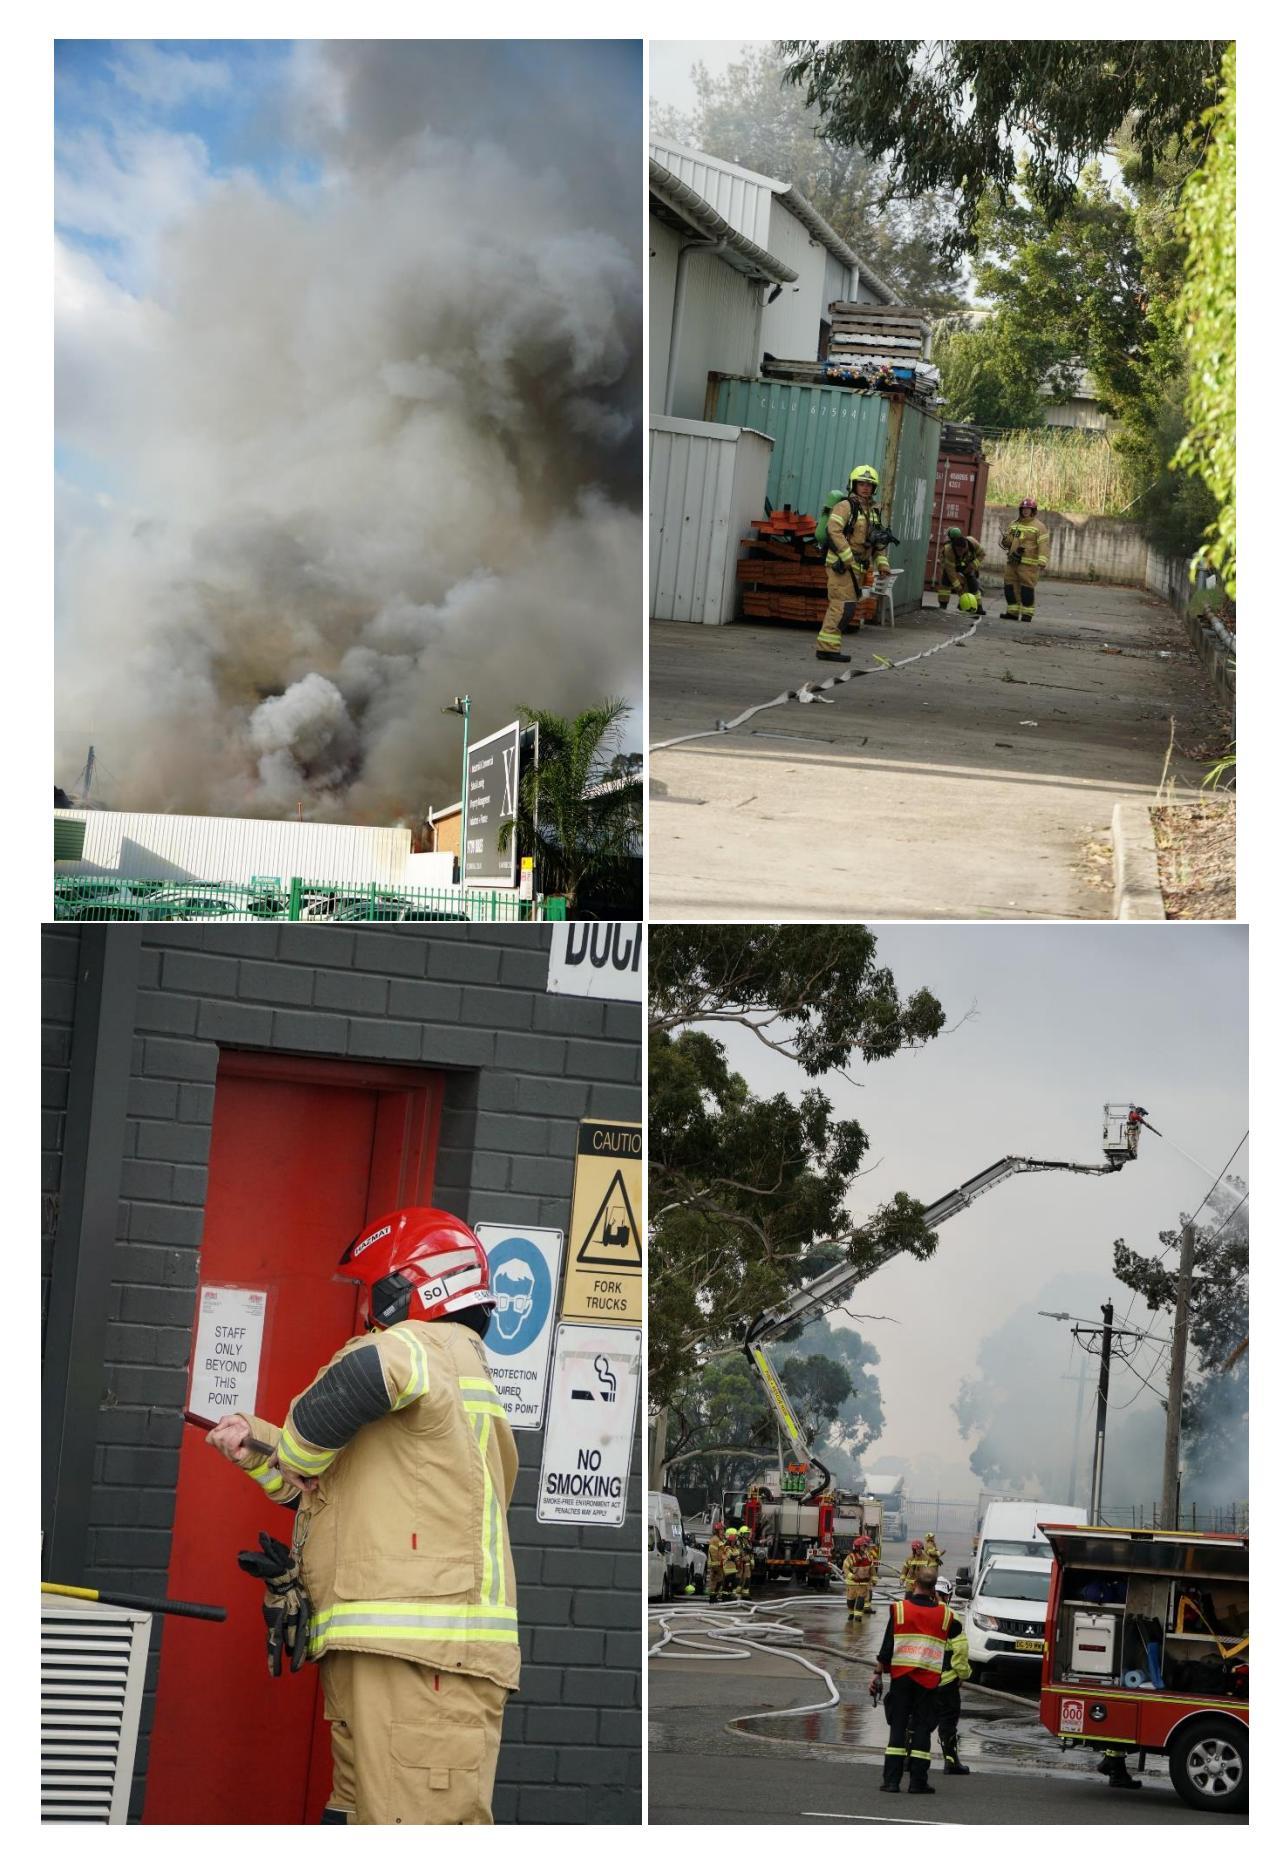
Top left: Heavy fire activity impacts te Exposure Charlie warehouse. Top right: At the same time, firefighters are laying an attack line, prior to entry being gained into the exposure (lower left), where firefighters extinguished a spot fire and ensured the warehouse remained protected. The I.C. surveys Alpha Sector (lower right).
