MW1 C STATION TRAINING AND INCIDENT CASE STUDIES

FILE NO. 2024 /02.

MILPERRA 6th ALARM TIMBER JOINERY FIRE

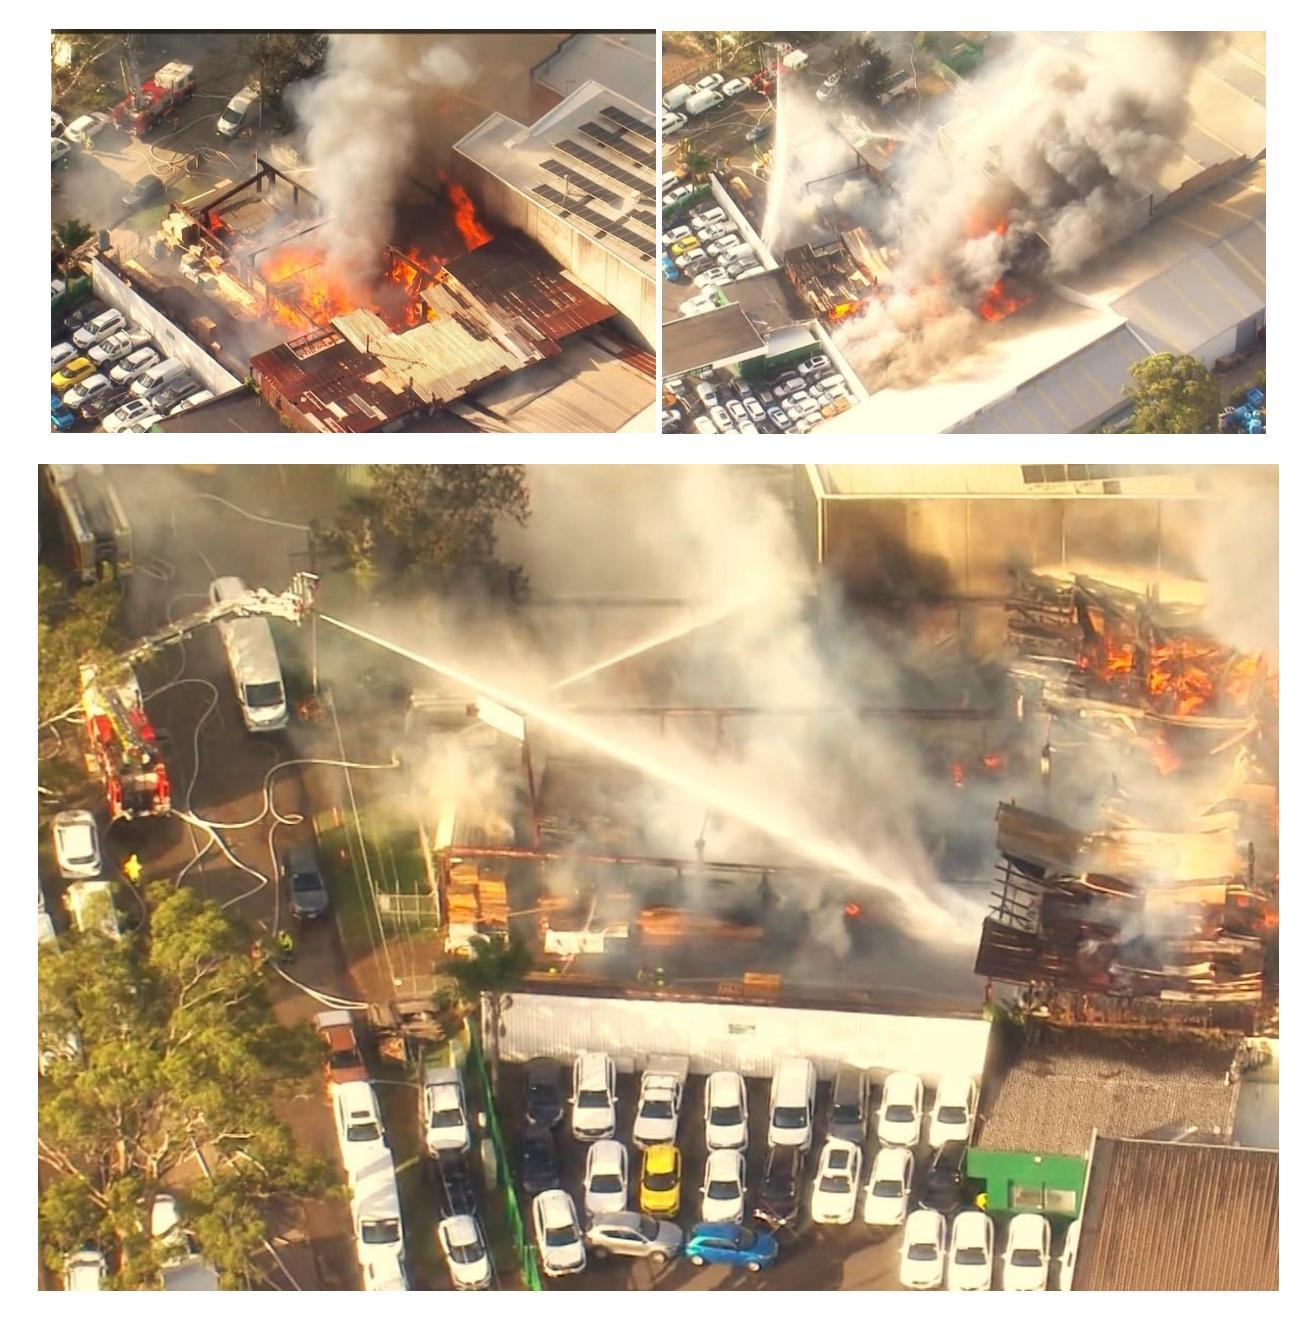
Firefighters faced numerous challenges at Milperra, including a fast-moving fire, high fuel load, fire driven by strong winds and multiple exposures in close proximity to the main fire occupancy.

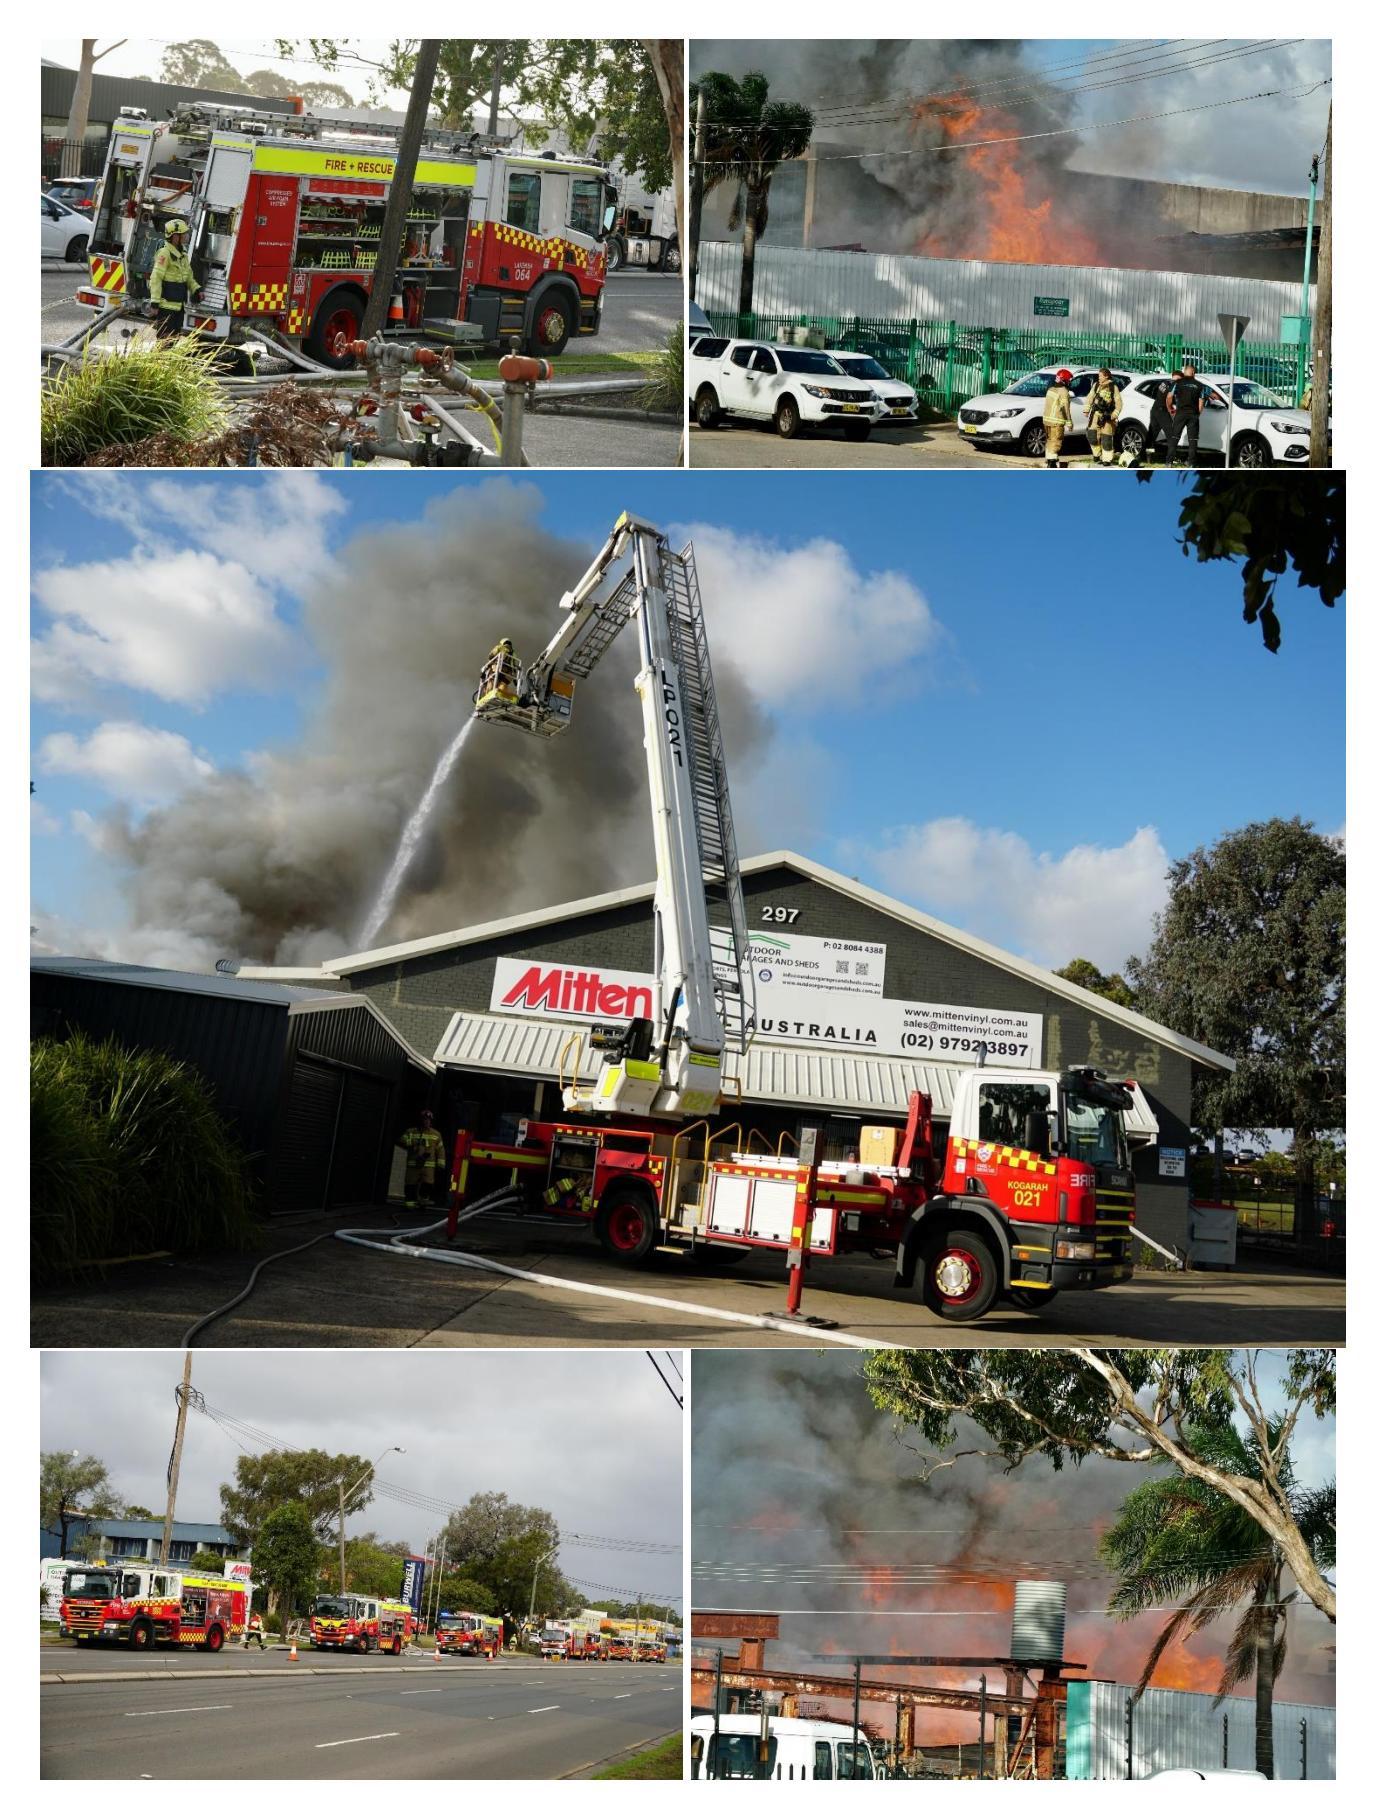
Top Left: CP 64 obtaining water from the booster supply hydrants pumps water via 2 x 70 mm lines to Ladder Platform 21 (middle), protecting exposures Charlie and Delta. Top right and Lower right: Intense fire activity erupts from the yard. Firefighters battled hard to contain the fire to the premises of origin. Lower left: Appliances located on Milperra Road.

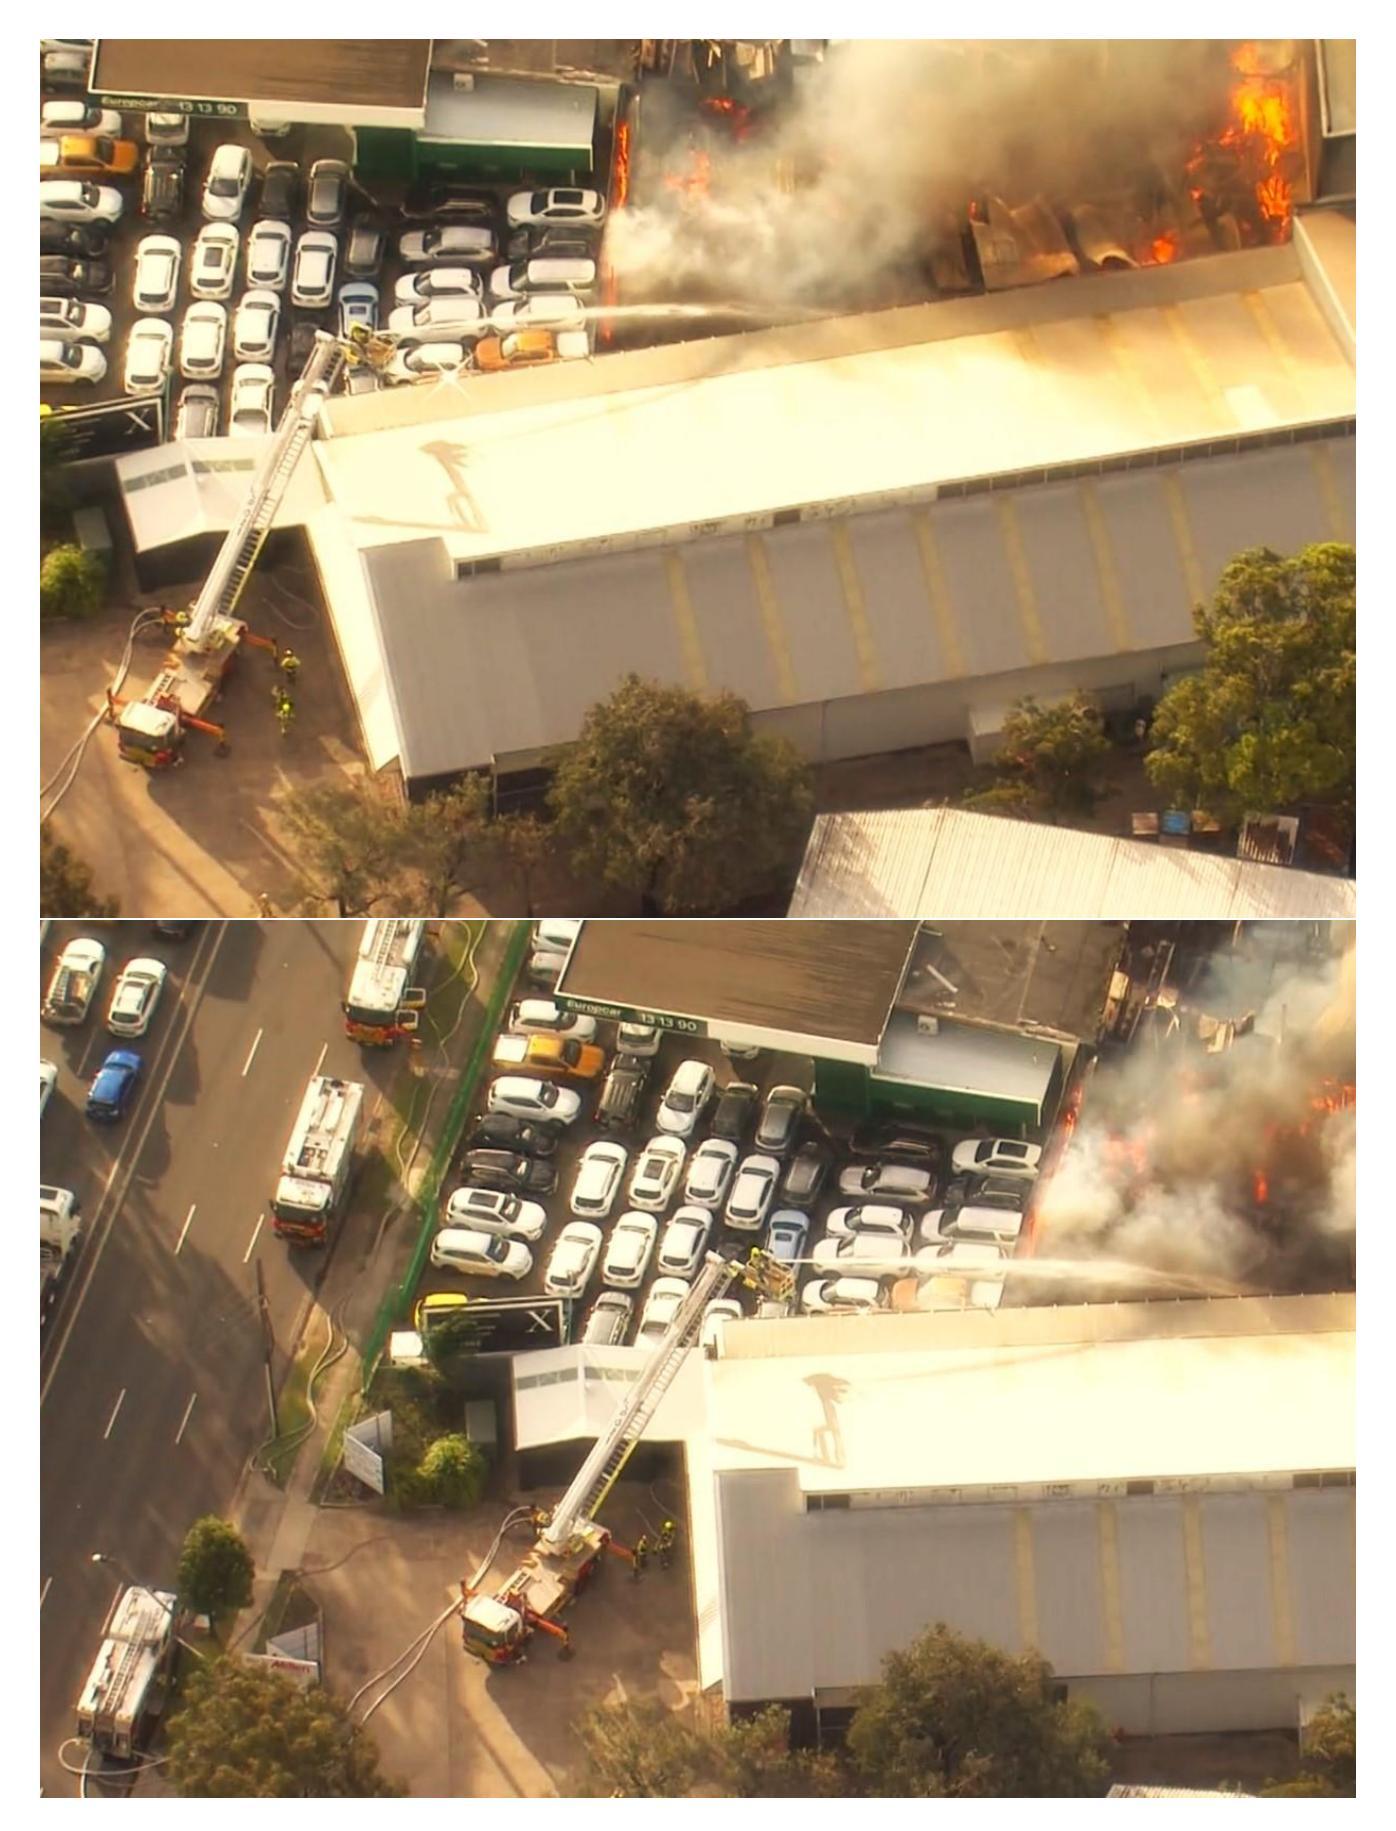
Ladder Platform 21 alternated between directing protective streams along the western wall of Exposure Charlie and the northern wall of Exposure Delta. Working closely with hose crews on the ground, these coordinated operations ensured heavily threatened exposures were protected.

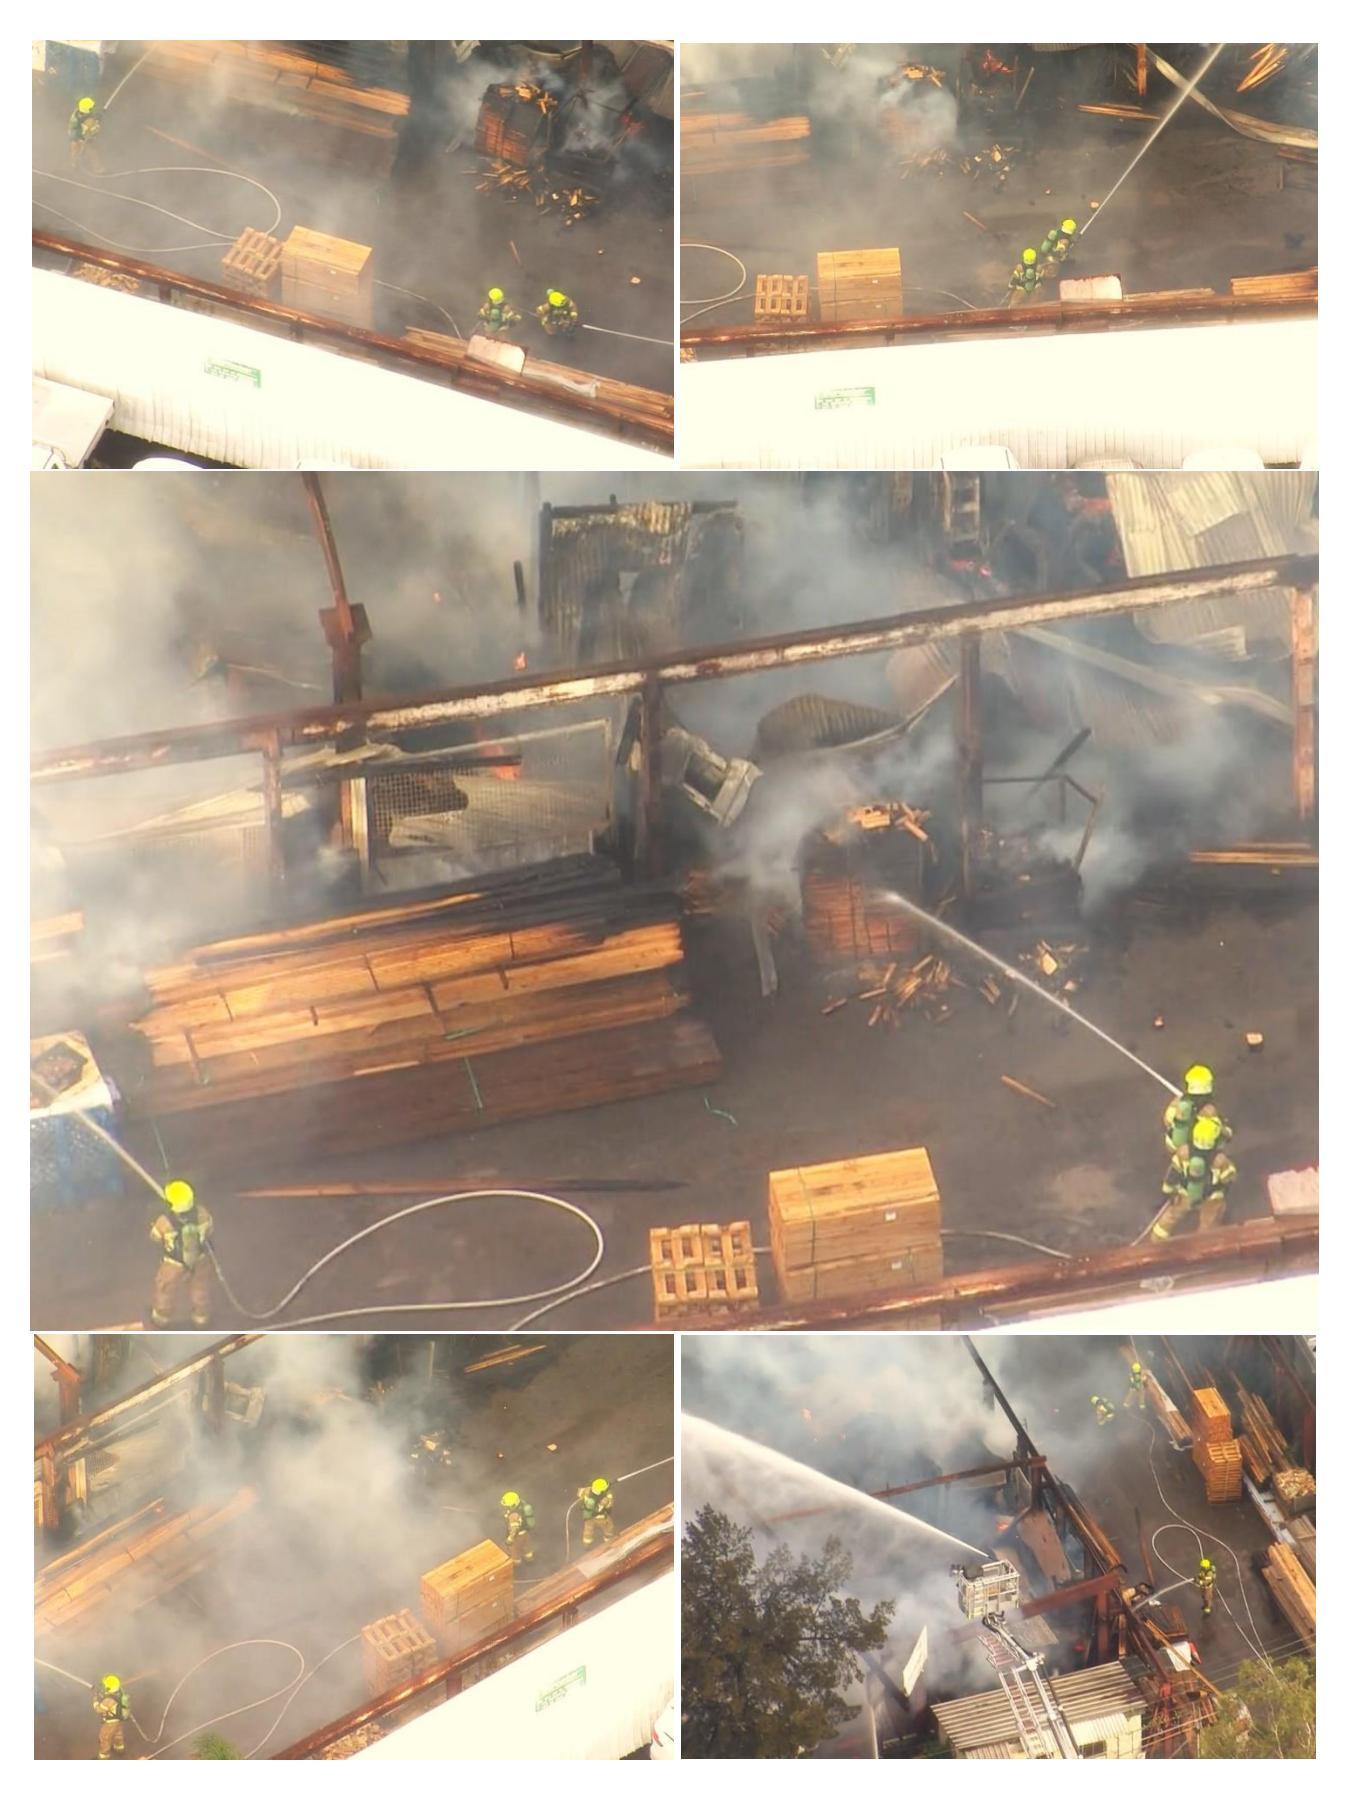
Firefighters begin to advance into the timber yard from Alpha Sector, wetting down timber not already involved in fire and extinguishing spot fires and burning timber stacks. These operations saved a significant amount of stock. They also reduced the fire area and created a fire break, stopping the fire from travelling through timber stacks to reach Exposure Delta.

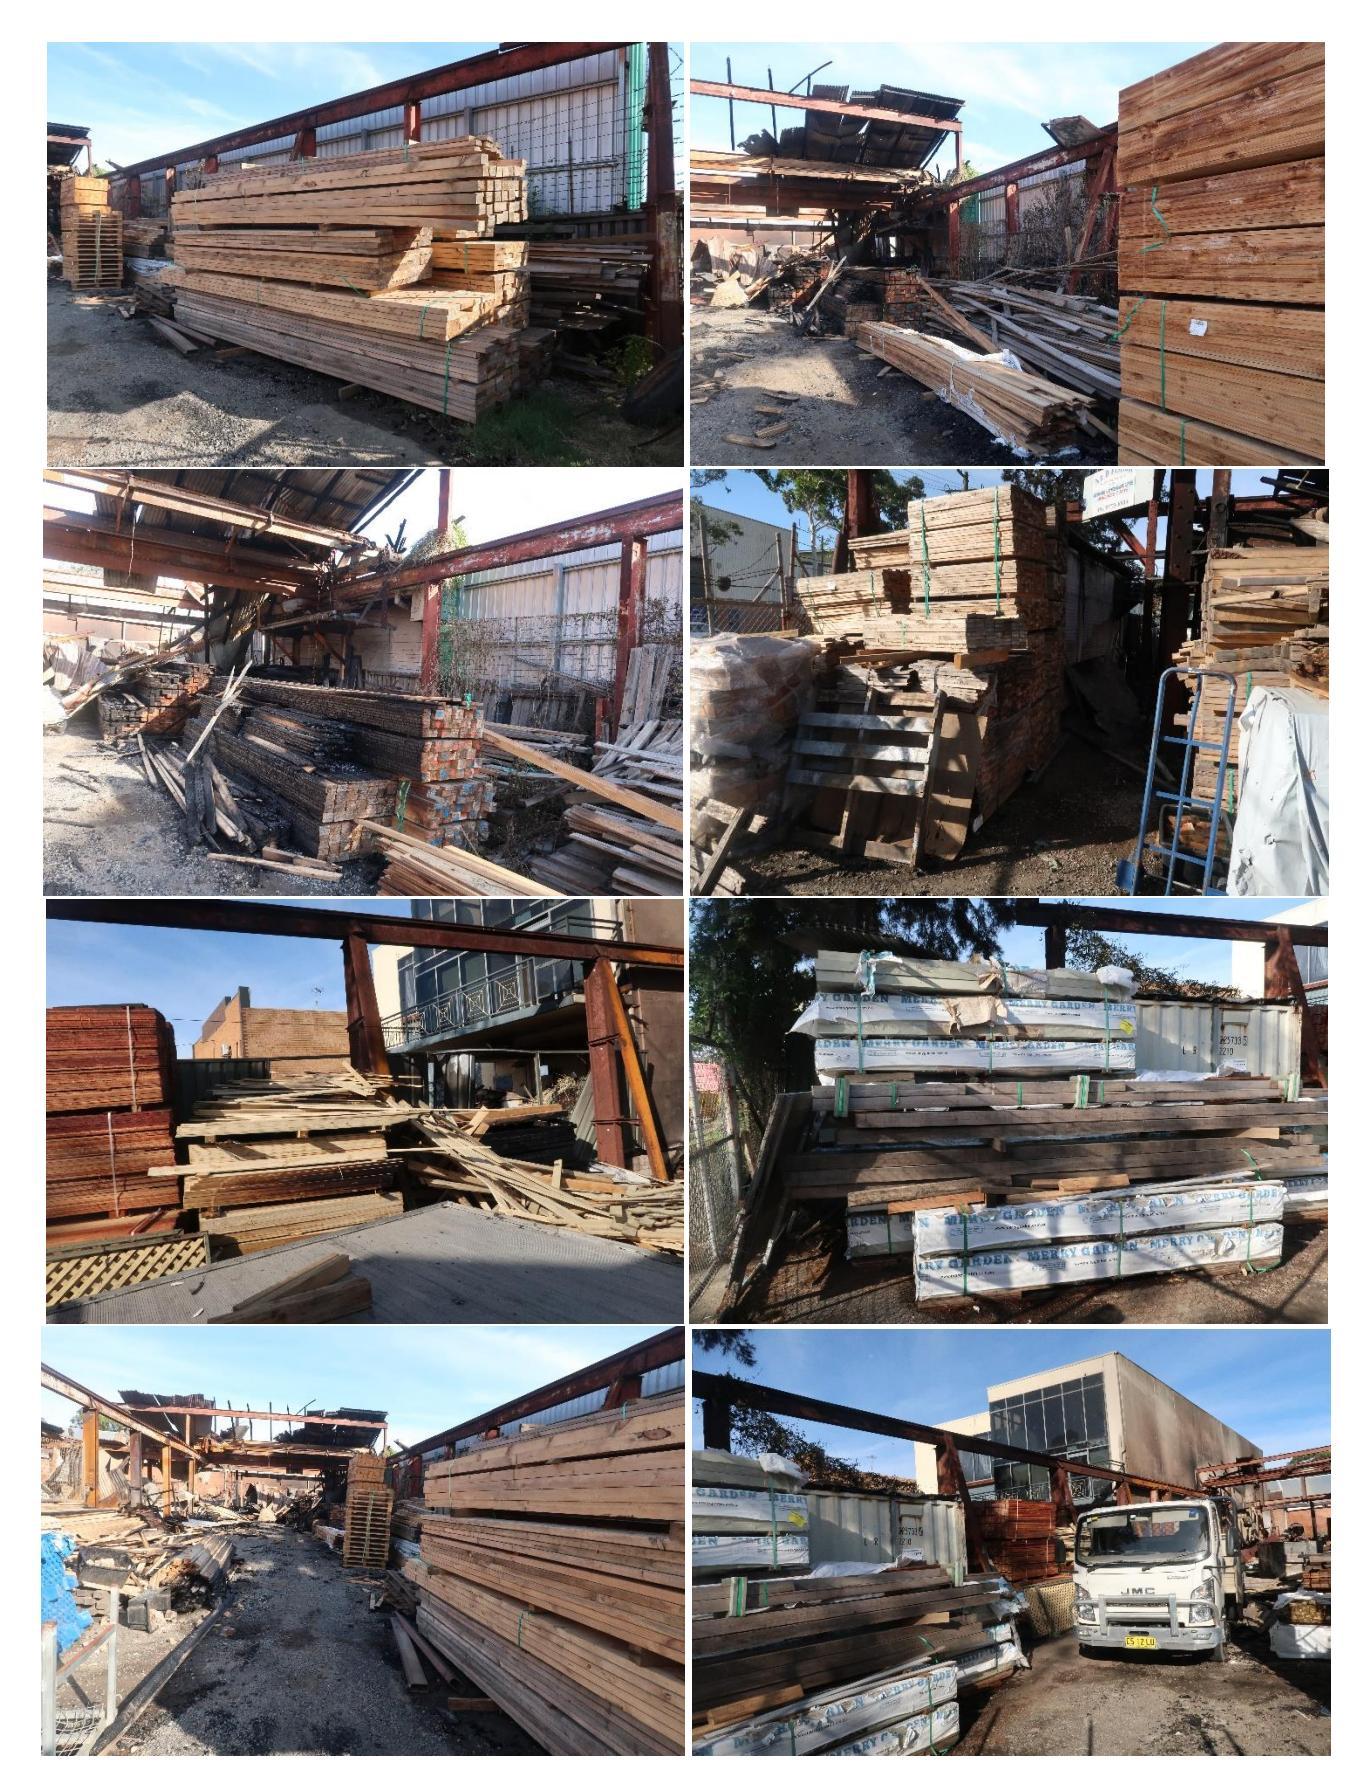
Firefighters protected a large quantity of timber packs and stacked timber, reducing the size of the fire area and creating a fire break that stopped the fire spreading to additional exposures. A truck inside the yard was also saved (lower right). Although the fire represented a major loss for the business owner, there was significant value in the stock firefighters managed to save.

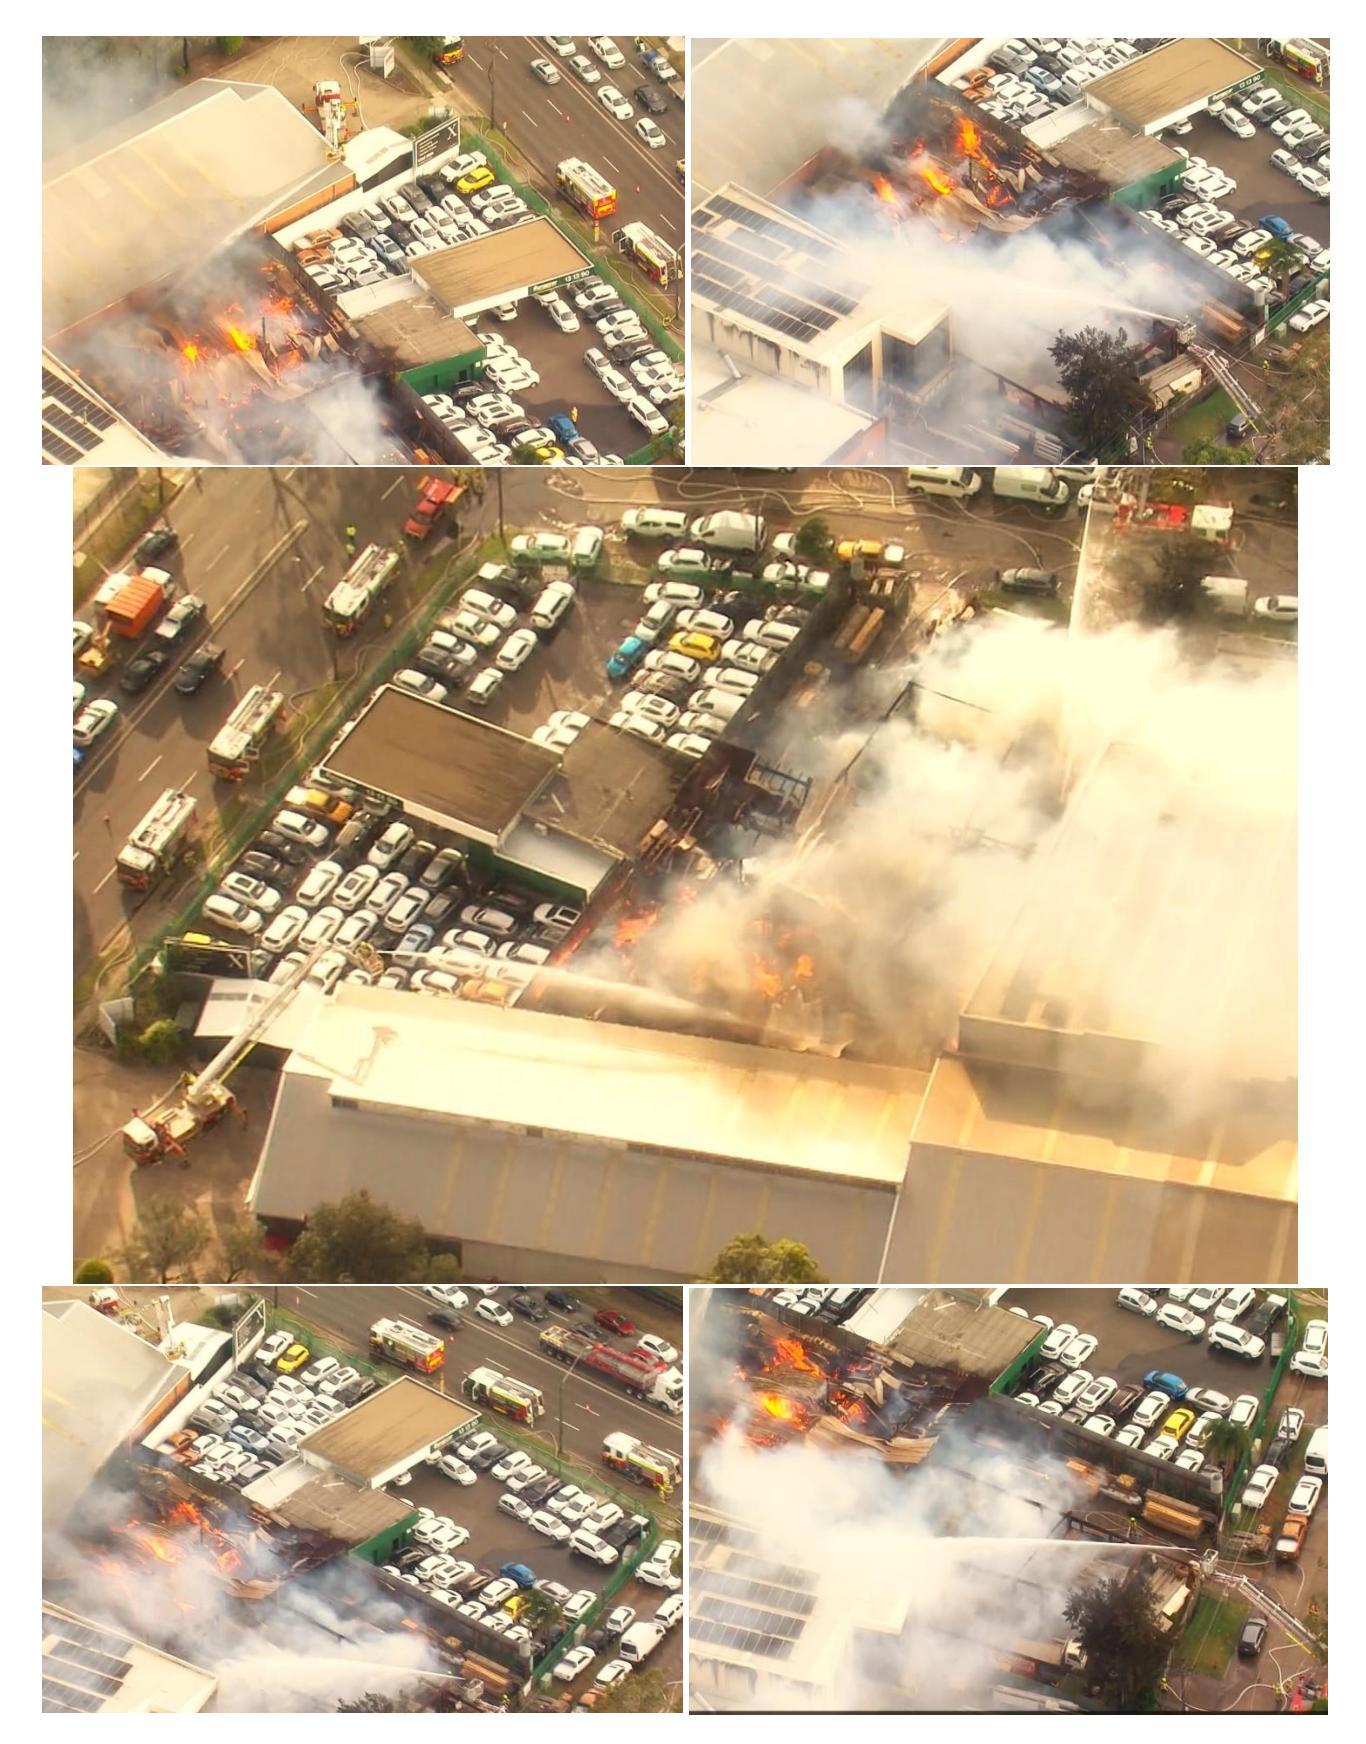
The aerial appliances did an outstanding job, establishing protection with aerial master streams on all sides of the main fire occupancy and conducting effective direct attack on the fire, reducing fire intensity sufficiently for fire control to be gained; what isn't so obvious is the planning from the initial fireground commanders to establish adequate water supplies from appropriate mains to support the master stream operations. Equally important was the work of firefighters who rapidly established the water supplies. In addition to the great skill of the operators, the aerials were effective because sufficient water supplies were established.

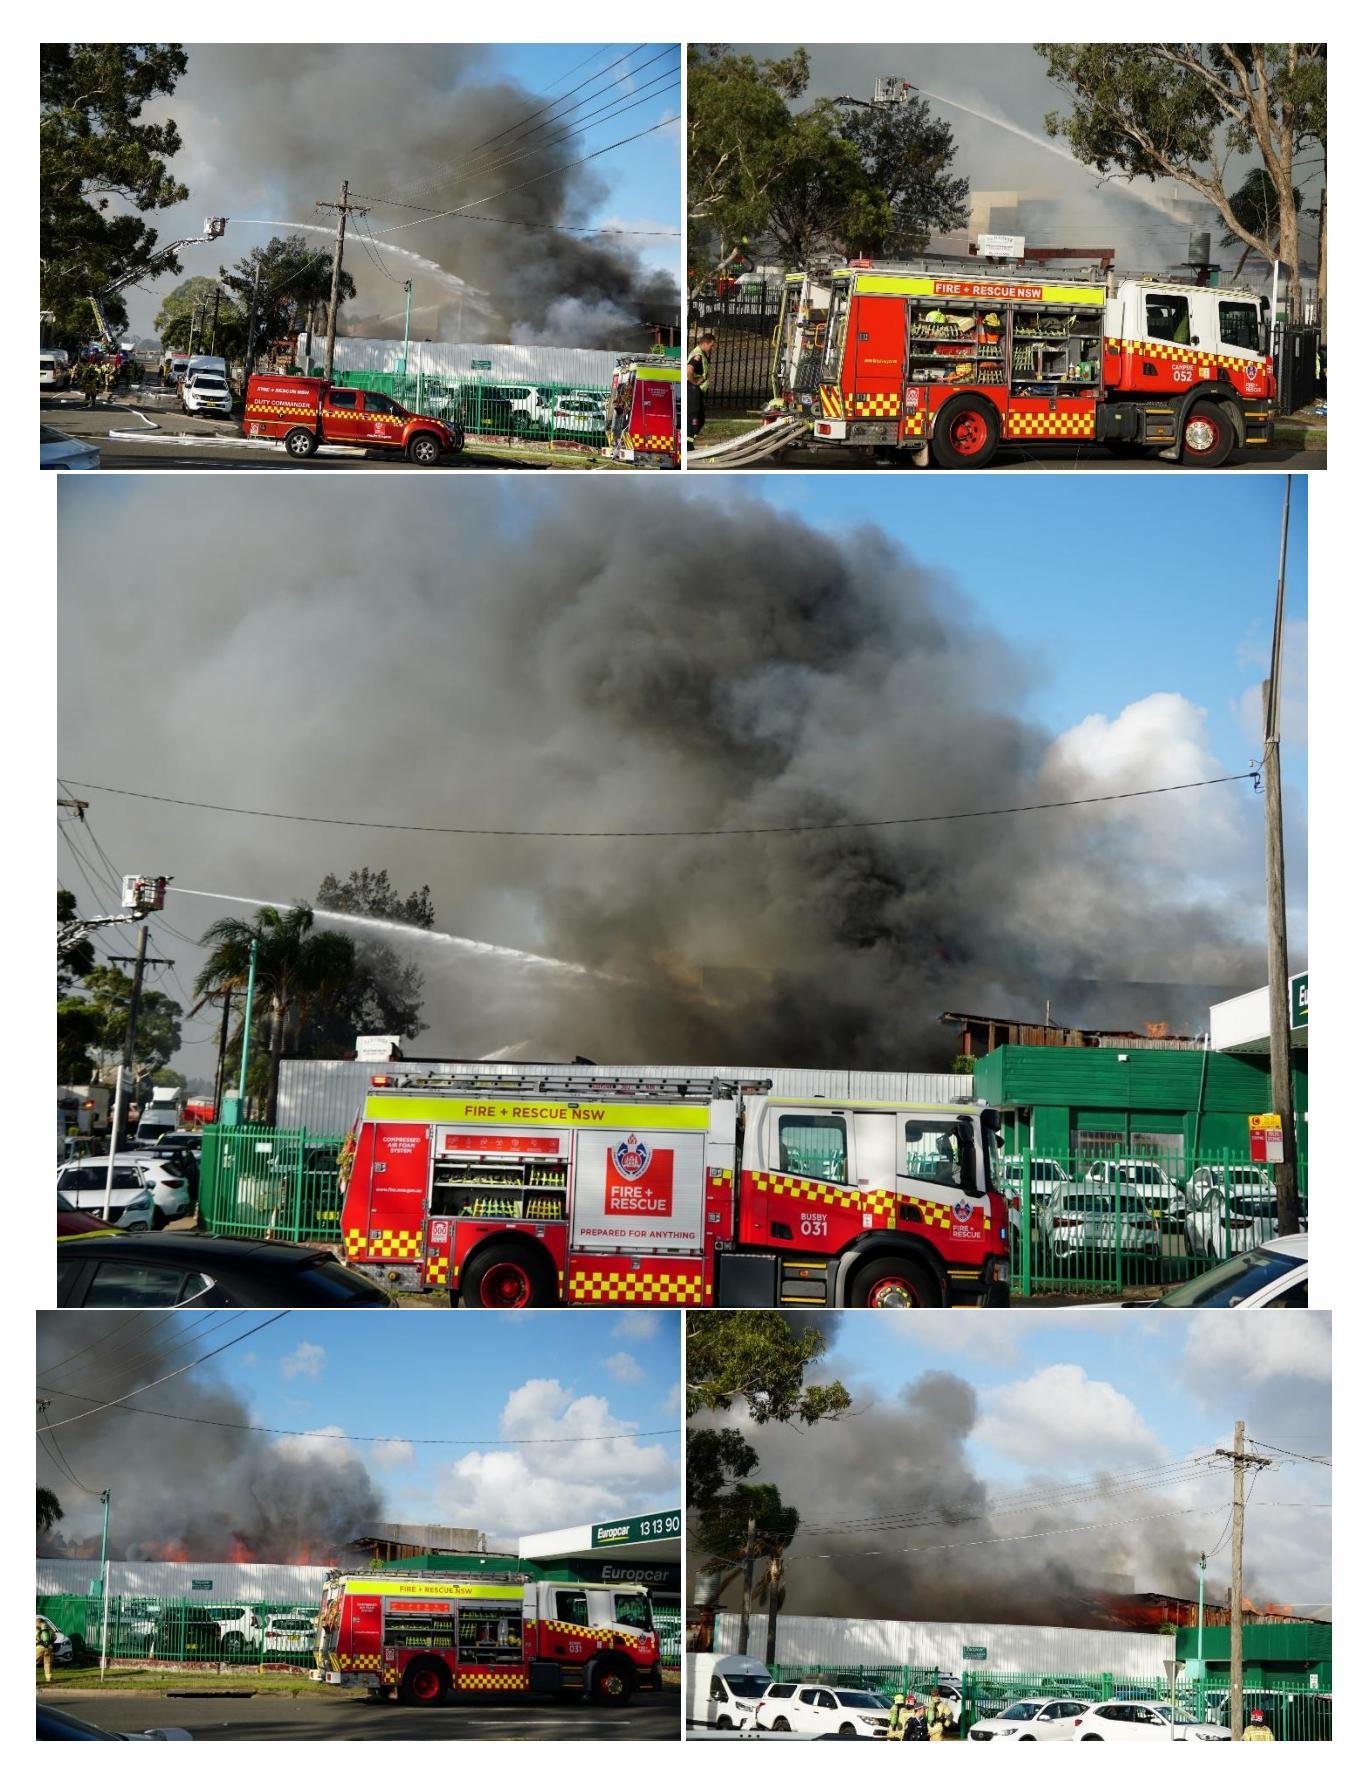
CAP 47 initially placed an aerial stream in opertaion with two 70 mm supply lines (top left) providing a fair stream. When a supply was established with four 70 mm lines the aerial stream was greatly improved (upper right and middle), allowing firefighters to conduct an effective attack on the fire, resulting in fire intensity being reduced and fire control being established. Lower: The fire produces heavy black smoke as firefighters establish a water supply for CAP 47.

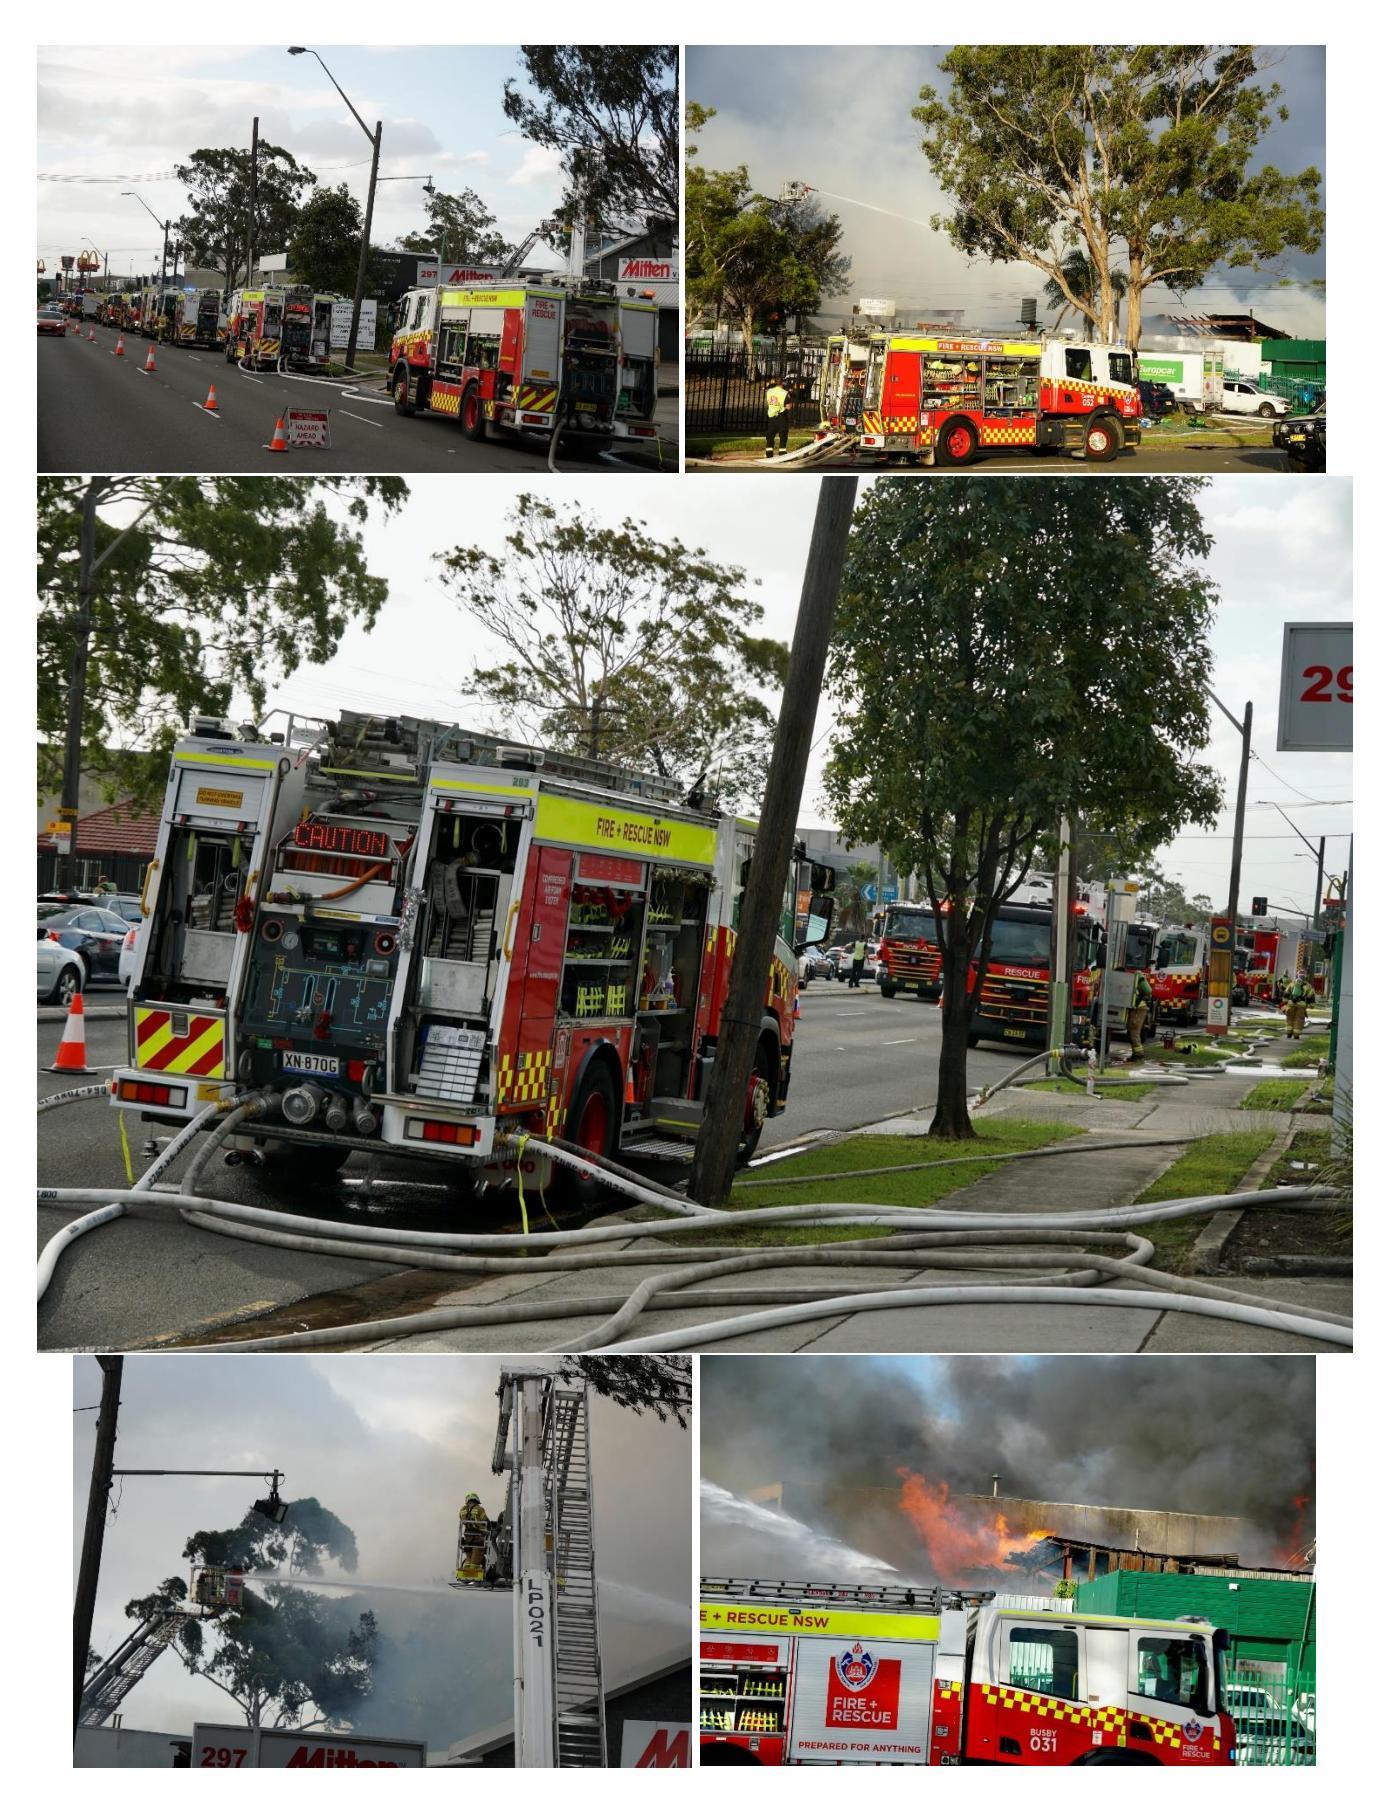
Top and middle: Firefighters established multiple water relays to supply the aerial appliances. Lower left: CAFS Aerial Pumper 47 and Ladder Platform 21 attack the fire. Lower right: An aerial master stream attacks heavy burning in the middle of the timber yard.

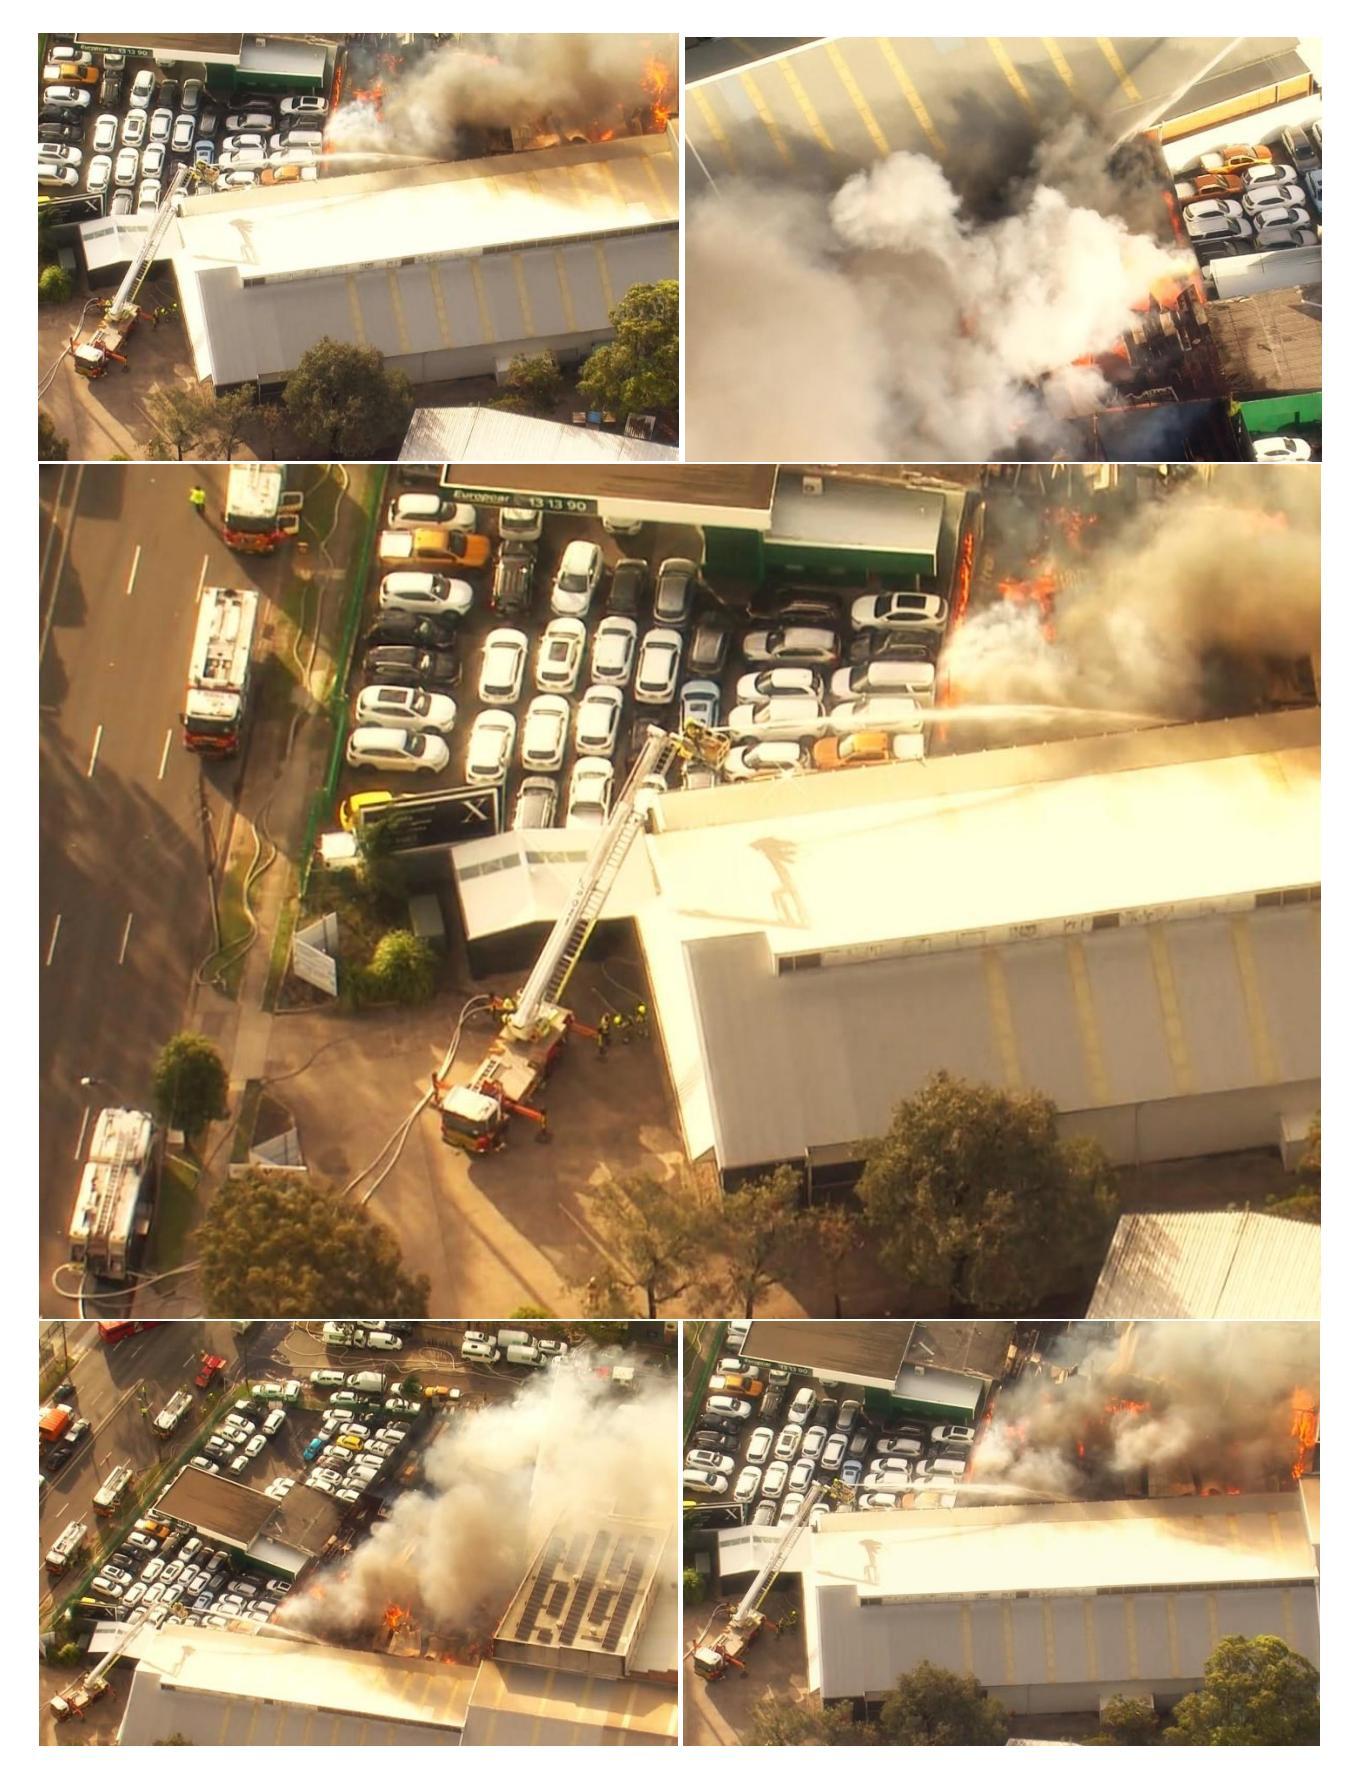
Ladder Platform 21 alternated between directing protective streams along the western wall of Exposure Charlie and the northern wall of Exposure Delta. Working closely with hose crews on the ground, these coordinated operations ensured heavily threatened exposures were protected.
