MW1 C STATION TRAINING AND INCIDENT CASE STUDIES

FILE NO. 2024 /02.

MILPERRA 6th ALARM TIMBER JOINERY FIRE

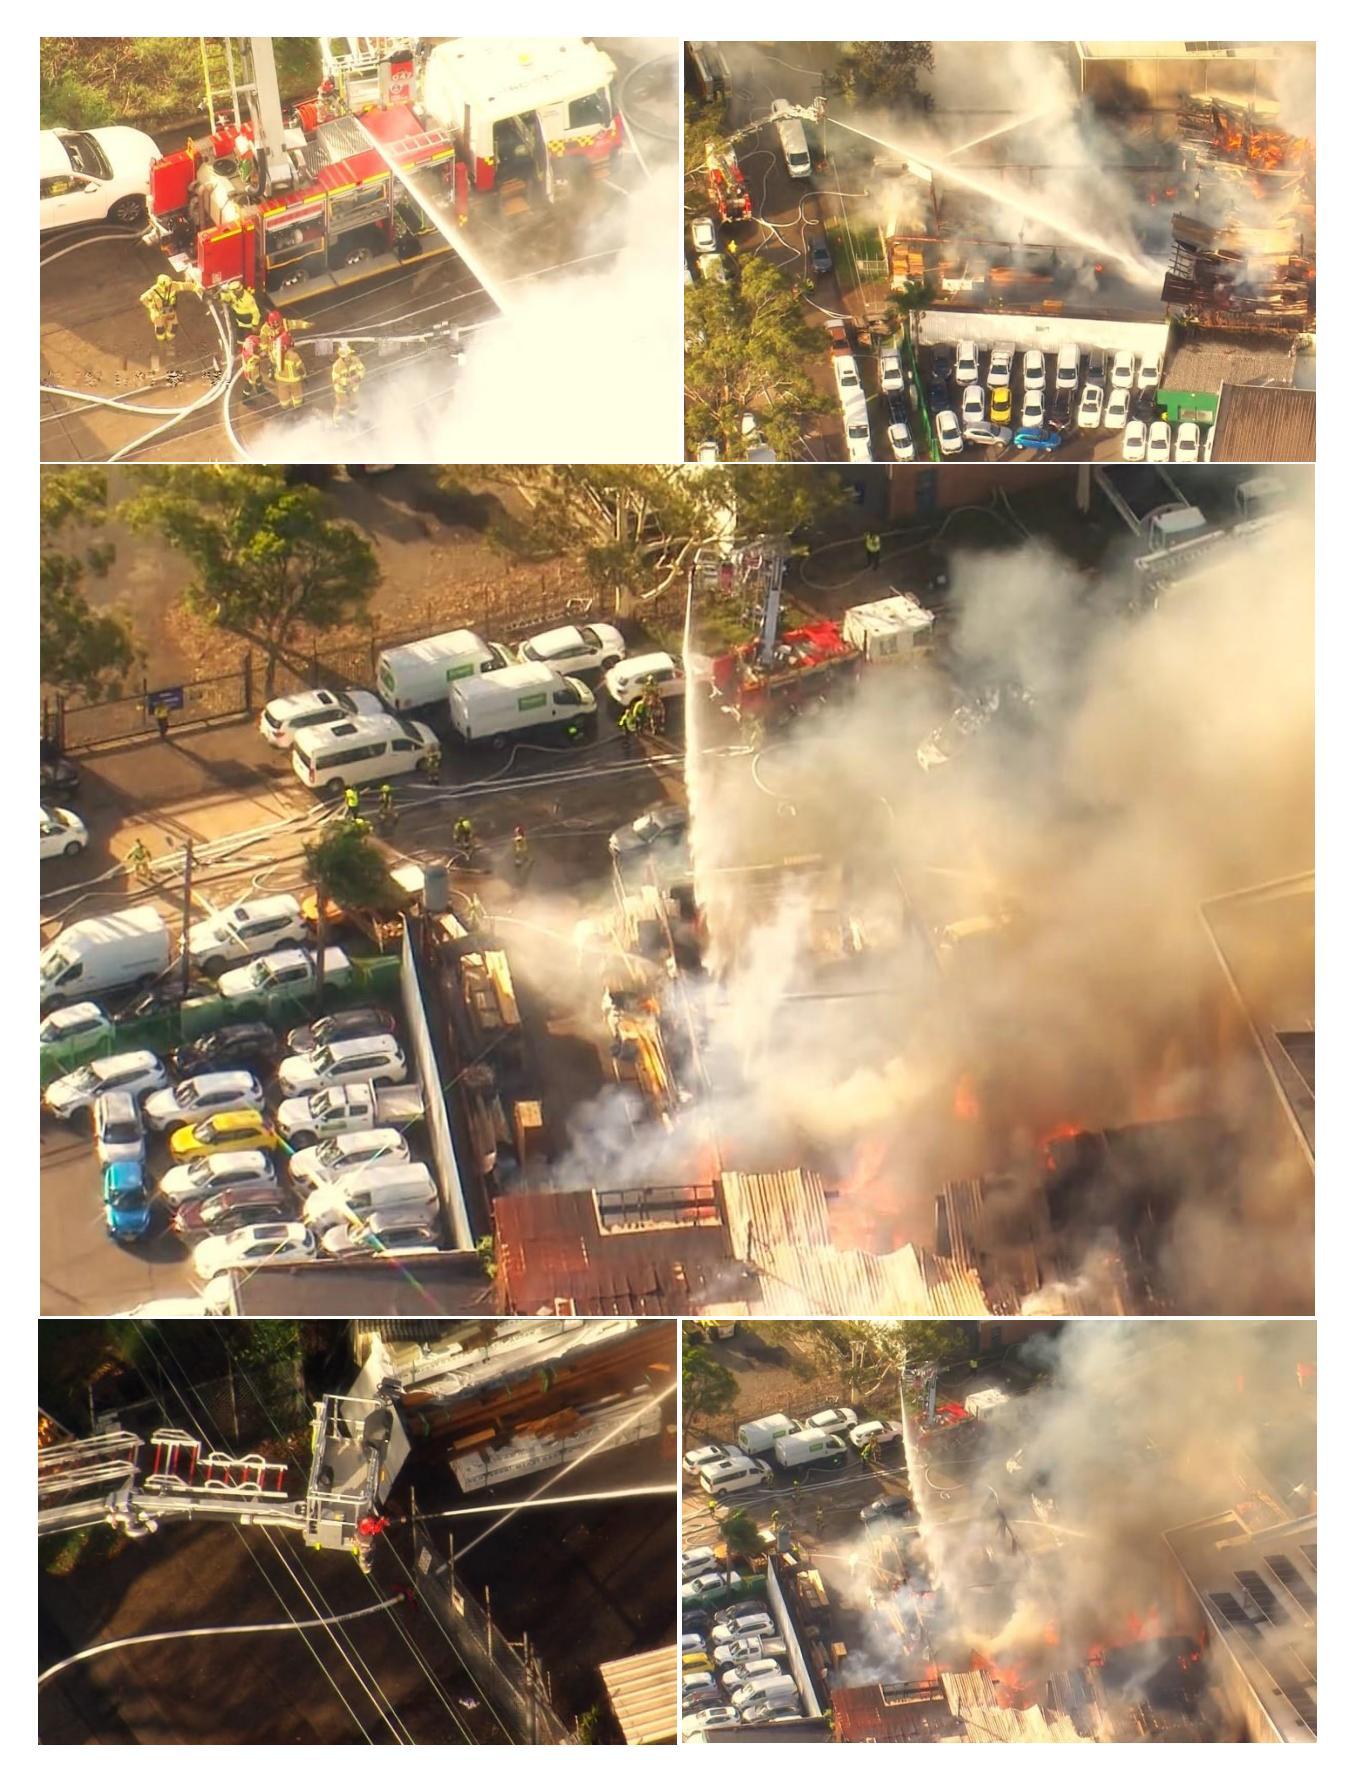
The aerial master stream of CAFS Pumper 47 is directed on the fire, resulting in a significant reduction in fire intensity and establishment of fire control. Firefighters located mains remote to the location of the aerial, ensuring the aerial water supply draw from supplies already being used. The aerial monitor is fitted with stacked tips, creating a solid aerial that was more effective under the windy conditions than a hollow stream from a diffuser spray nozzle. The aerial stream was highly effective.

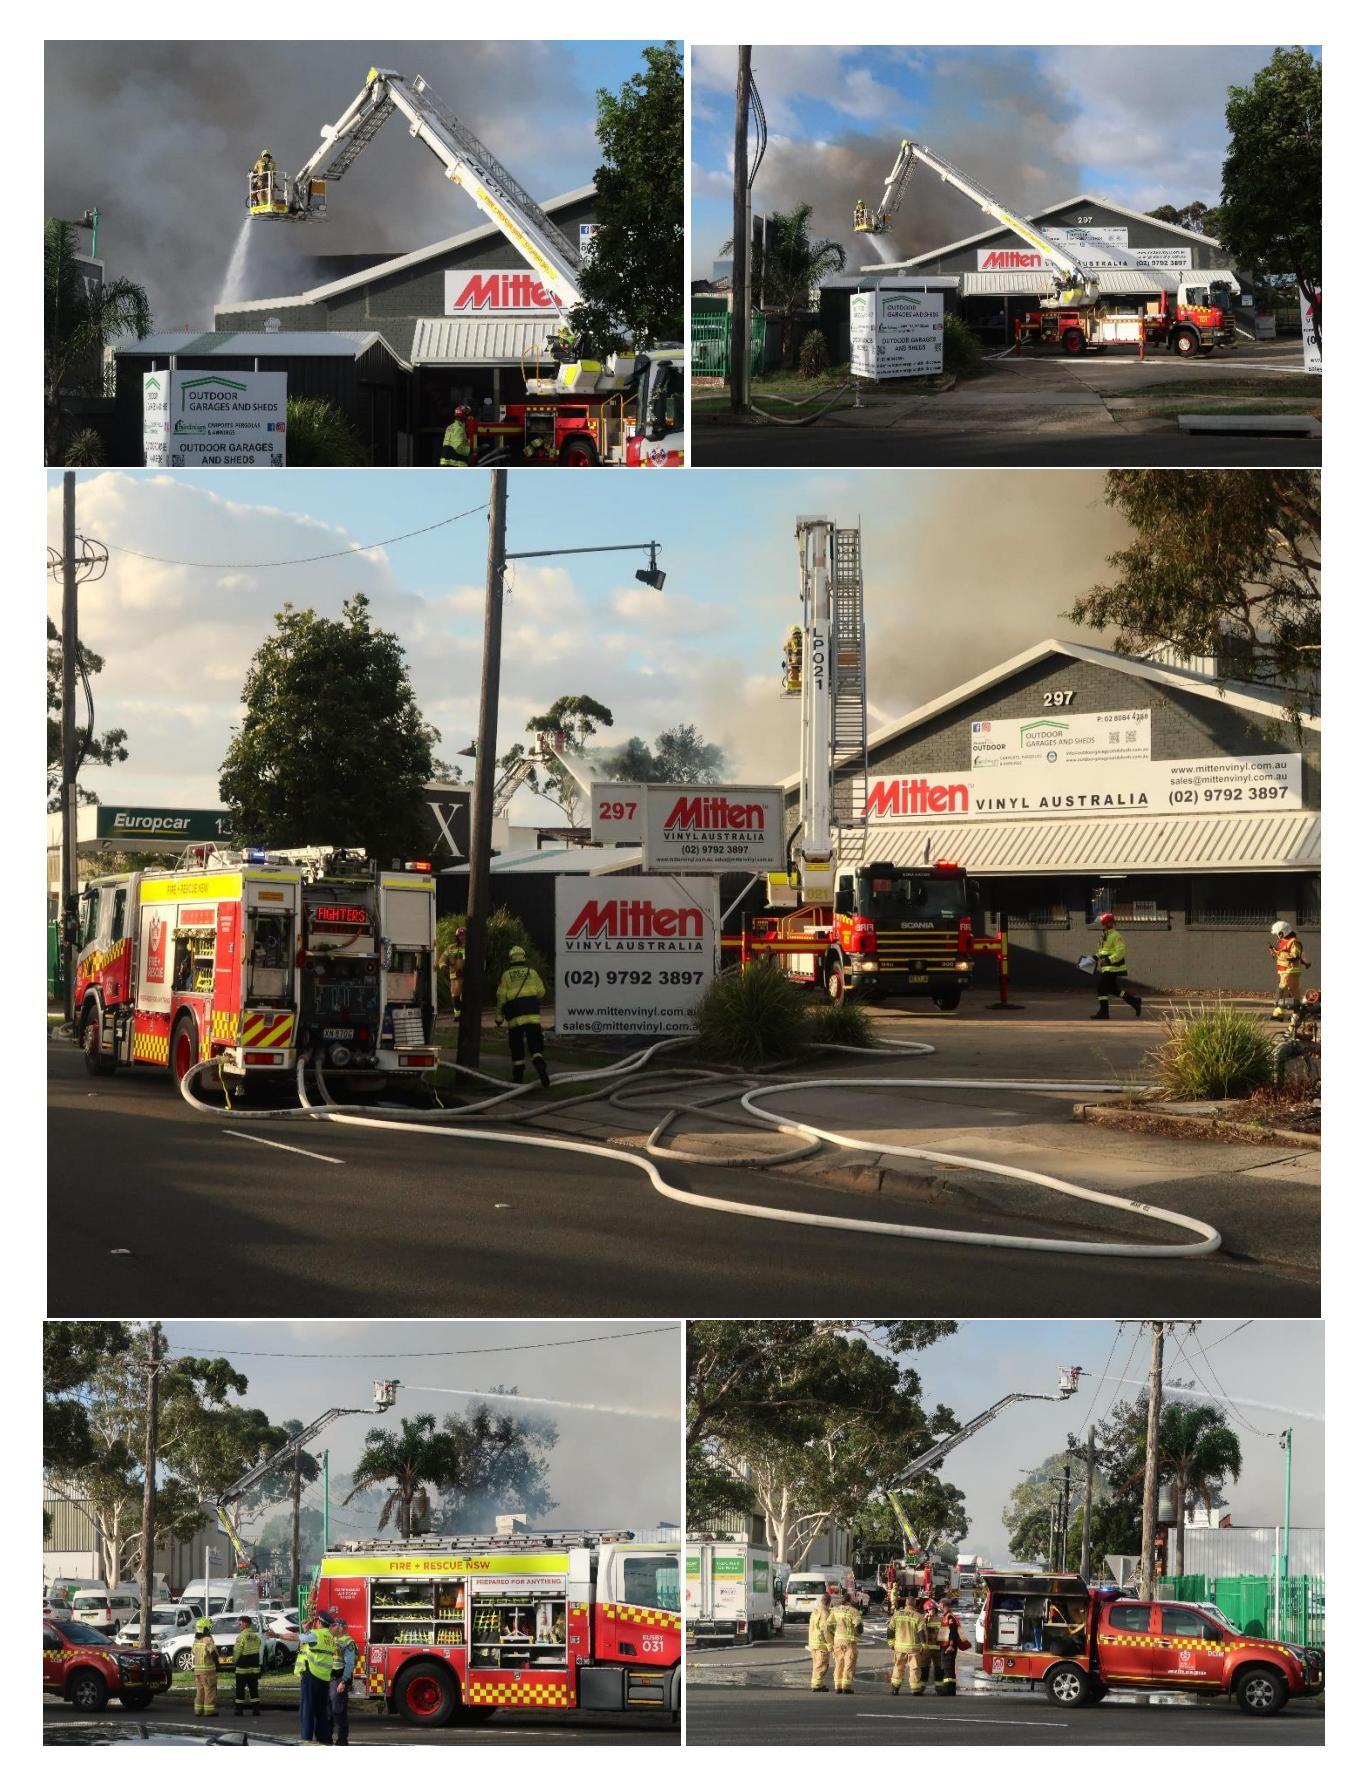
Upper and middle: Ladder Platform 21 attacks the fire from the Charlie Delta corner. The aerial stream was able to protect heavily threatened Charlie and Delta exposures. Lower: CAFS Aerial Pumper 47 directs an aerial master stream onto the fire, reduicng fire intensity.

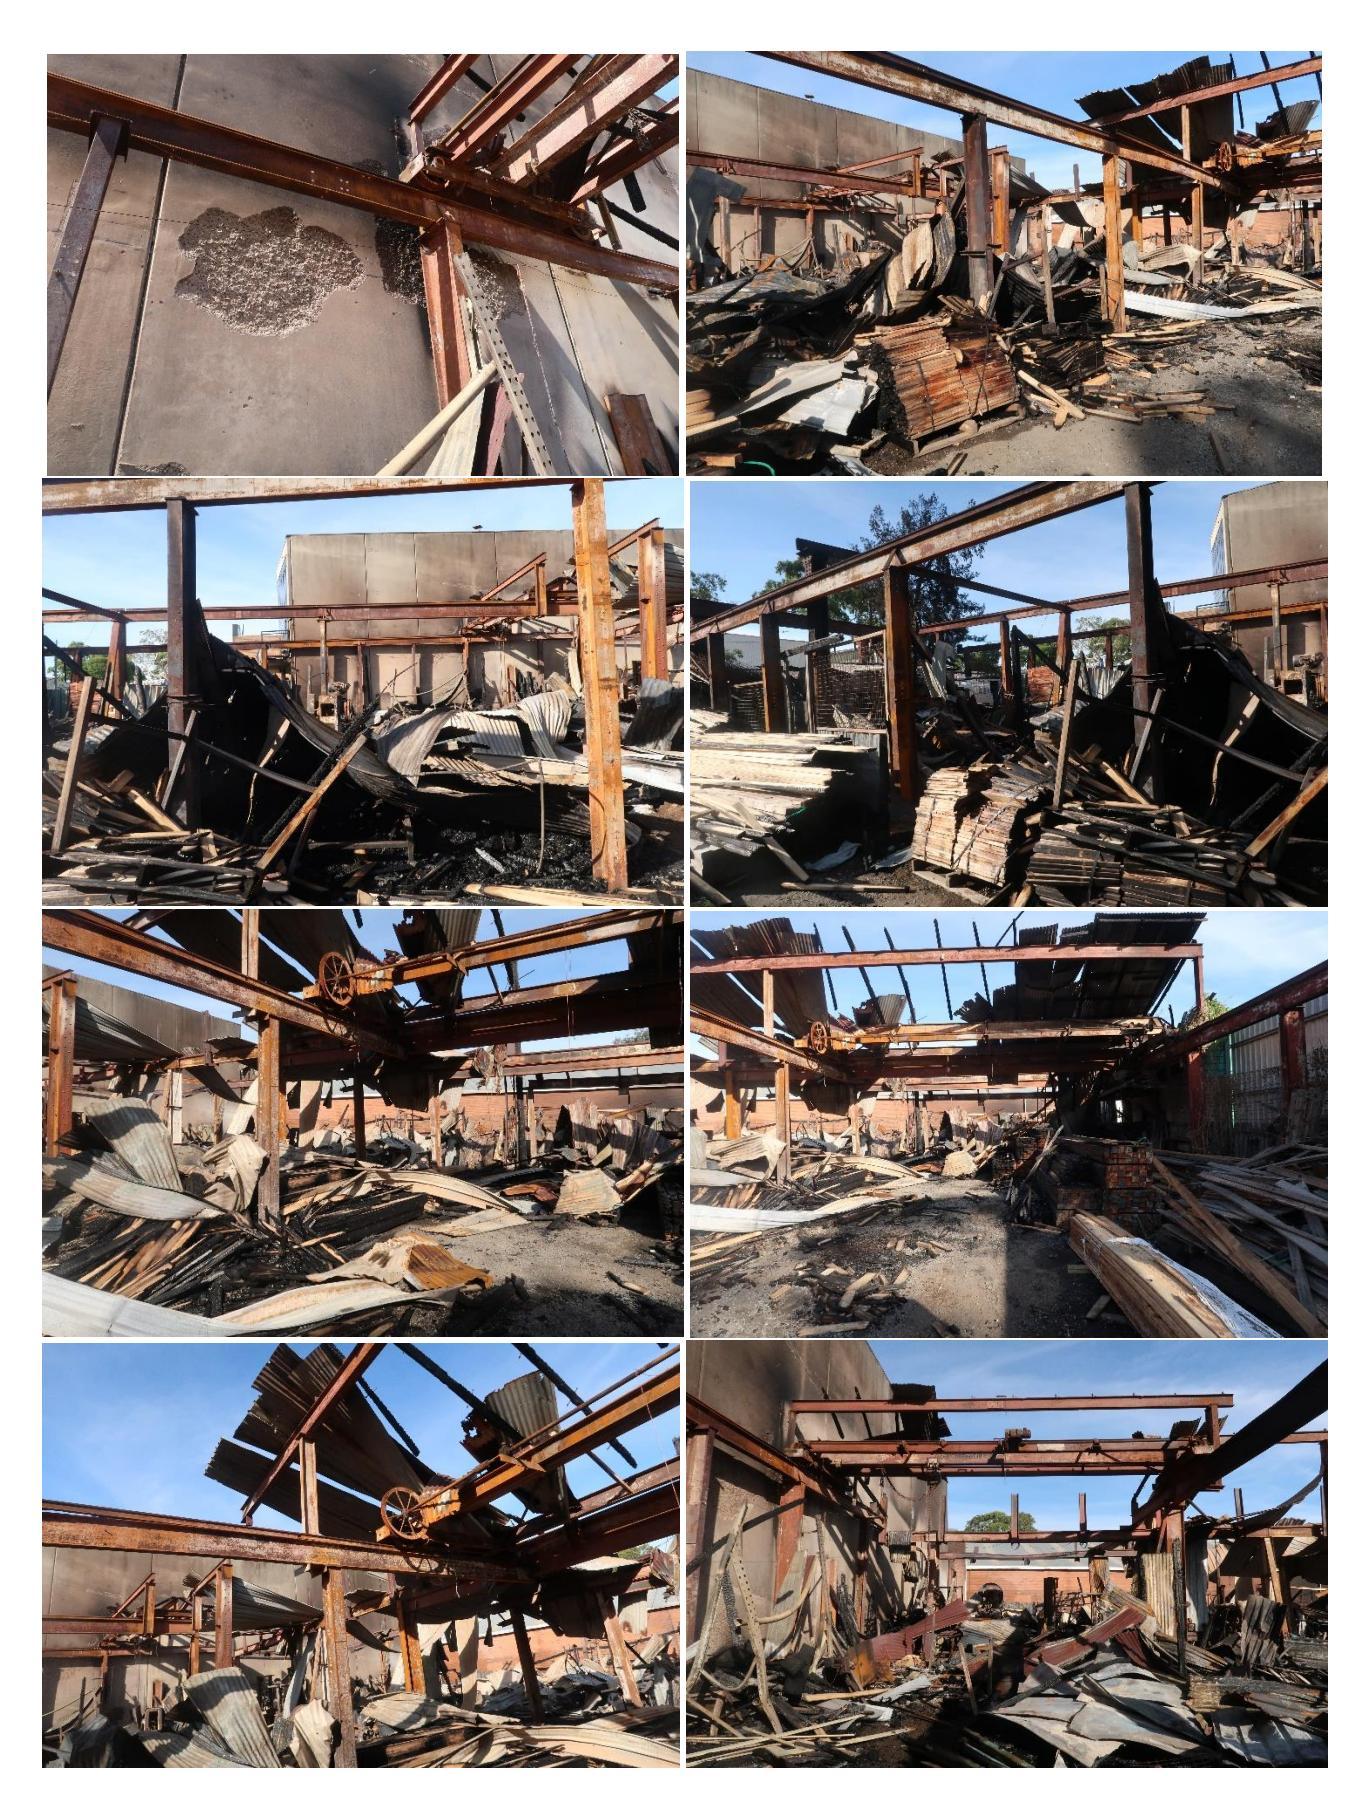
An interesting feature of the site were the two overhead gantry cranes located on the north and south sides of the yard, formed from prefabricated rolled steel.
