**NSWFB RETIREES FIRE NEWS  
INCIDENT REPORTS**

**4<sup>th</sup> ALARM GIRRAWEEEN FACTORY COMPLEX  
FIRE**

### **Incident Summary:**

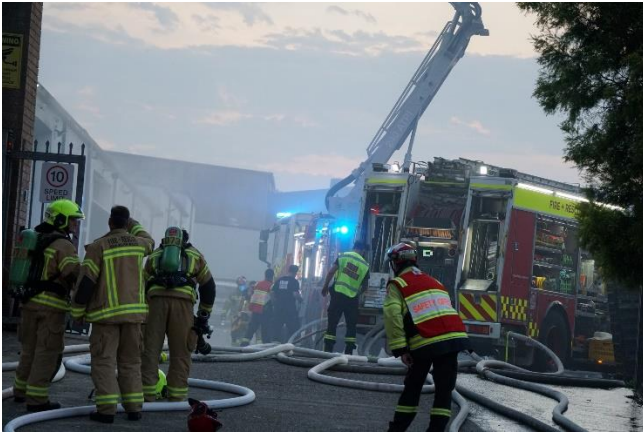
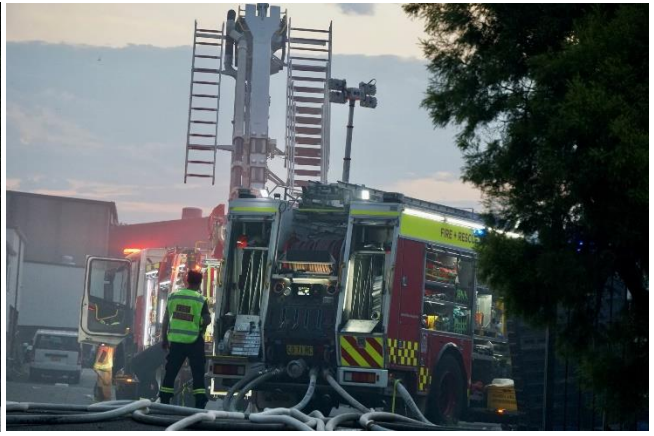
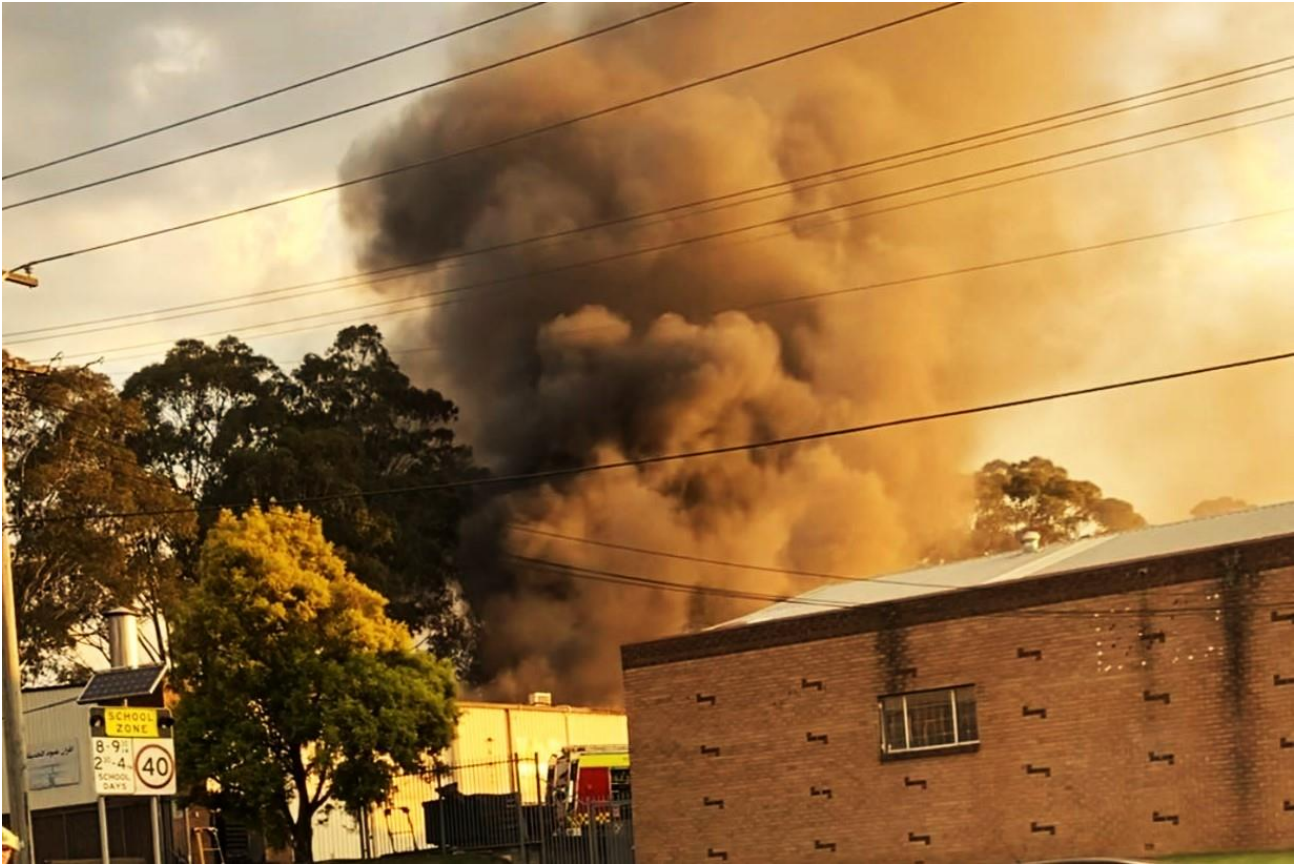
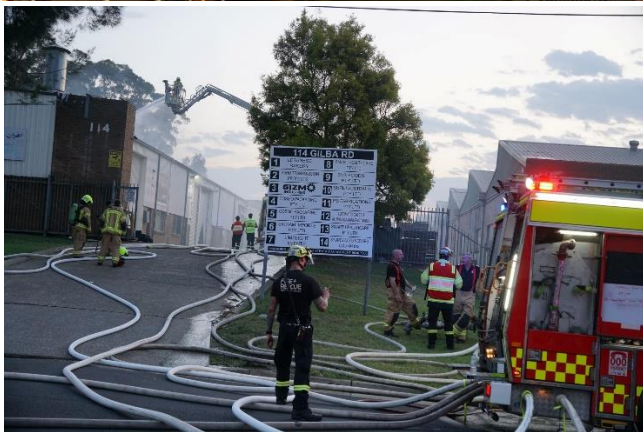
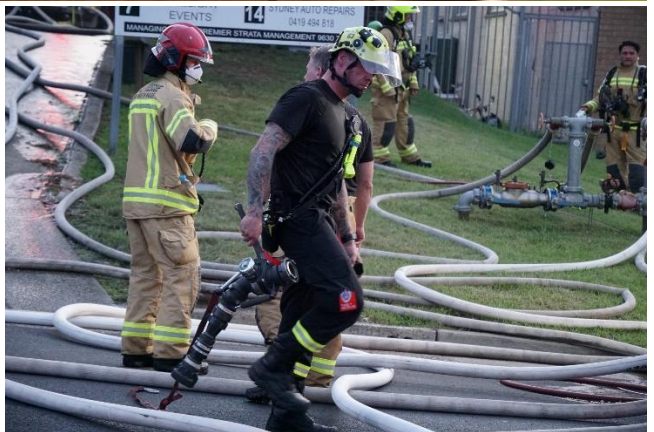
Operations in Alpha Sector consisted of attack lines going into Factory Units 4 and 5. When fire conditions escalated due to the involvement of expanded polystyrene insulated sandwich panels, internal crews were temporarily withdrawn while the aerial stream of CVAFS Aerial Pumper 97 attacked the fire. Firefighters had to lay hose almost 100 metres from the street to supply appliances with water.

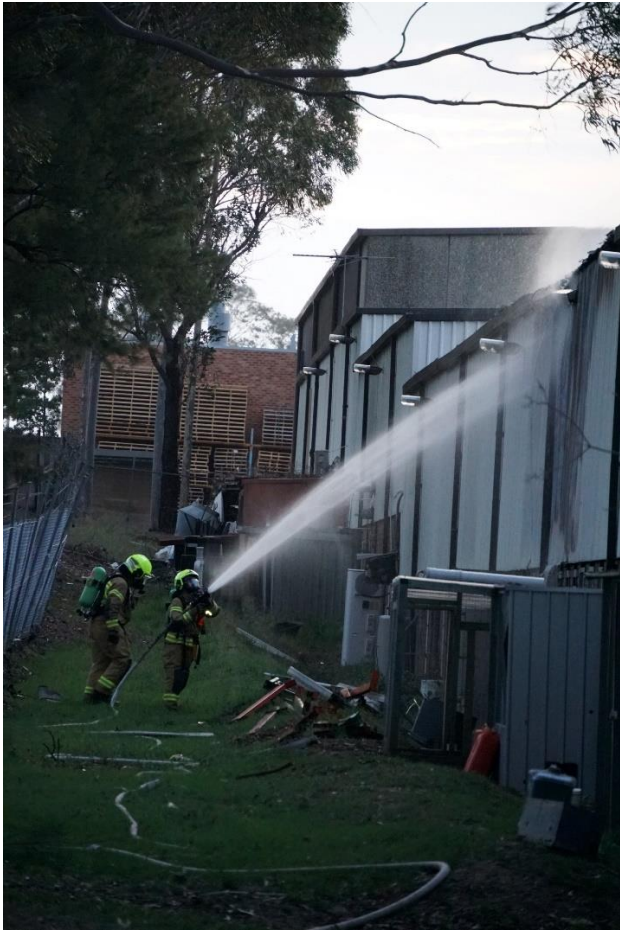
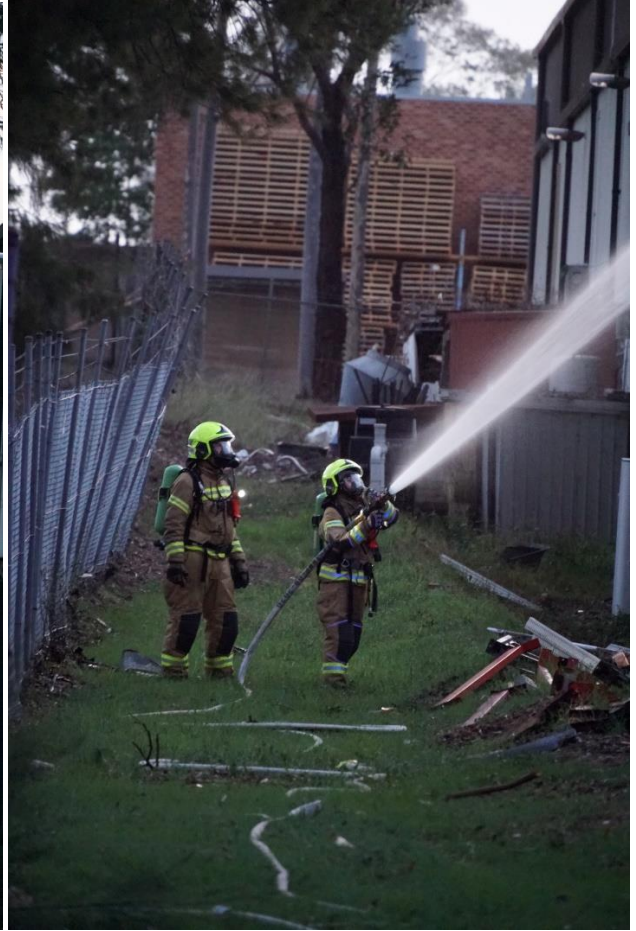
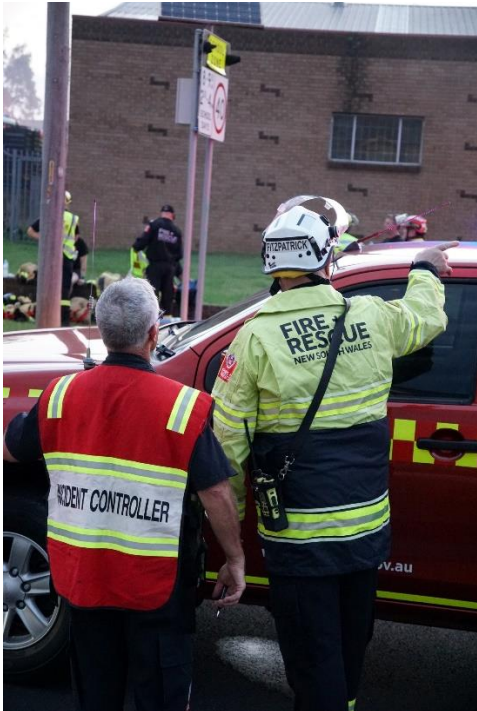
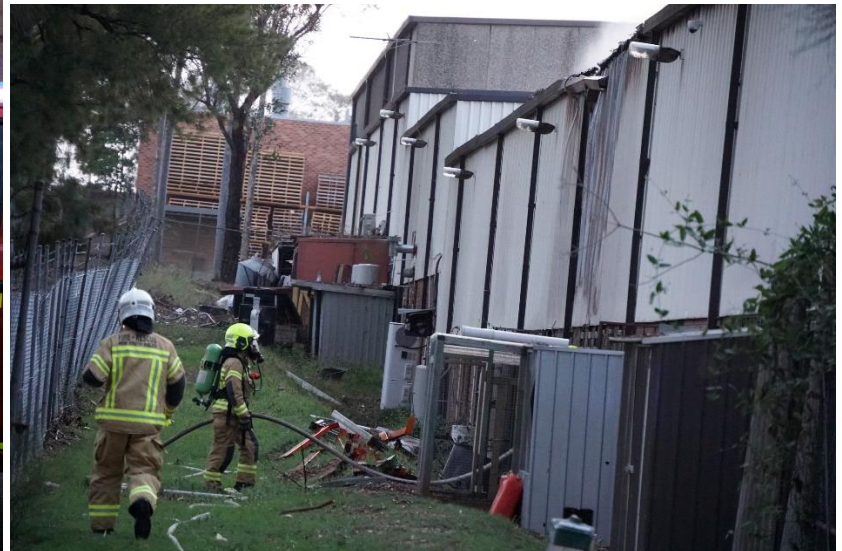
Operations in Charlie Sector were initially defensive (top). Once a significant reduction in fire intensity had been achieved, crews in Charlie Sector made entry into the building and attacked fire burning on elevated racking (lower). At this point Duty Commander MS3 Inspector Bruce Fitzpatrick had been appointed Charlie Sector Commander.

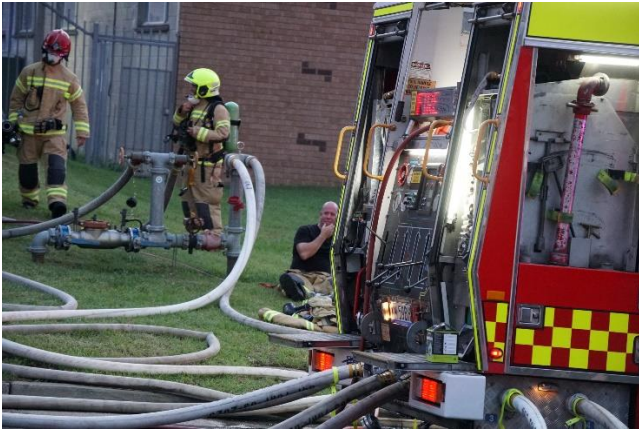
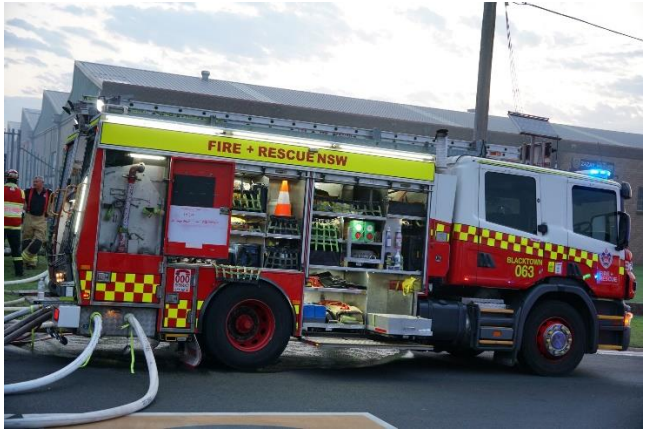
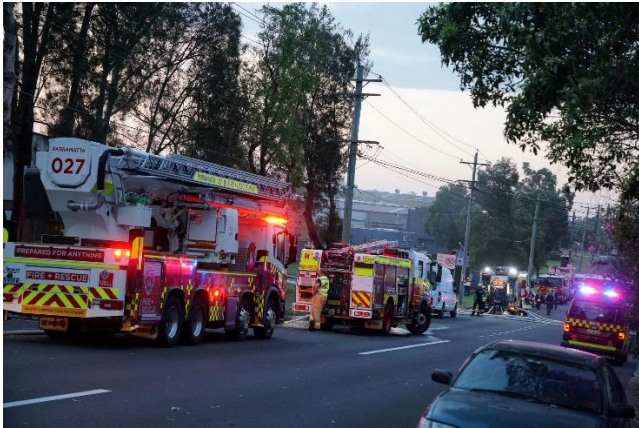
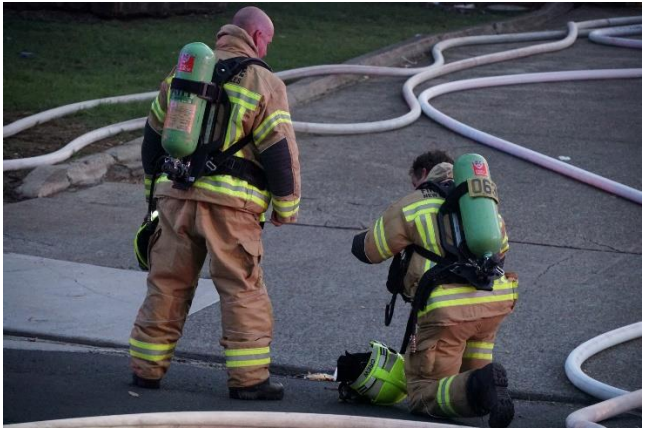
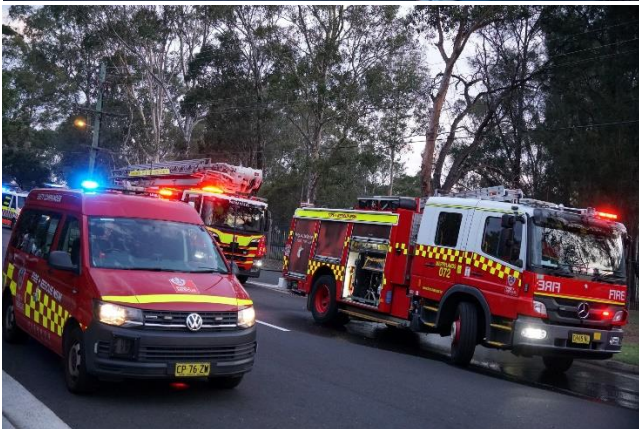
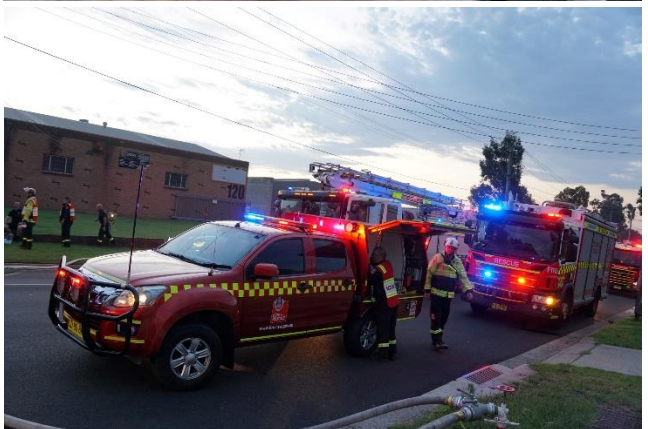
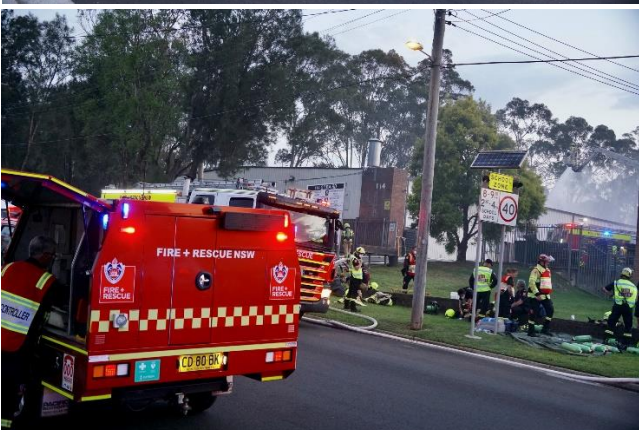
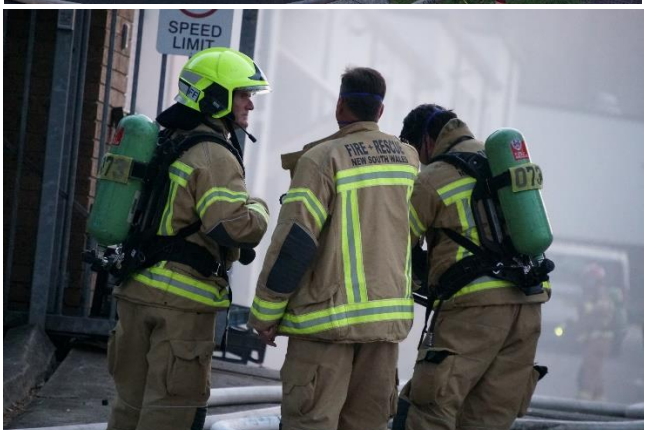
Top: Rescue Pumper 63 provided water to appliances attacking the fire. Middle upper: Appliances in staging and on-deck crews prepare to relieve fire attack crews. Middle lower: Incident Command Point – The Incident Commander established an effective command point at the Duty Commander vehicle. Bottom: A view of the rehabilitation area and on-deck crews await tasking.

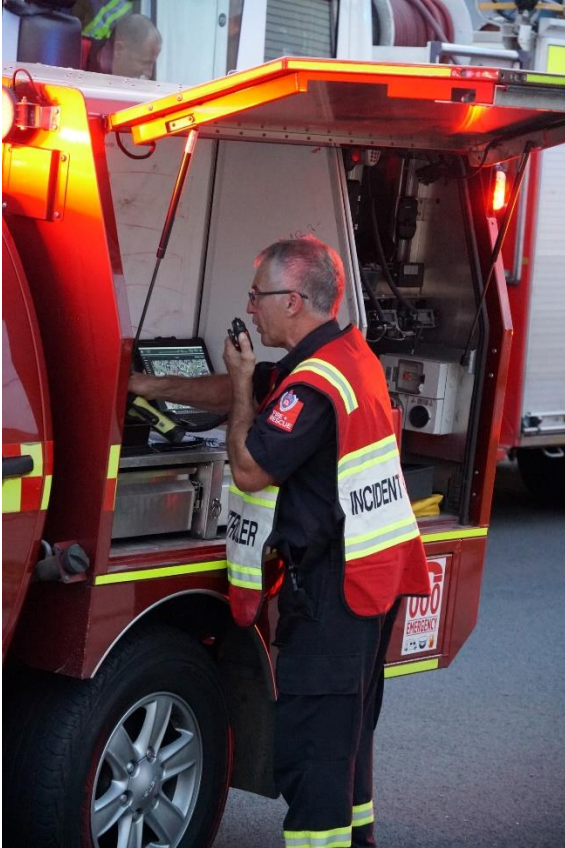
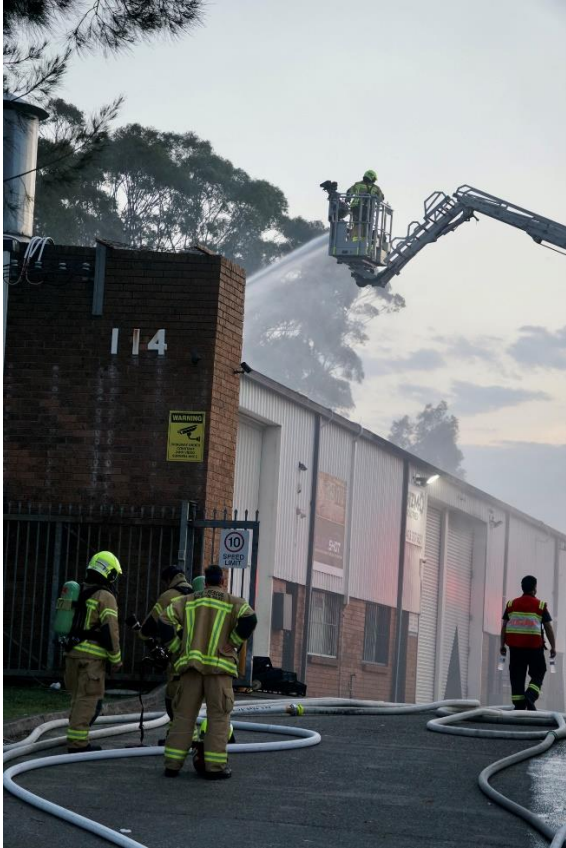
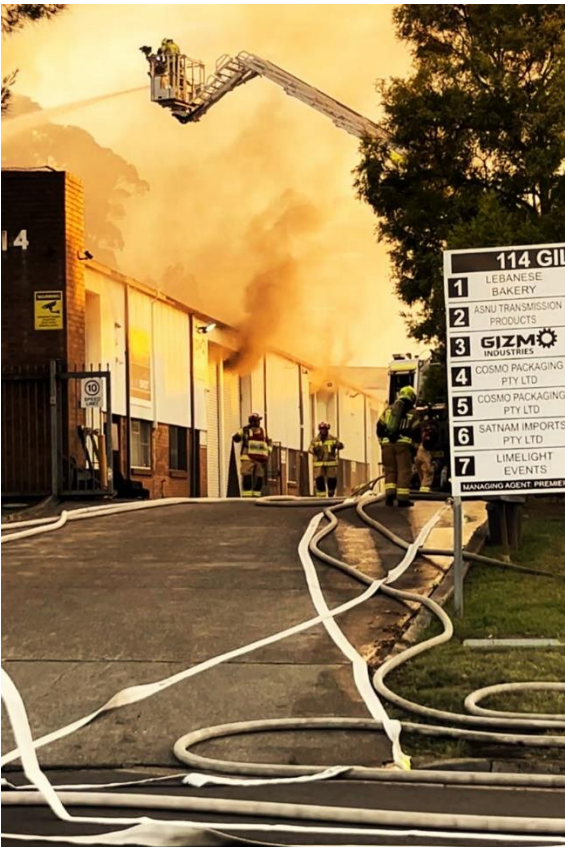
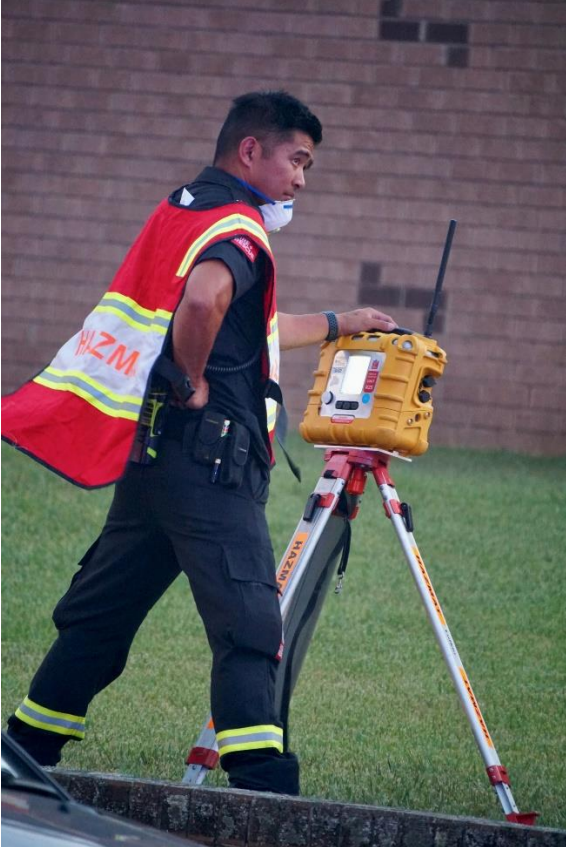
Upper left: Incident Commander Duty Commander MW1 Inspector Bob Mey is on the radio to the Sector Commanders, coordinating firefighting as the aerial appliance goes into operation. Inspector Mey's high levels of experience, focus and calm demeanour are an enormous asset on the fireground. Upper right and lower left: CAFS Aerial Pumper 97 cage operator Firefighter Mark Sampson directs and aerial stream into the breached polycarbonate roof panels, resulting in a significant diminishing of fire intensity. Lower right: Hazmat 77 firefighters positioned a number of AreaRAE monitors across the site.

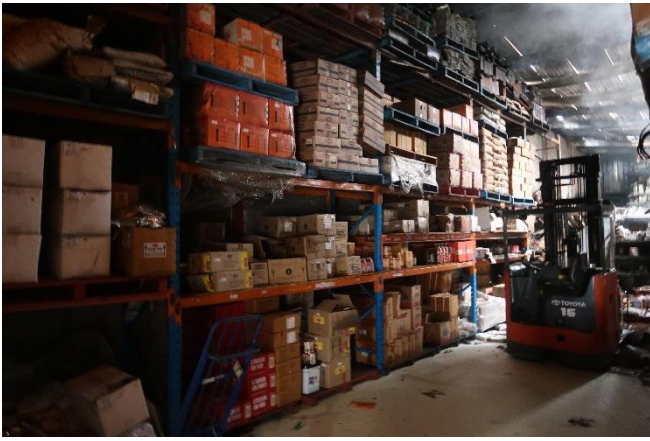
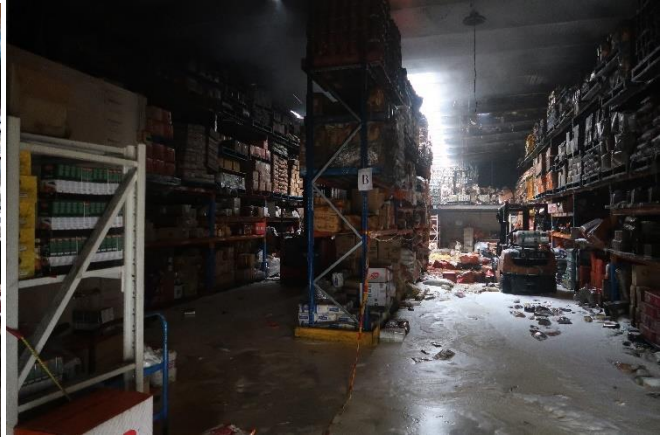
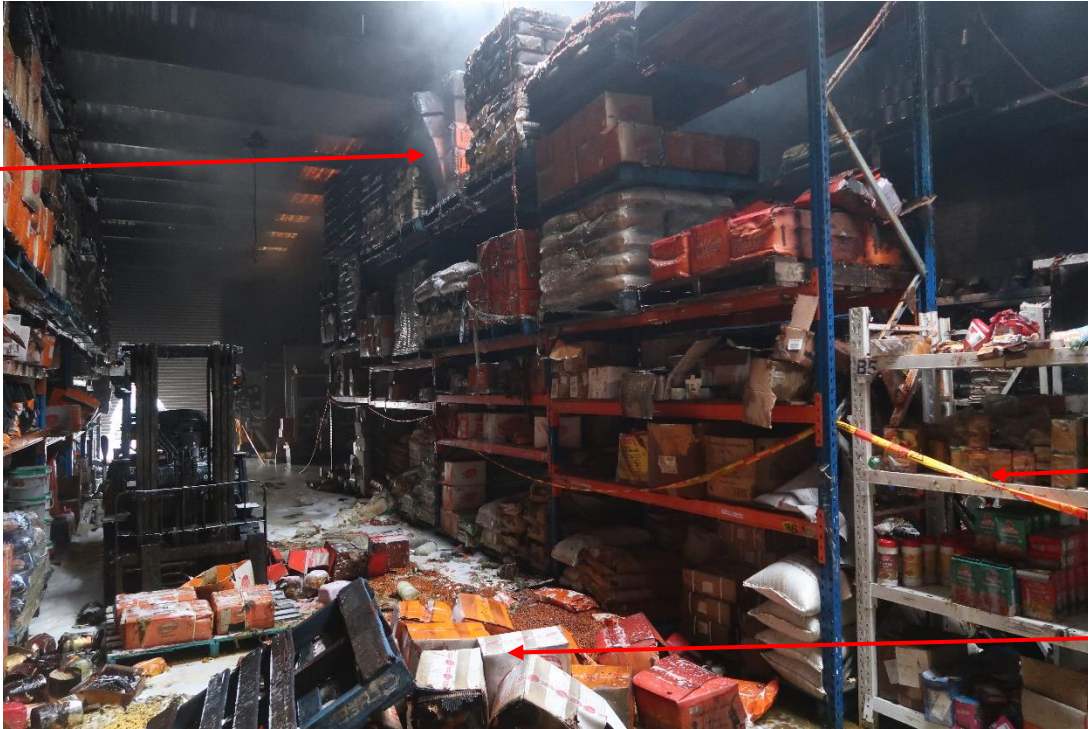
There are indications the fire initially involved electrical equipment that was part of the refrigeration system for one of the factory units two cool rooms, which were formed from expanded polystyrene insulated sandwich panels. The insulated sandwich panels at the front of the cool room (A) acted as a barrier, preventing thermal imaging cameras from detecting heat, allowing the fire to remain concealed at the rear of the cool room. Panel Delamination (B) occurred, allowing the expanded polystyrene panel cores to become involved in fire, producing extreme fire conditions.
