NSWFB RETIREES FIRE NEWS INCIDENT REPORTS

4th ALARM CAMPBELLTOWN SERVICE STATION FIRE

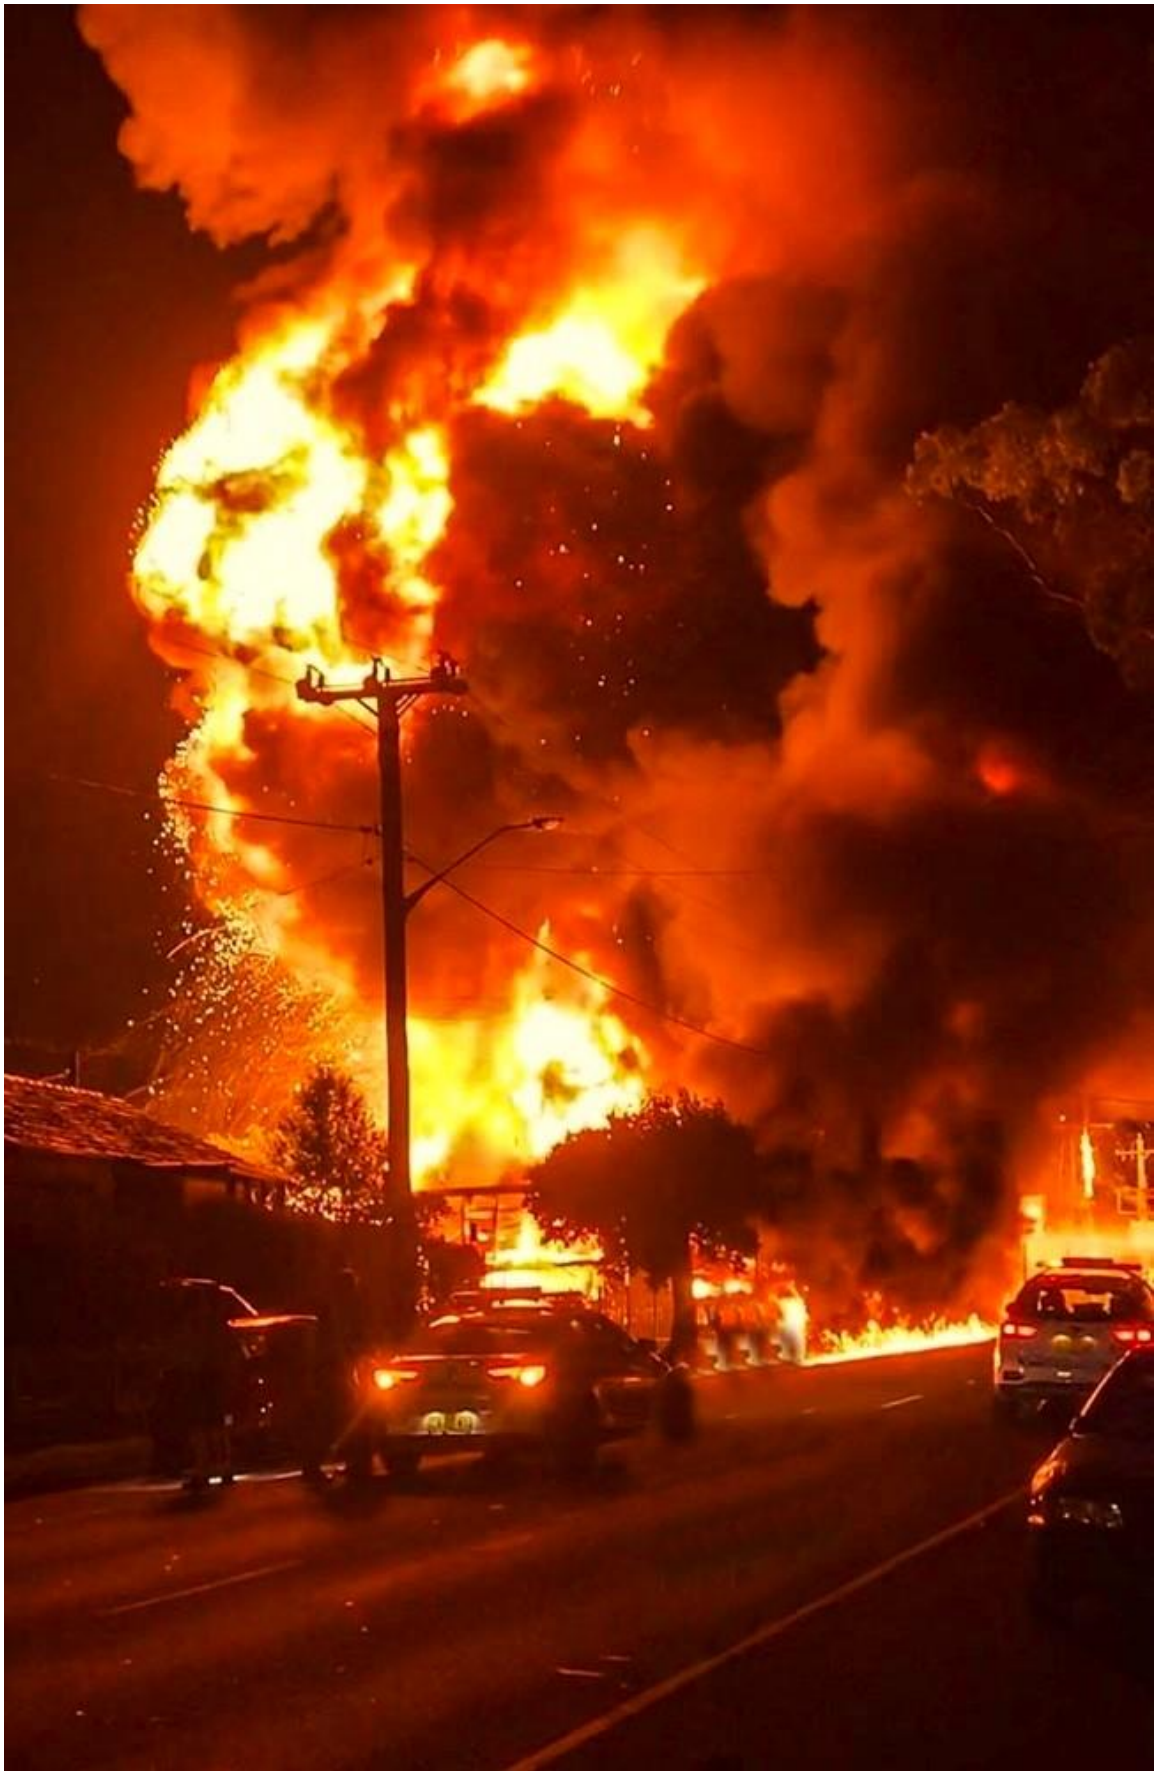
This photograph was taken by a member of the public shortly after firefighters arrived on scene. The petrol tanker, service station and several vehicles are totally involved in fire as a boiling liquid expanding vapour explosion (BLEVE) of a 210 kg LPG cylinder occurs. A running fuel fire is flowing along the gutter.

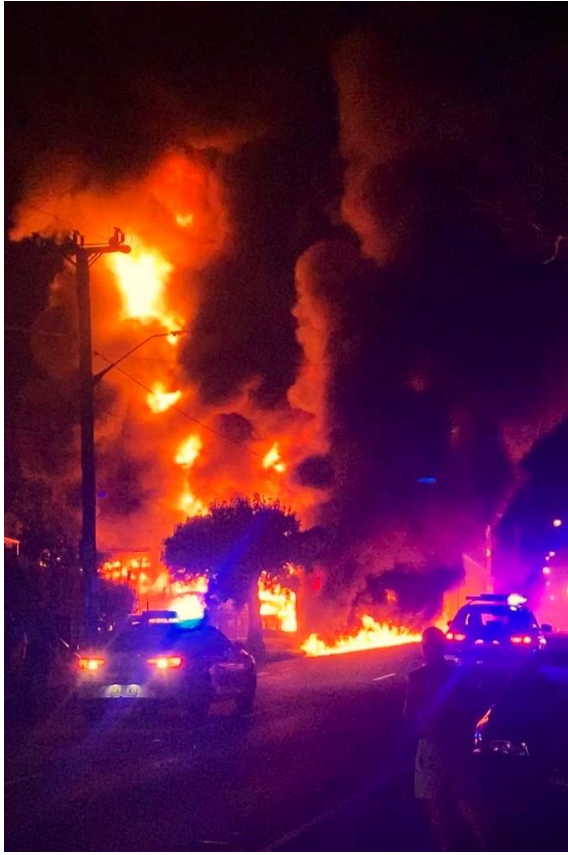
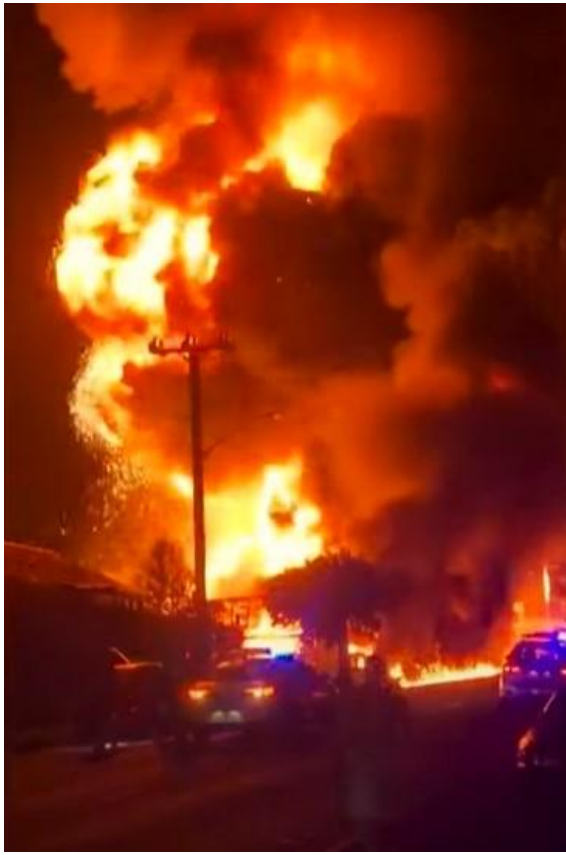
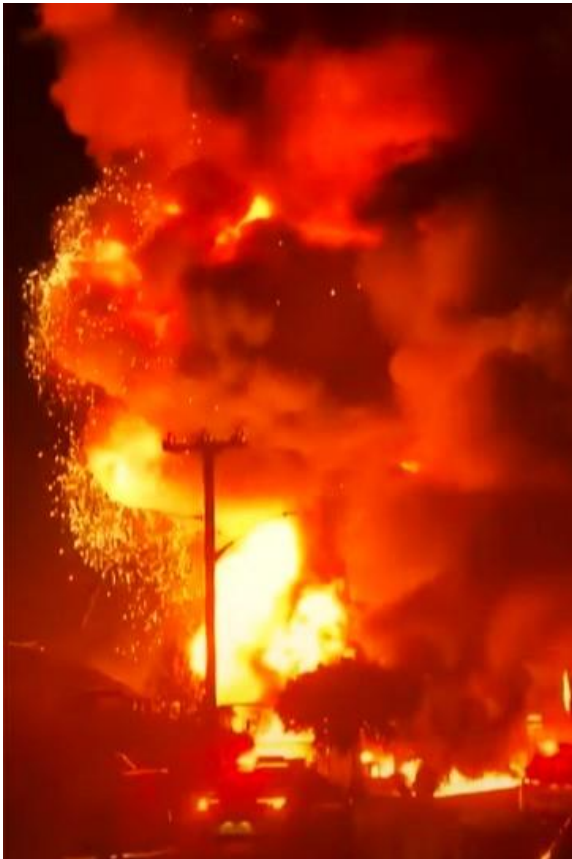
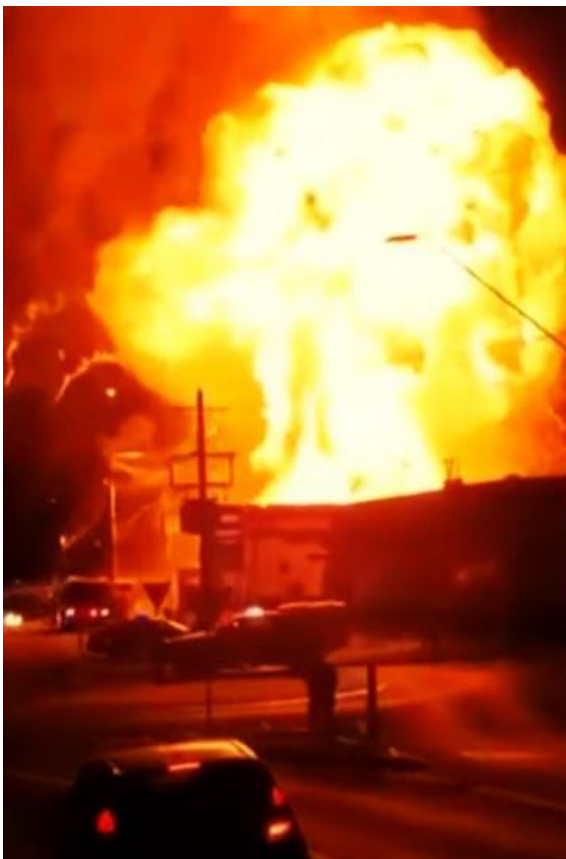
Fierce flames light up the night sky as fire and a heavy smoke column erupts from the burning tanker. The results of a 210 kg LPG BLEVE at bottom left Pictures supplied by a member of the public.

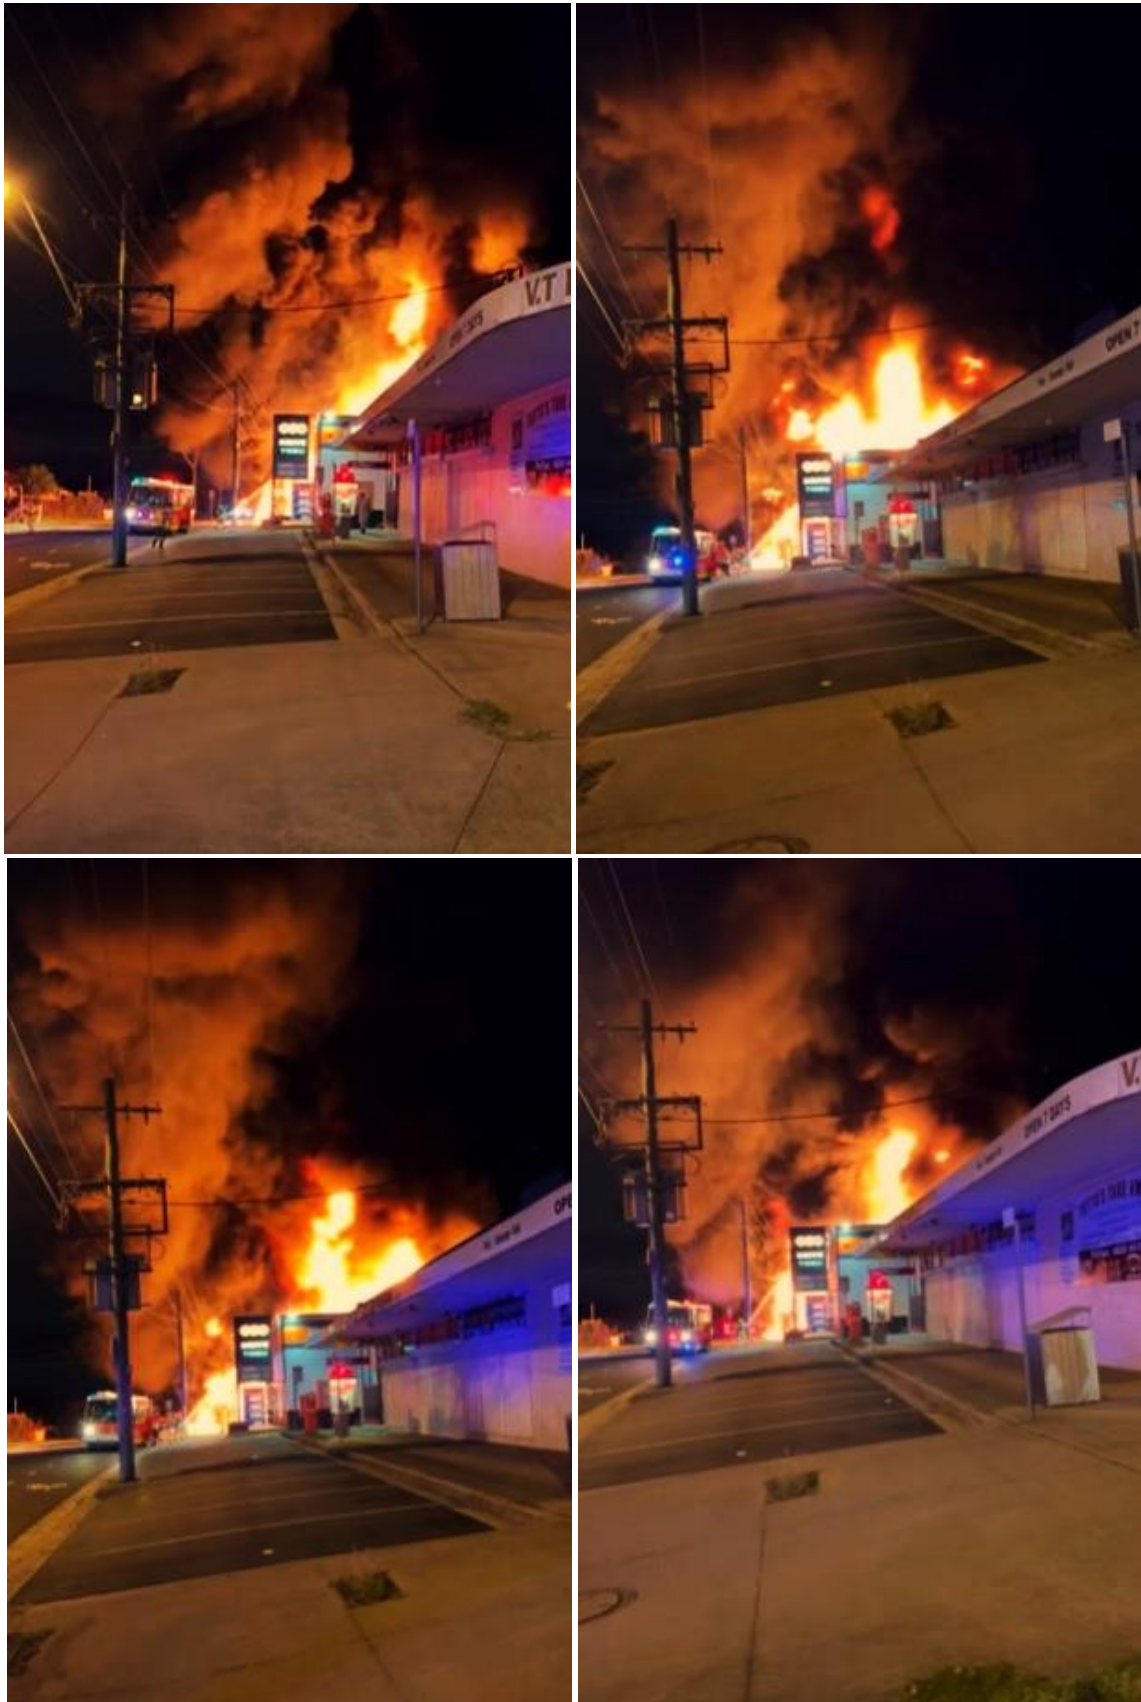
The first water goes onto the fire. These photographs taken by members of the public show the initial 70 mm line being placed in operation by the crew of CAFS Pumper 88. Fire conditions are ferocious and Exposure Delta is being heavily impacted by intense radiant heat. The initial operations by CAFS Pumper 88 placed a cooling stream onto wall of Exposure Delta, protecting the first shop in a row of shops from becoming involved in fire.

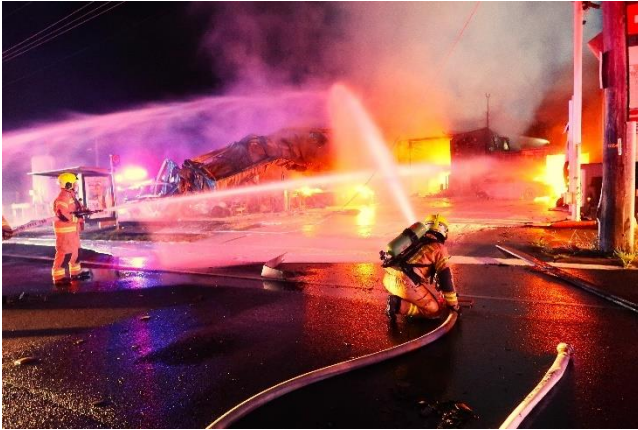
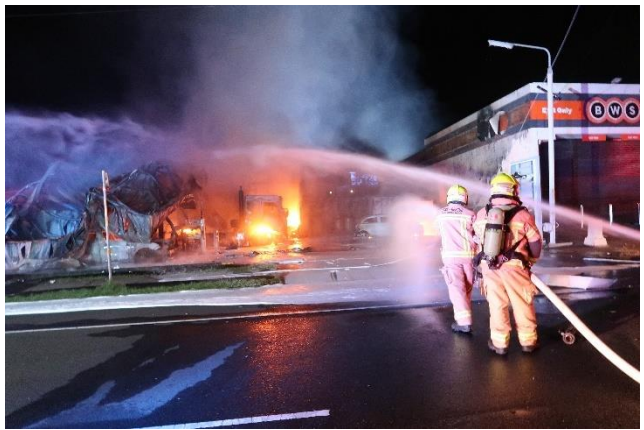
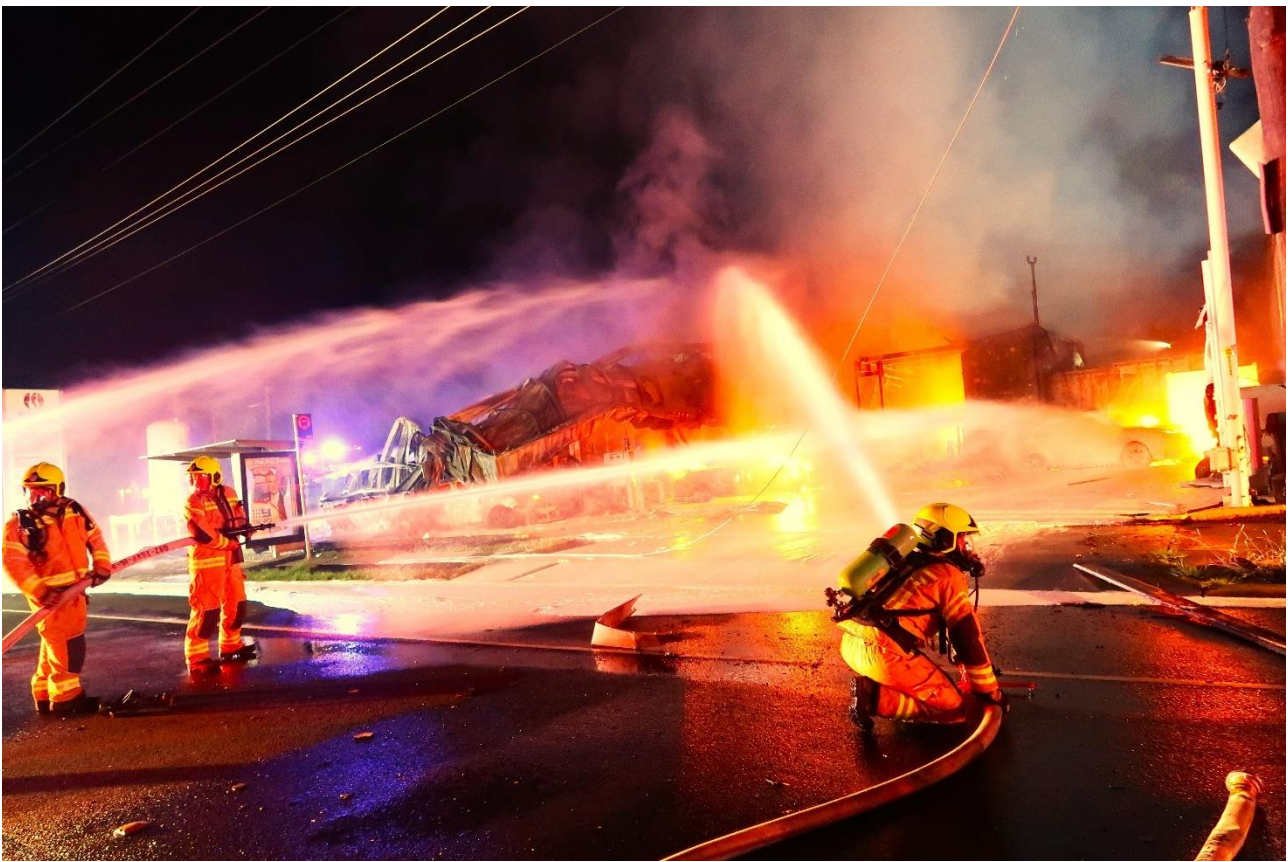
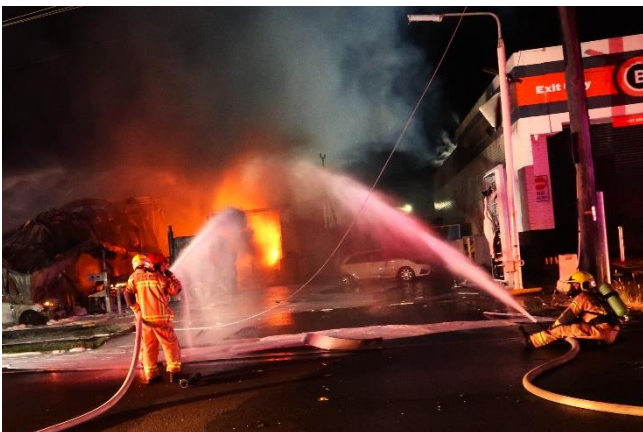
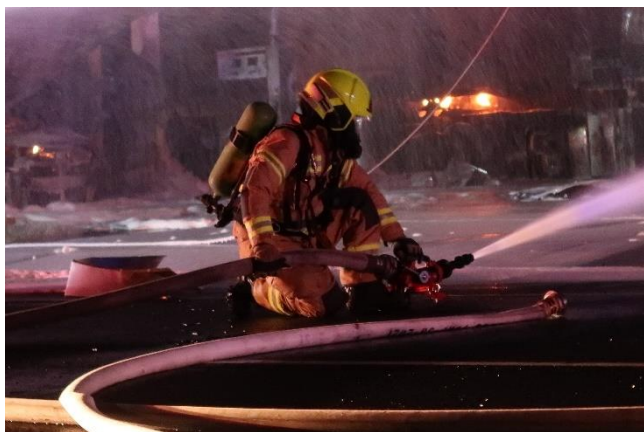
Initial lines were placed in operation in Alpha Sector to protect heavily threatened Exposure Delta 1, cutting the fire off and stopping the fire's progression along Lindesay Street to the south. Firefighters displayed strong determination to contain the southern flank of the fire. "As goes the first line, so goes the fire."

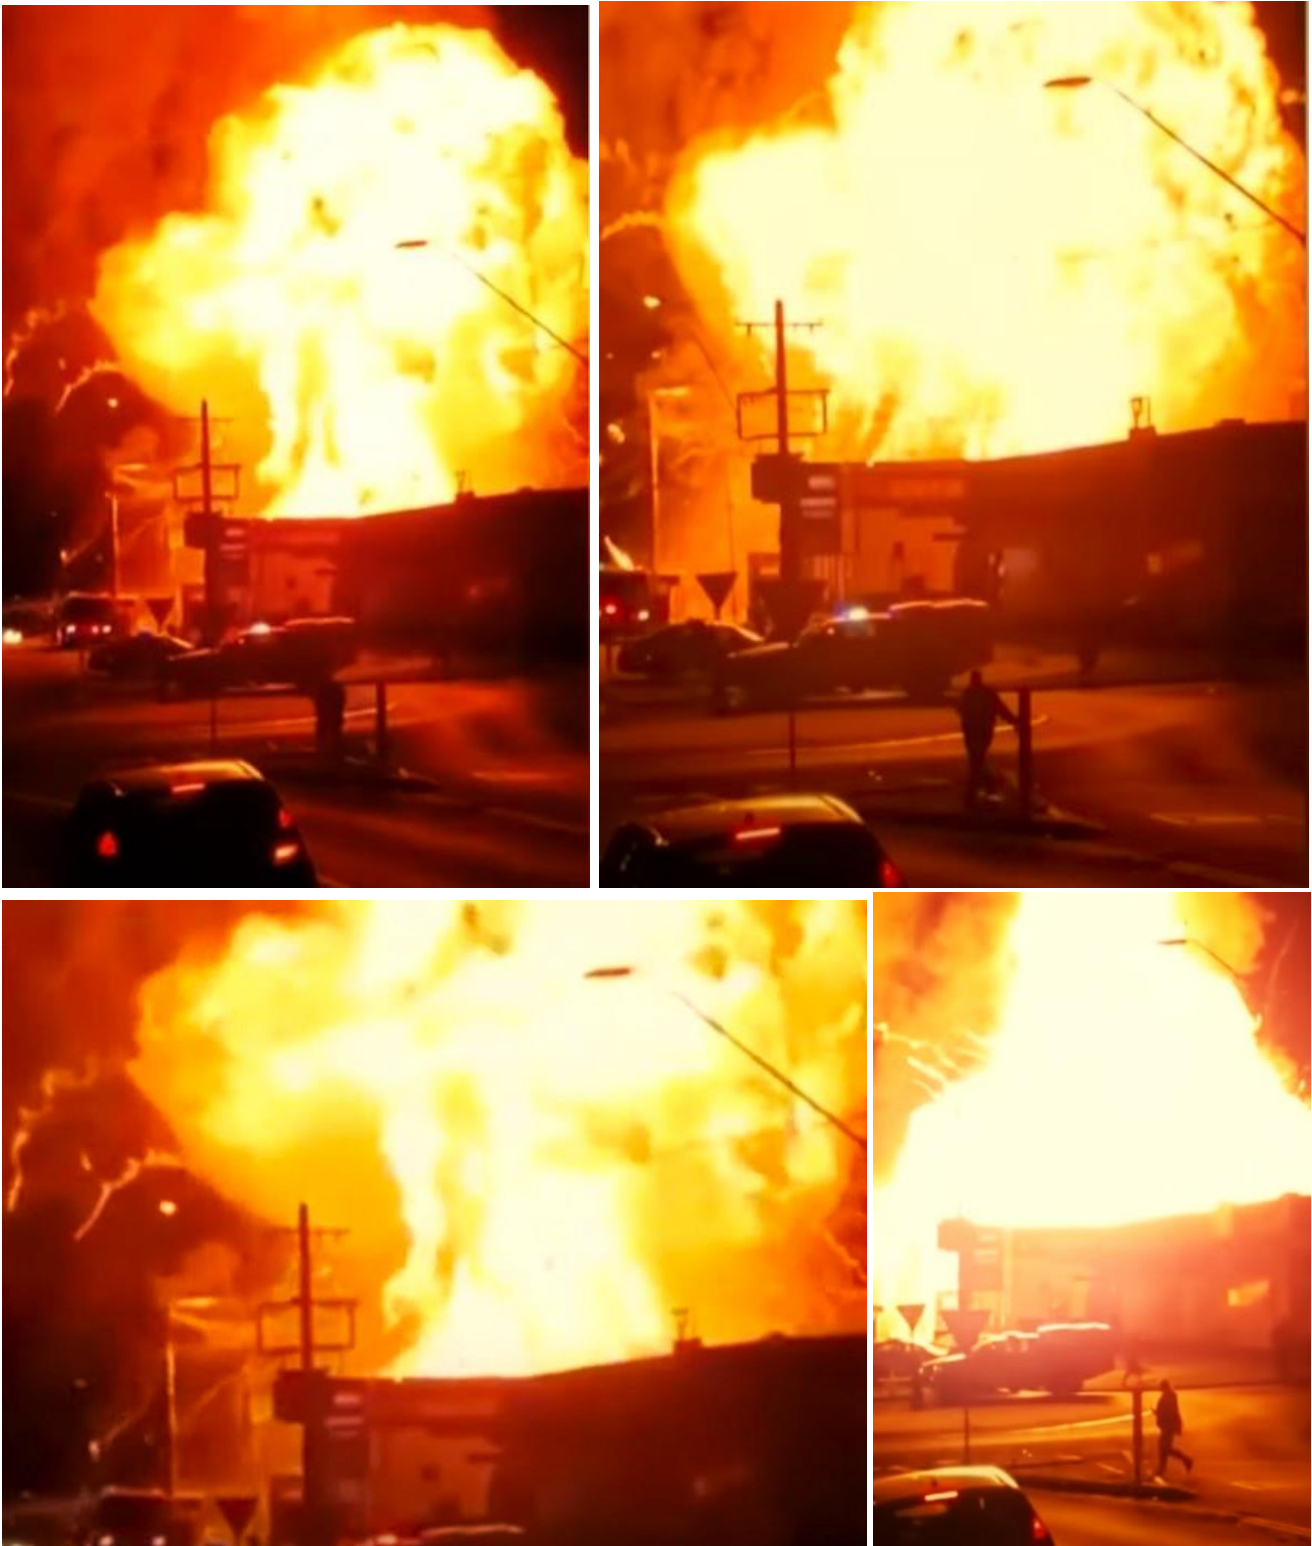
Taken by members of the public these photographs show boiling liquid expanding vapour explosions (BLEVEs) occurring involving 210 kg LPG cylinders. These photographs were taken from a distance of approximately 250 metres from the service station and are indicative of the size and intensity of the explosions.

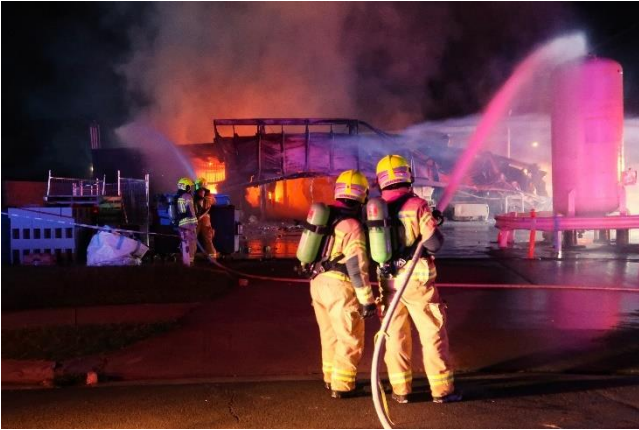
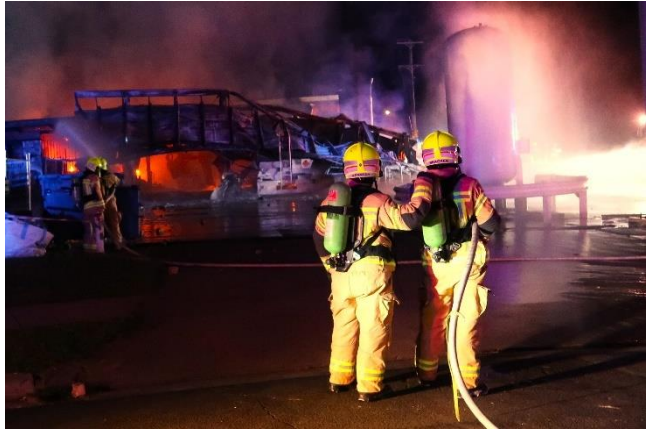
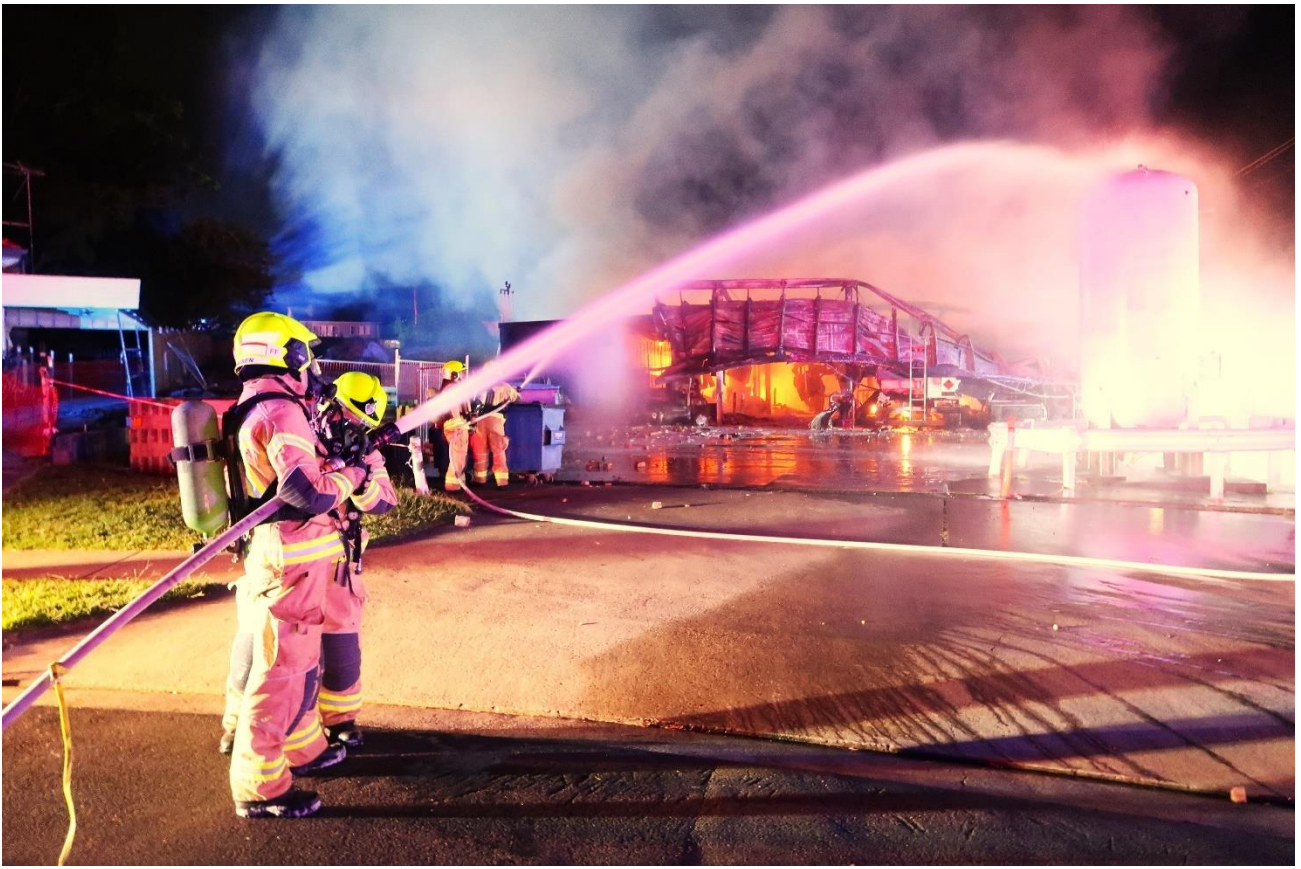
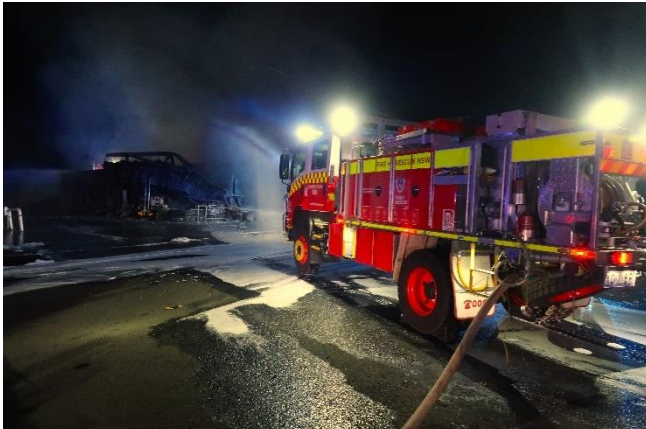
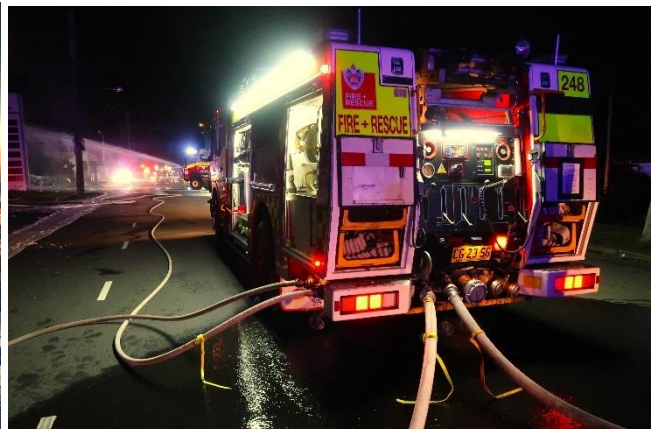
Operations on the Bravo side of the fireground. Firefighters cool the 8,000 litre bulk LPG storage tank that was being impacted by intense radiant heat from the burning tanker fire. Crews also begin to attack the service station fire. The front monitor of CAFS Taner 88 directs a Class A foam stream onto the burning service station. Pumper 248 supplies 38 mm attack lines to crews working in Bravo Sector.

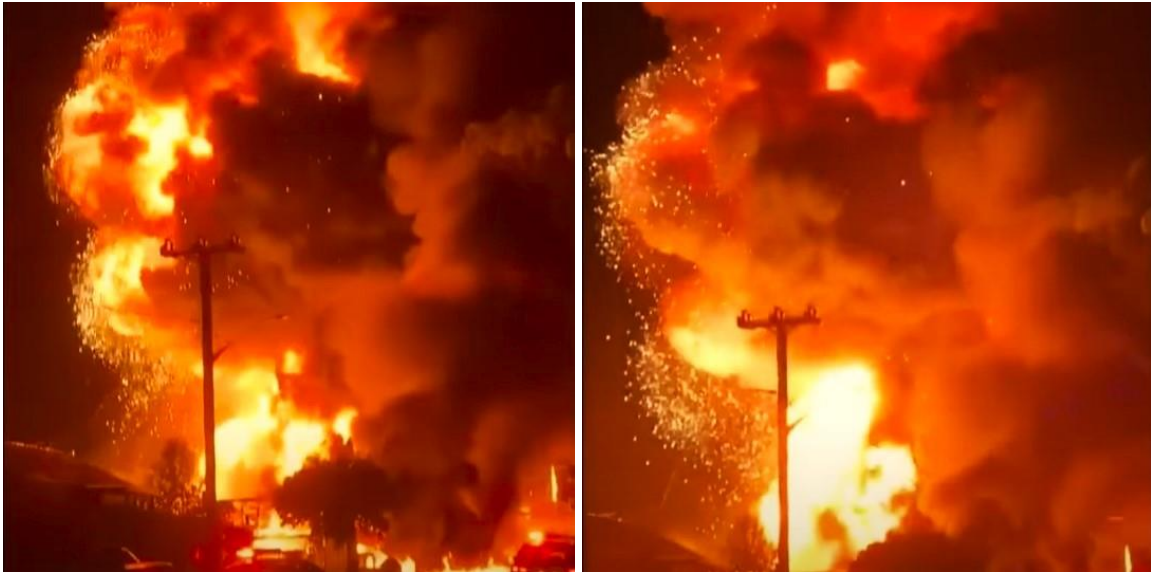
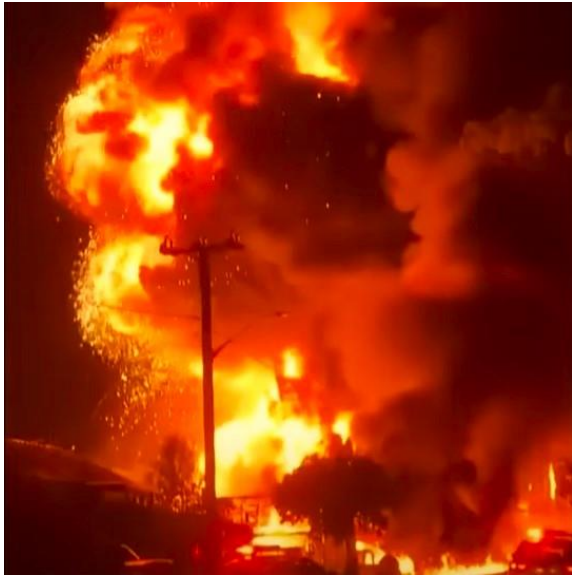
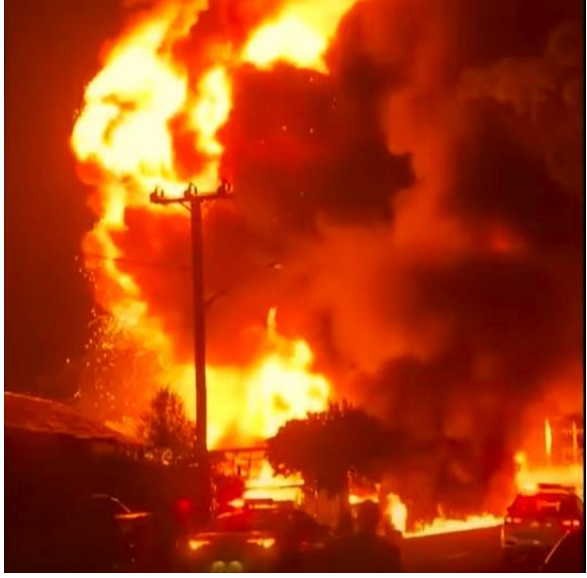
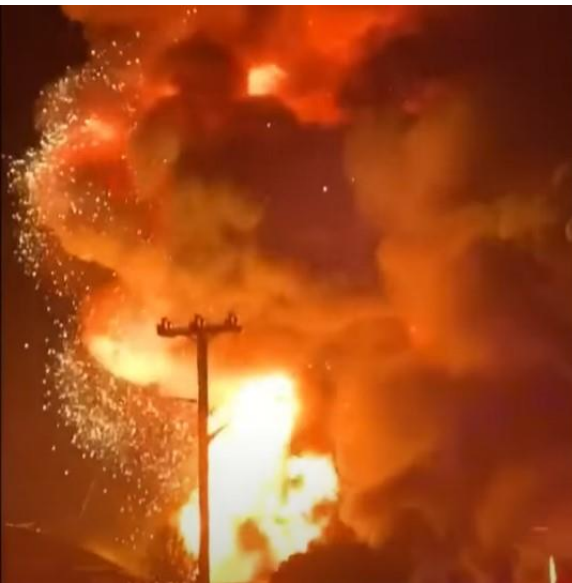
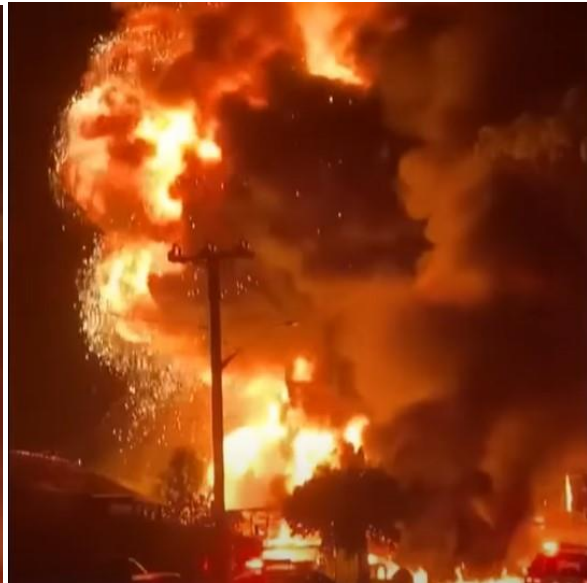
Incredible photographs taken by members of the public approximately 250 metres to the north of the service station capture a boiling liquid expanding vapour explosion of a 210 kg LPG cylinder located at the front of the service station. Firefighters battled this enormously ferocious fire, establishing containment on all sides. Radiant heat presented a significant threat of fire spread.

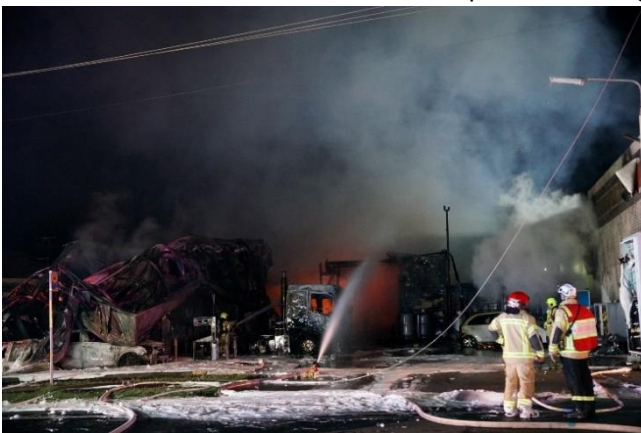
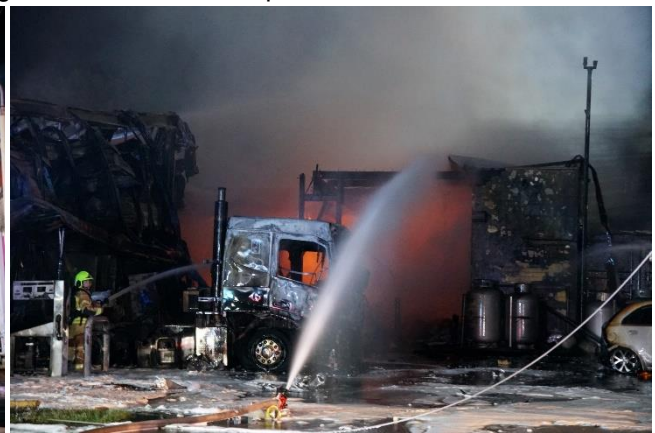
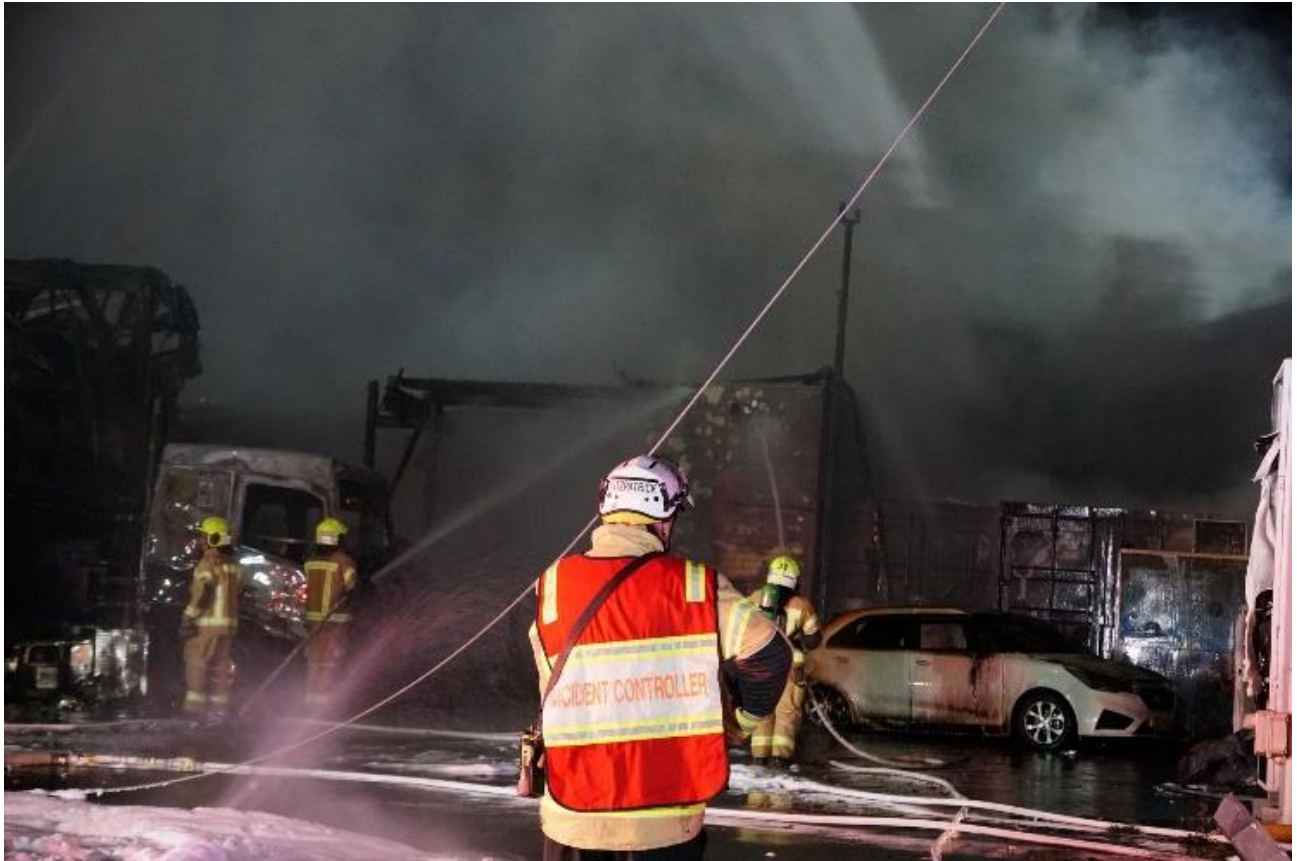
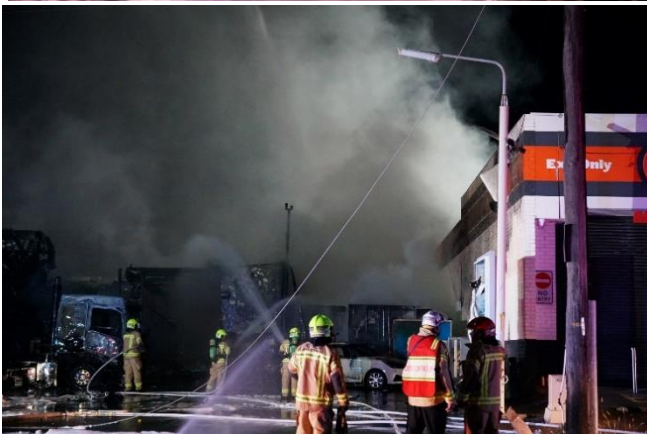
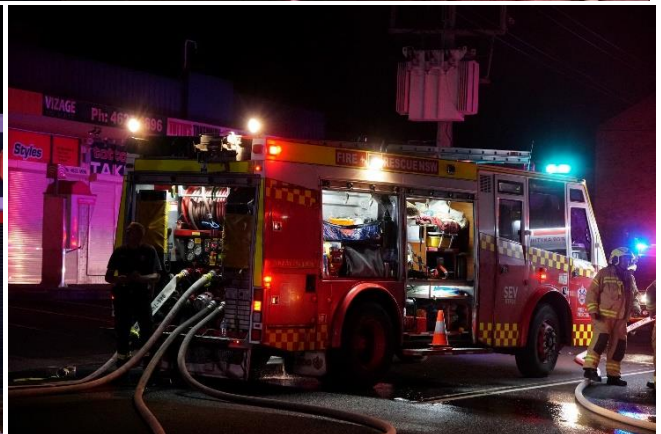
Command was transferred to Duty Commander MS3 Inspector Bruce Fitzpatrick. During the period Inspector Fitzpatrick commanded operations, containment and control of the fire were established. CAFS Pumper 88 (lower right) placed the first lines in operation, stopping the fire from spreading to heavily threatened exposures on the Delta side of the fire. A short time later crews were also working on the Bravo side of the fire.

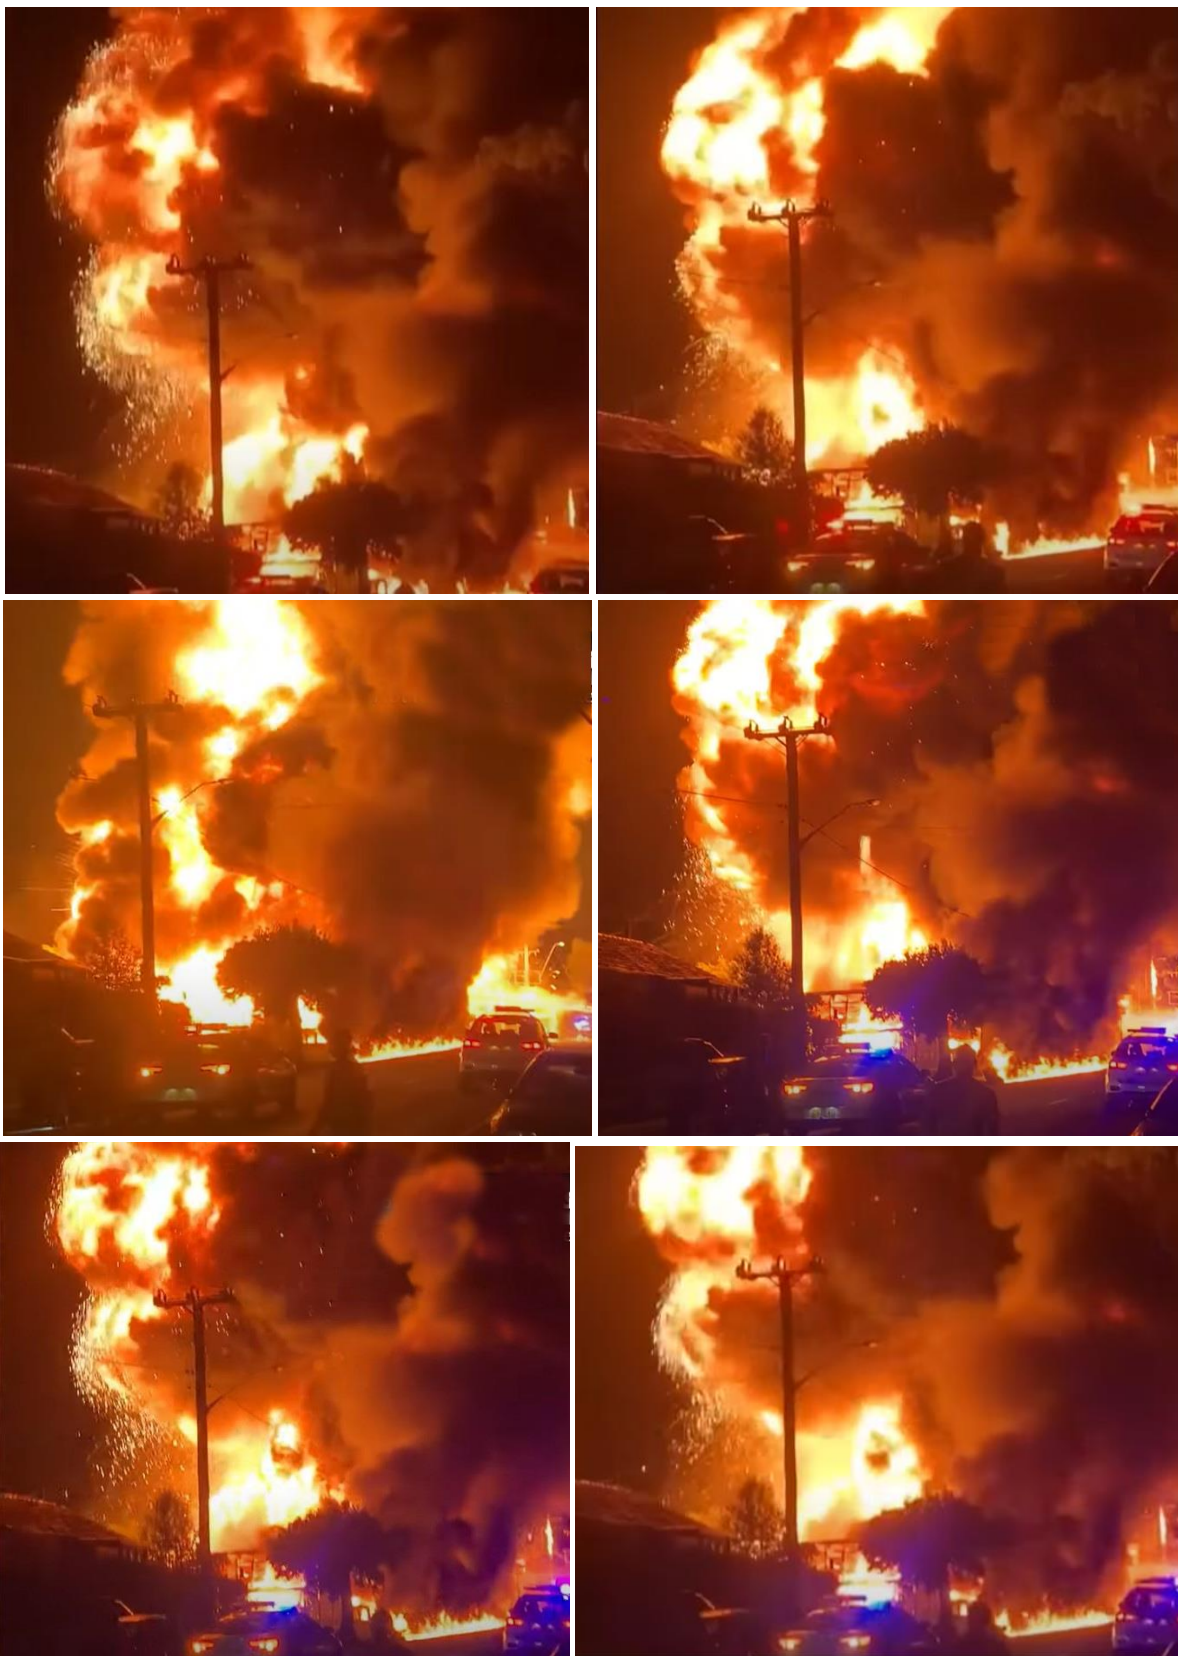
Photographs taken by members of the public approximately 250 metres to the north of the service station as fierce flames erupt from the fully involved petrol tanker. A running fuel fire can be seen in the gutter. Despite the extreme ferocity of fire conditions encountered, firefighters established a systematic firefighting plan enabling the fire to be contained, controlled and extinguished. The incredible efforts of responding firefighters enabled all exposures to be protected and saved.

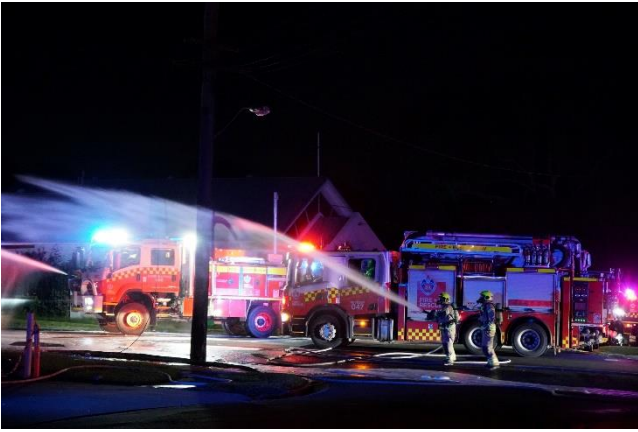
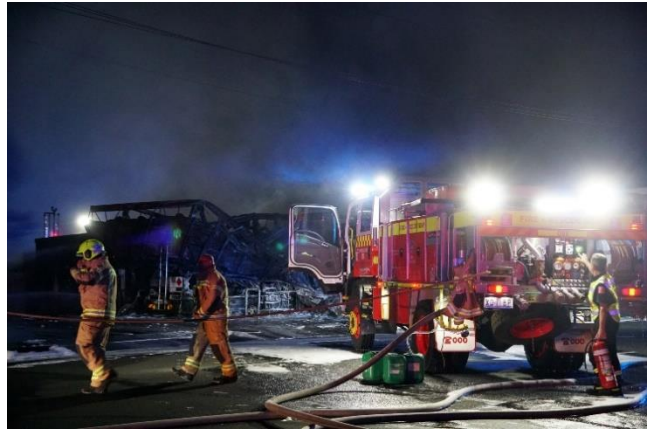
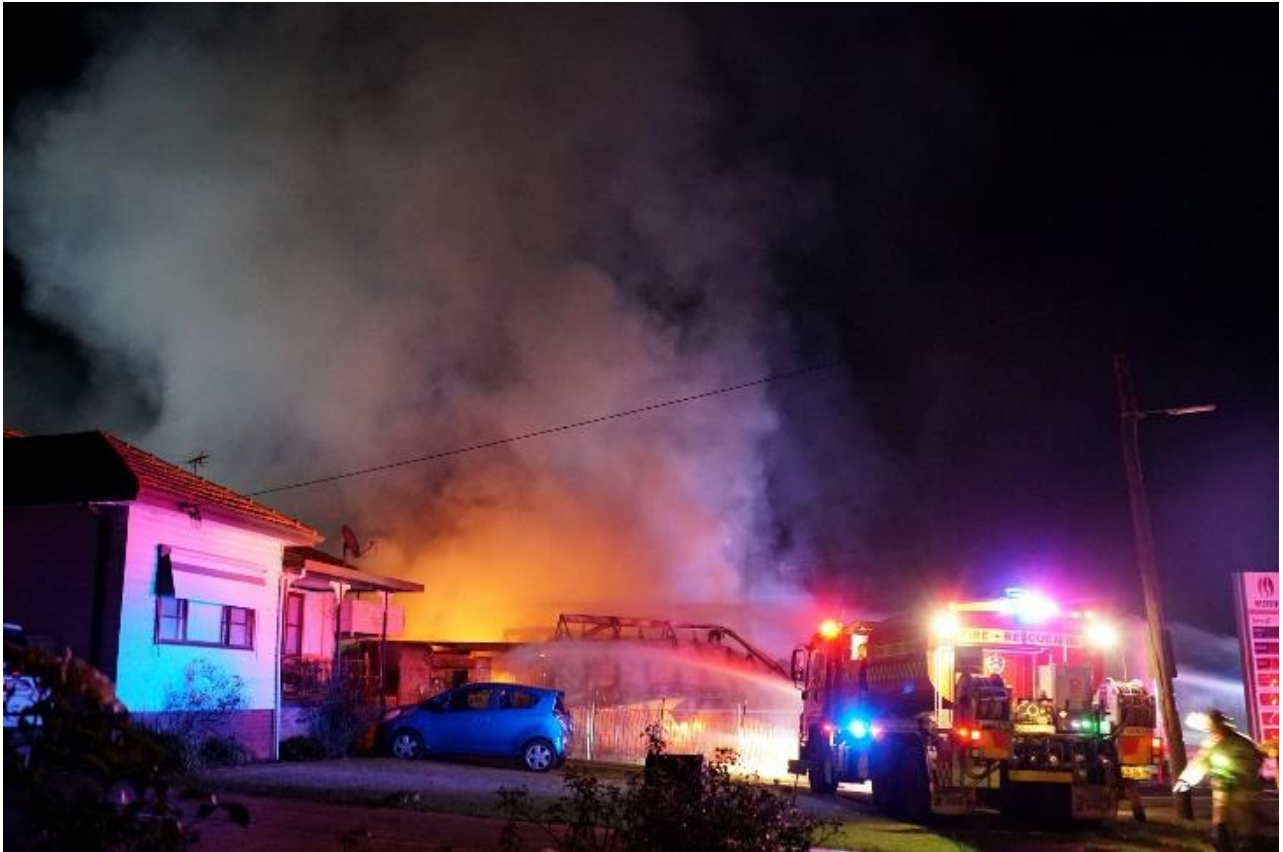
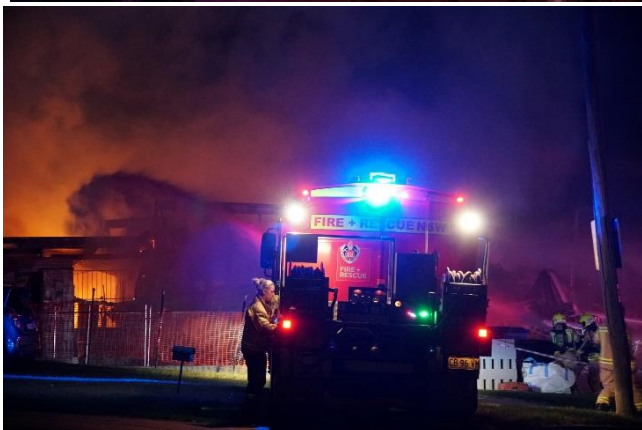
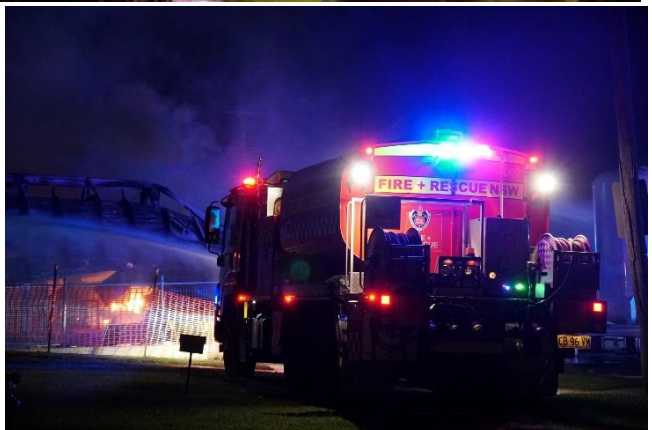
Firefighters were deployed to the Bravo side of the service station where several exposures were under threat from the extreme levels of radiant heat being produced by the fire. A residential house was under severe threat and beginning to ignite when firefighters directed cooling streams onto the walls of the structure, saving the house.
