NSWFB RETIREES FIRE NEWS INCIDENT REPORTS

4th ALARM CAMPBELLTOWN SERVICE STATION FIRE

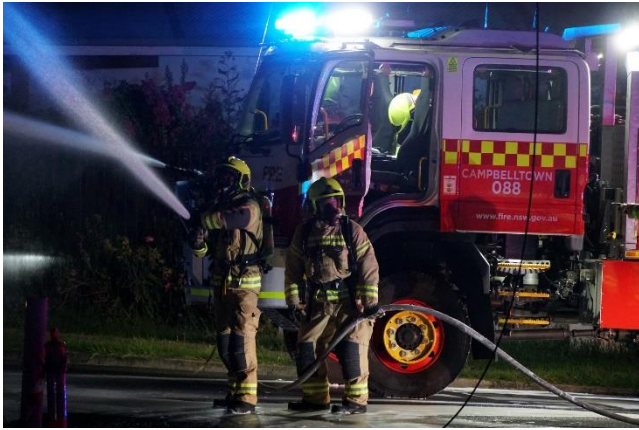
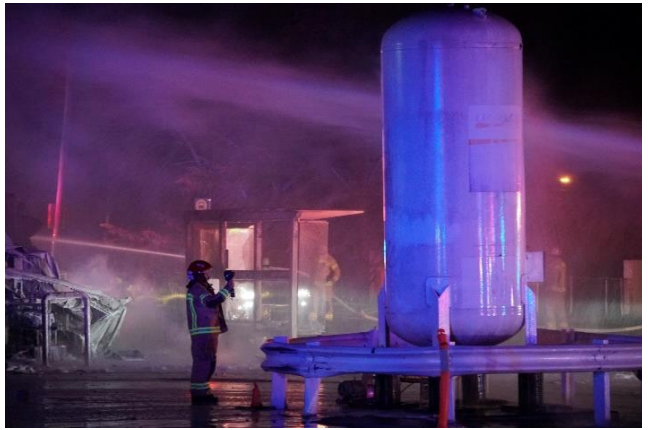
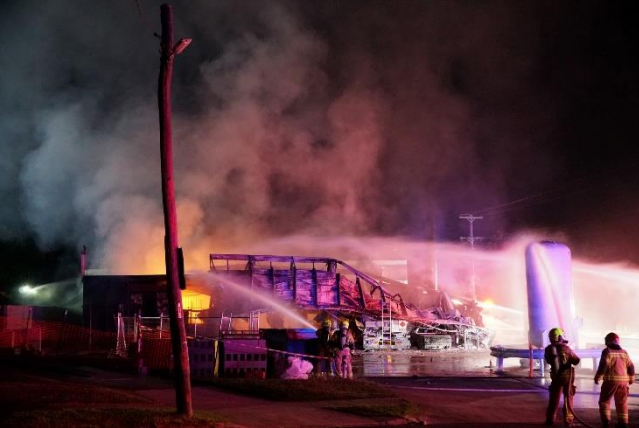
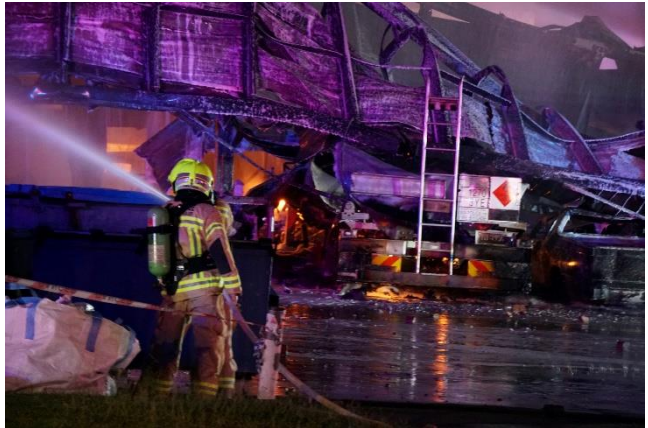
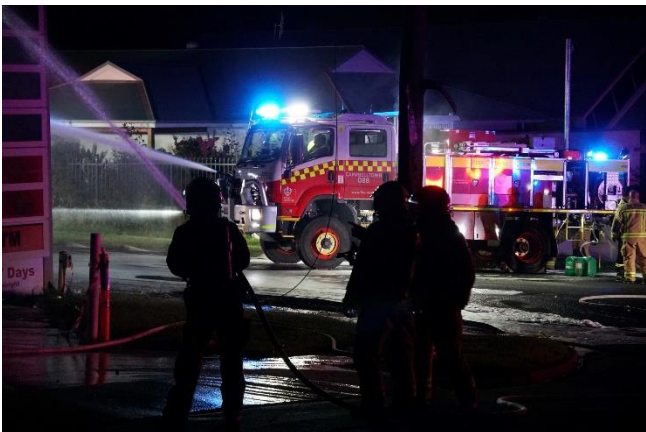
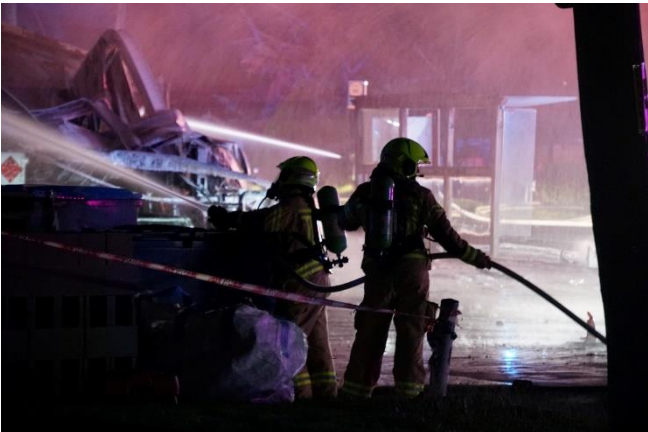
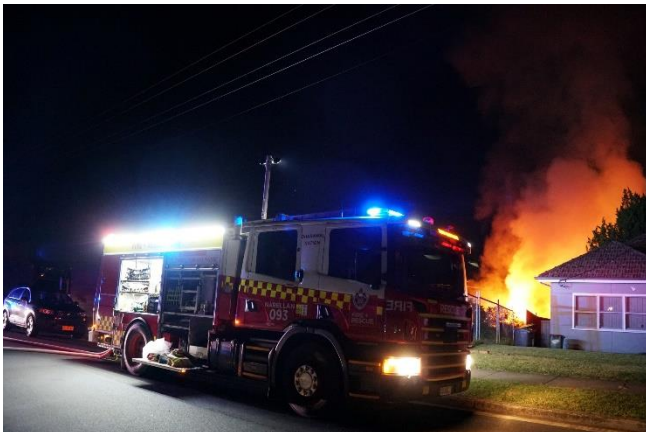
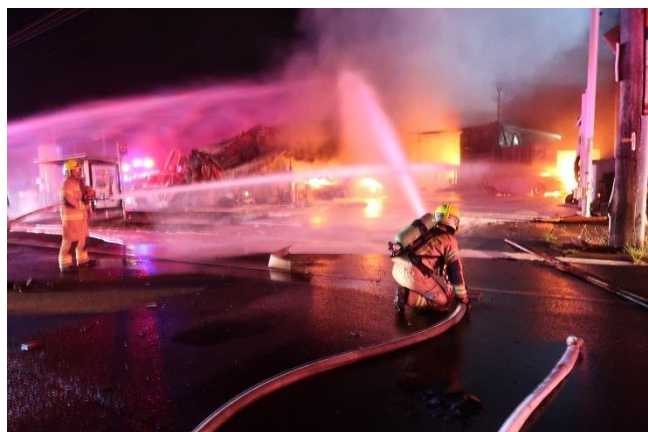
Firefighters protect exposures on the Bravo side of the service station and begin to direct attack lines onto the service station building. Lower left – Rescue Pumper operates on the Charlie side of the fireground. Lower right – Firefighters coll the walls of exposure Delta 1 and direct a cooling steam onto the 210 kg LPG cylinder bank.

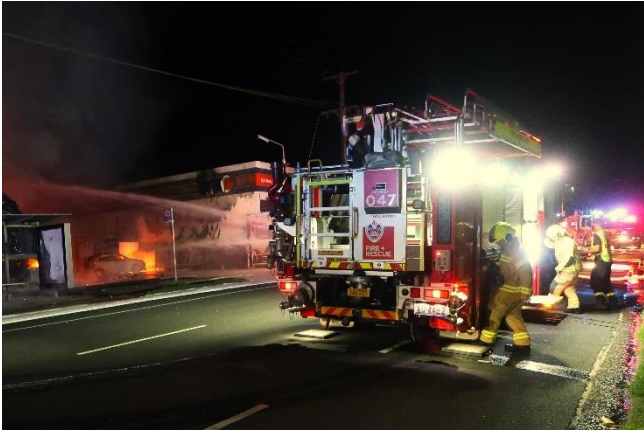
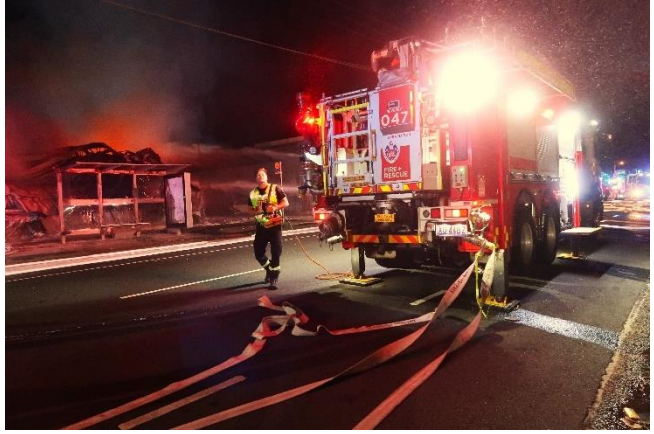
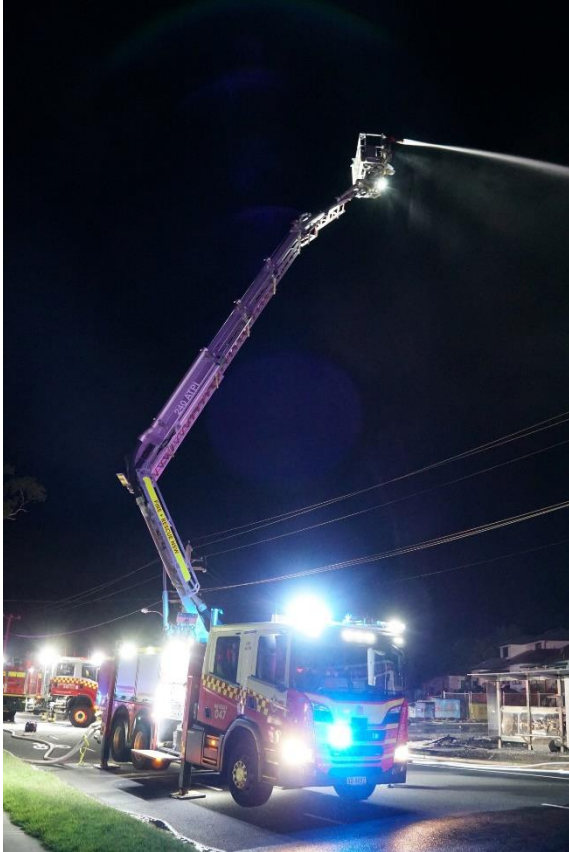
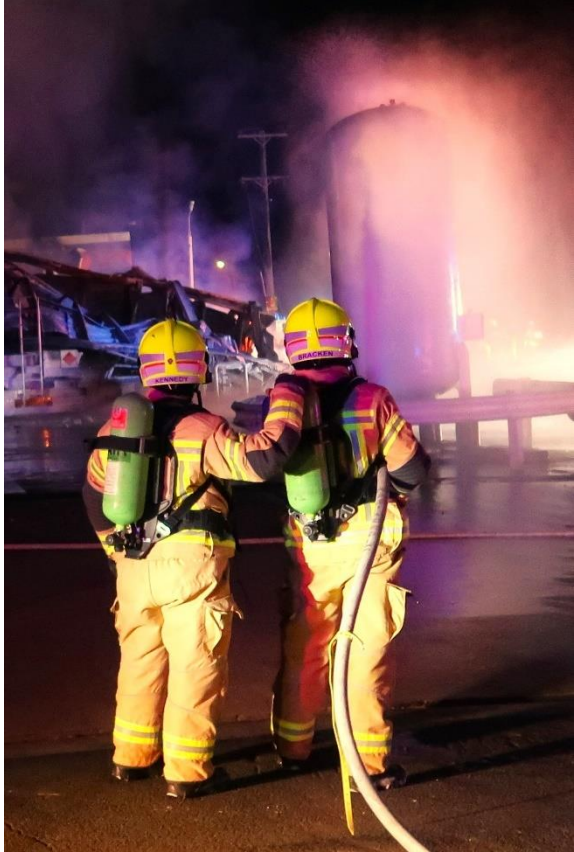
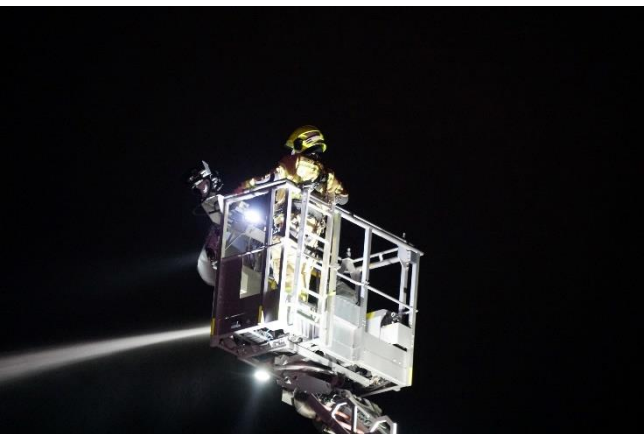
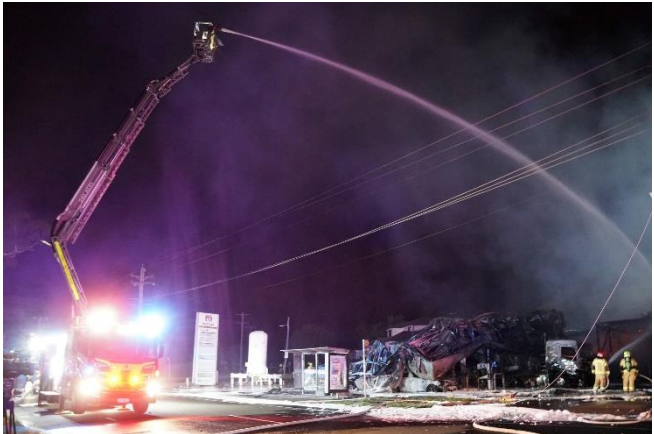
Firefighters place CAFS Aerial Pumper 47 in operation as a water tower. The presence of high-voltage overhead powerlines and initial water supply shortages restricted aerial appliance operations. Middle left – Firefighters cool the 8,000 litre LPG bulk storage tank.

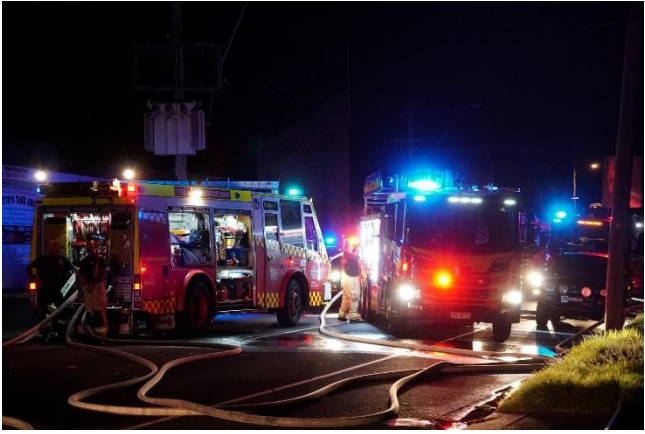
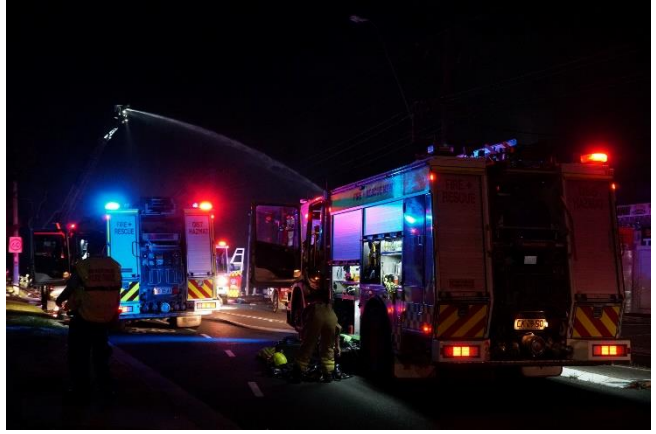
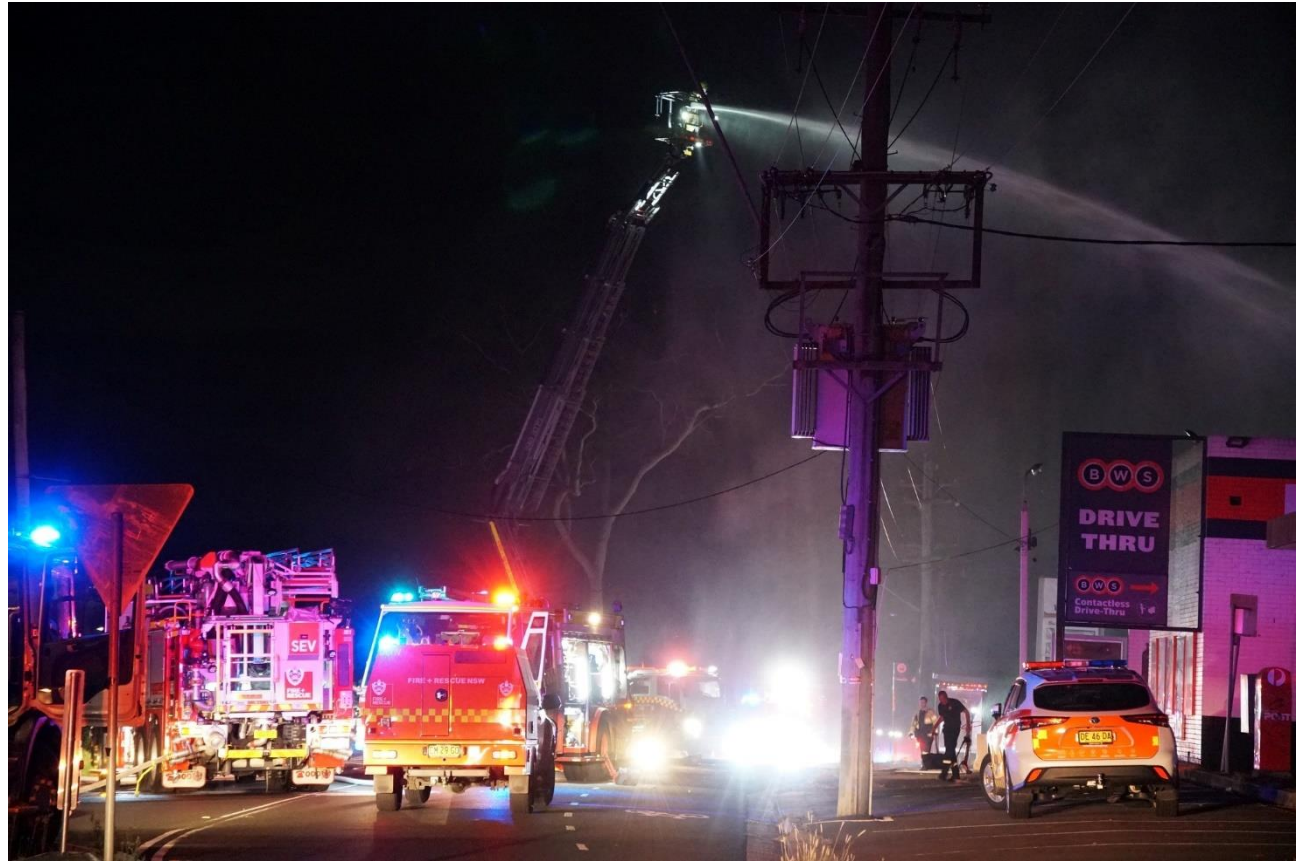
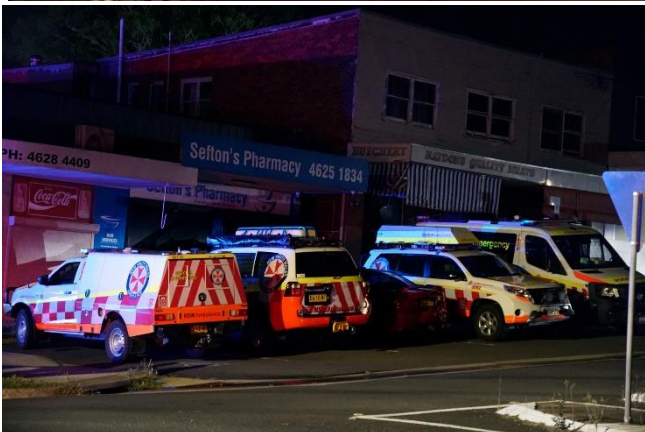
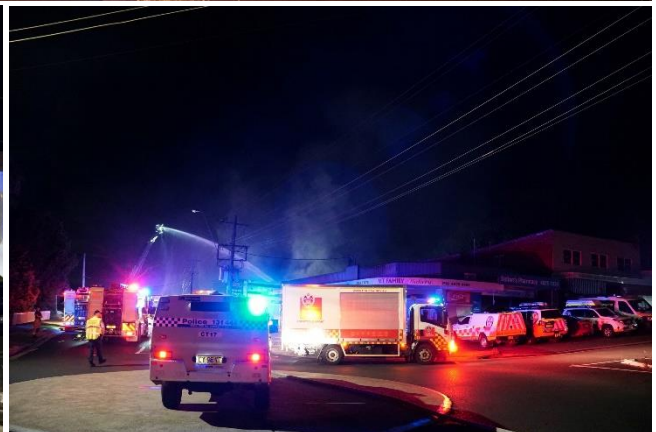
Top – CAFS Pumper 88 conducted initial fire attack. Middle – As water supplies improved, CAFS Aerial Pumper 47 was placed in operation, directing an aerial deluge onto the fire scene. Lower – FRNSW operations were supported with a strong response from Police and Ambulance.

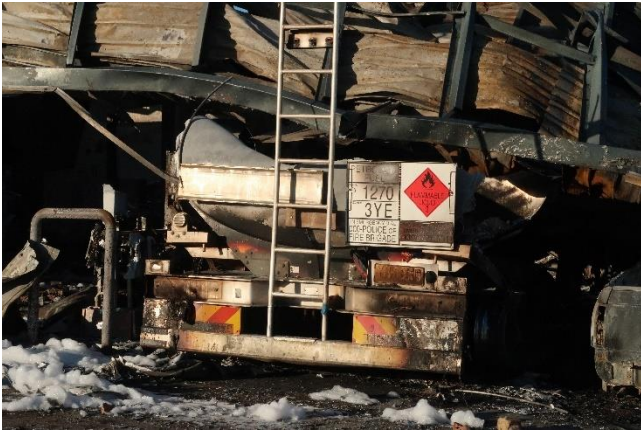
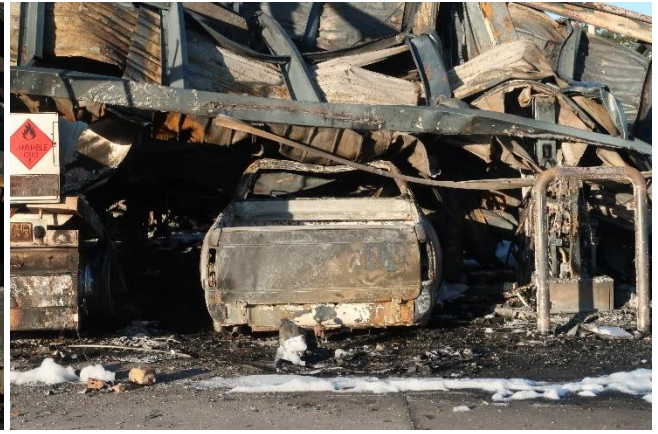
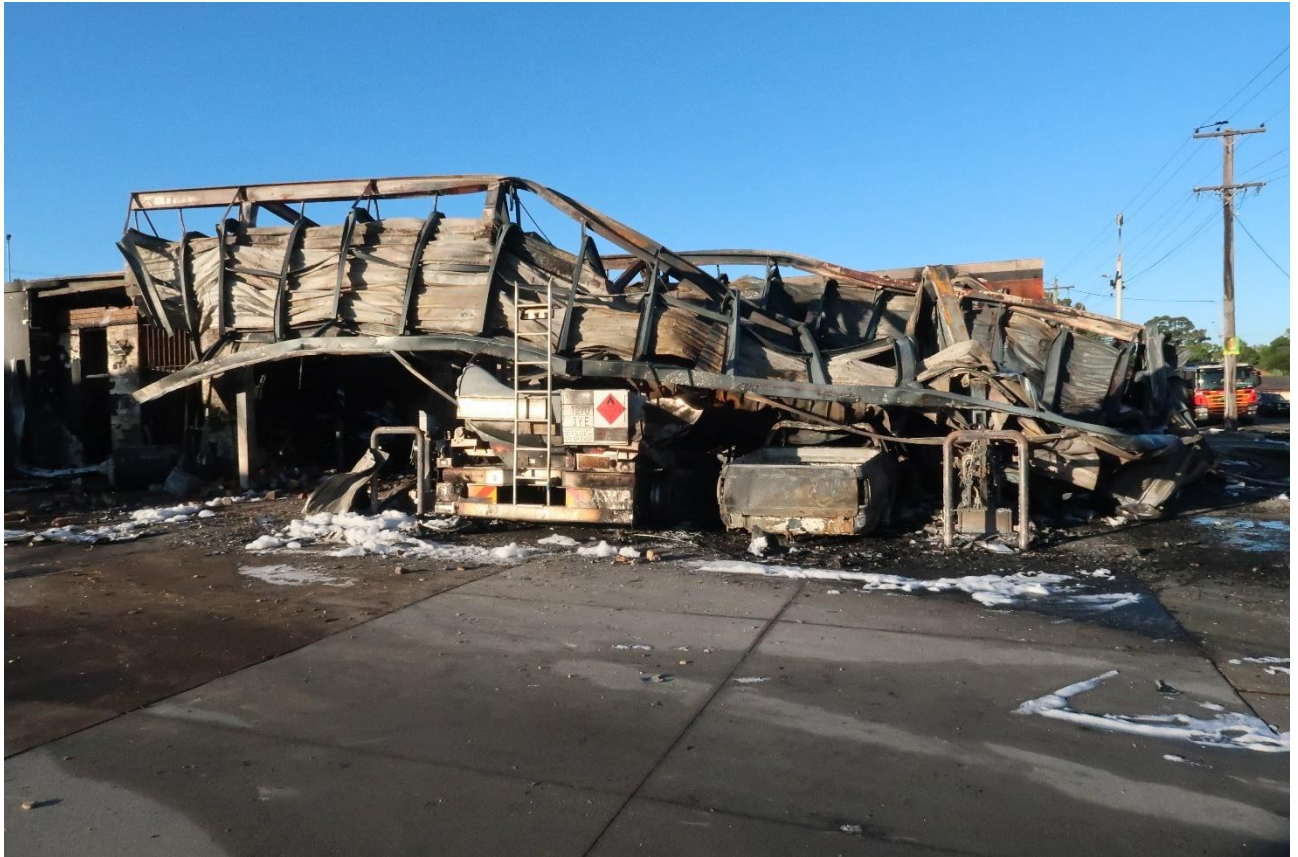
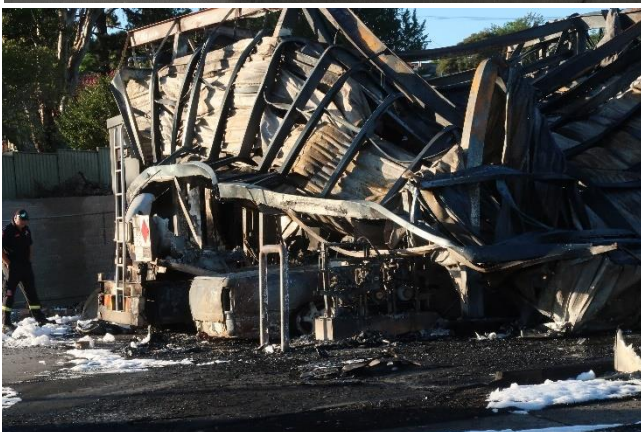
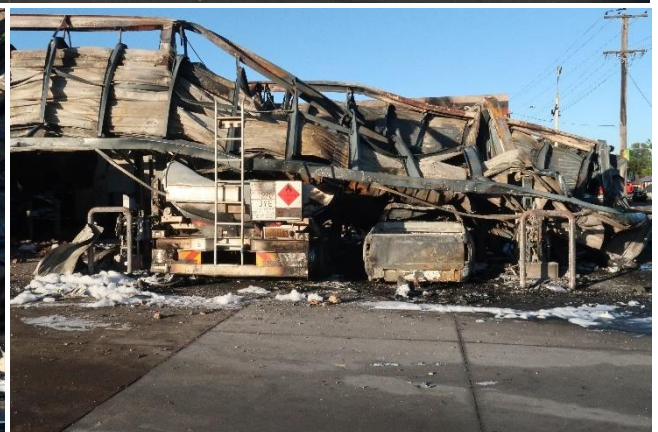
9. The structure supporting the awning forecourt was formed from unprotected steel and rapidly began to fail, resulting in a slow progressive collapse of the iron sheet awning onto the tanker. Structural steel begins to lose tensile strength at around 300°C. At this temperature, the steel will begin to soften. Significant loss of strength rapidly occurs after 400°C. At about 550°C, steel will lose half its load bearing capacity. At about 1,000°C, steel will only have about 10% or less of its load bearing capacity. The flame temperature for the burning petroleum was in excess of 1,000°C, resulting in significant failure of the unprotected structural steel and subsequent collapse.

The tanker was parked beneath the service station awning when the fire broke out. Intense heat from the burning petroleum caused the structural steel supporting the awning to collapse. Steel roof sheets collapsed onto the tanker, acting as a barrier restricting firefighting streams from reaching the fire.

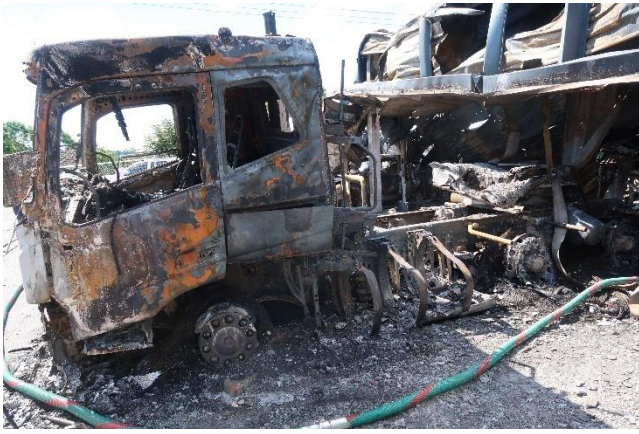
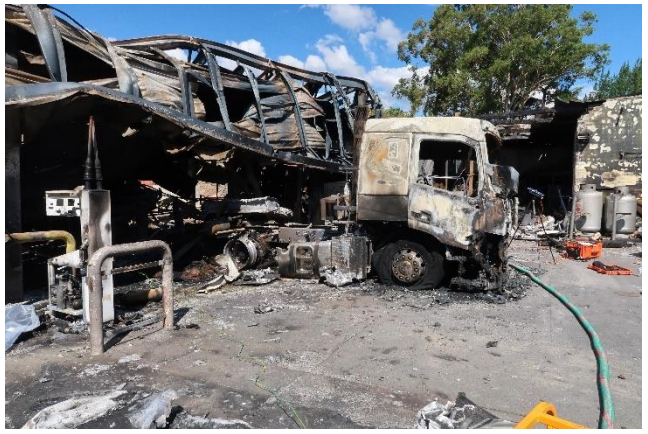
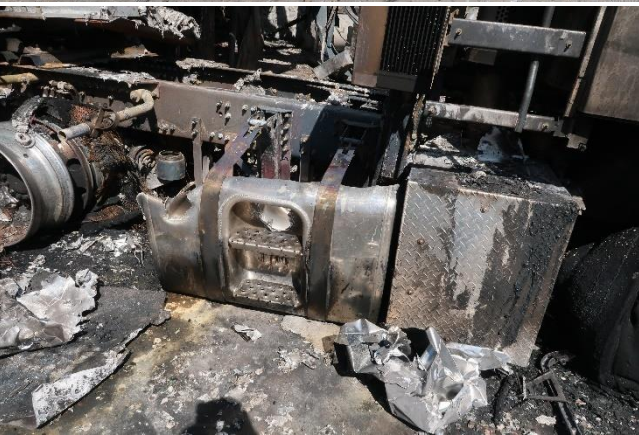
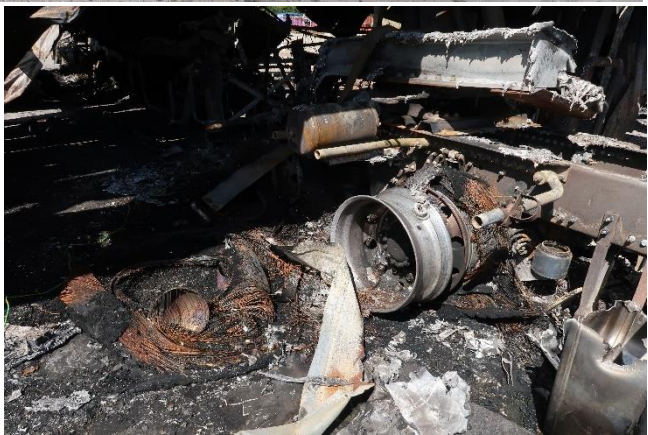
Most of the aluminium components melted. Steel rims are visible and only the steel belts of the tyres remain on most of the wheels of the prime mover.
