NSWFB RETIREES FIRE NEWS
INCIDENT REPORTS

**2ND ALARM ST MARYS GARAGE COMPLEX
FIRE**

Incident Summary:

Incident Type: Garage Complex Fire.

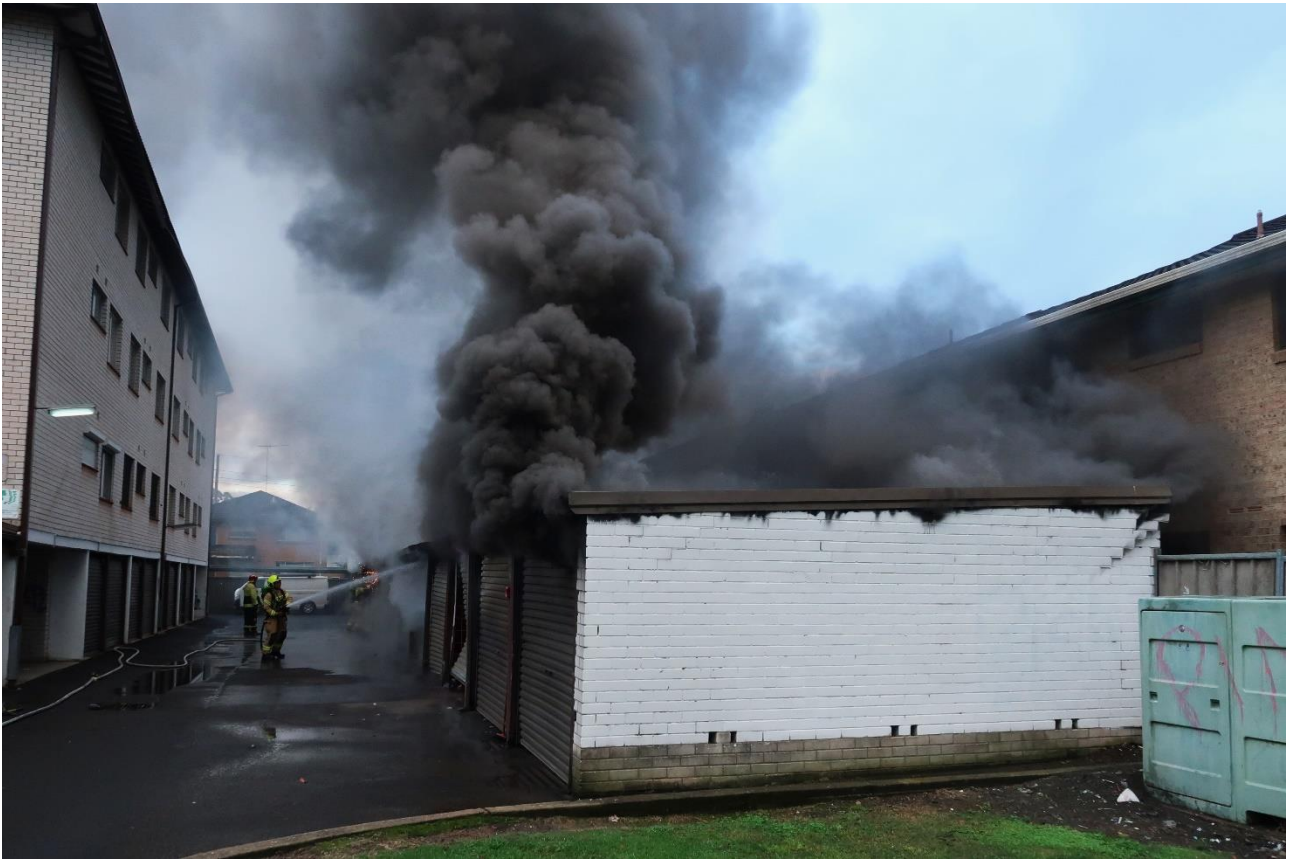
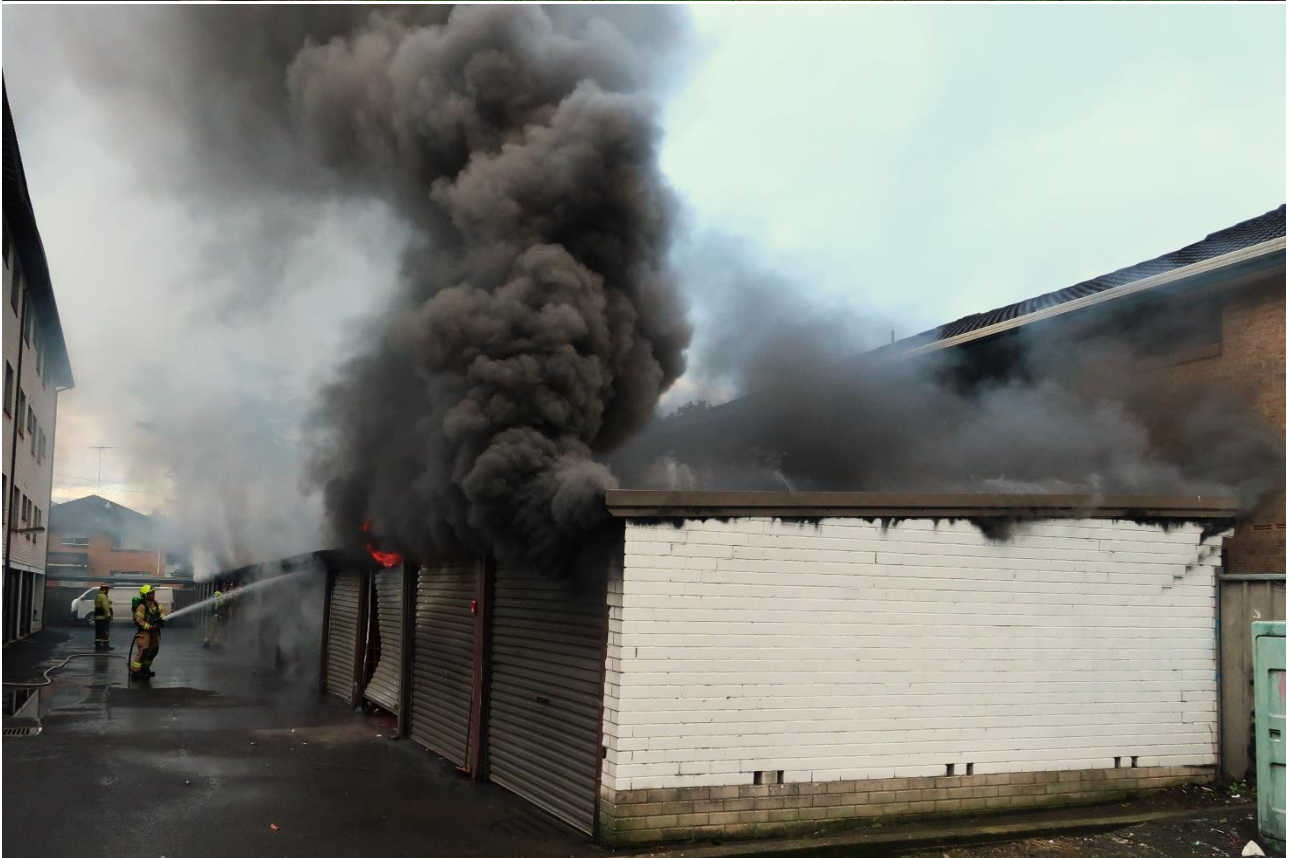
First arriving Hazmat Pumper 77 firefighters place the first attack line in operation. Heavy black smoke vent from the complex. Flame is visible venting from garage number three. Note on the right side of the photograph heavy smoke is beginning to vent towards Exposure Charlie, a residential unit block. As additional crews arrived on scene, firefighters established protection of Exposure Charlie.

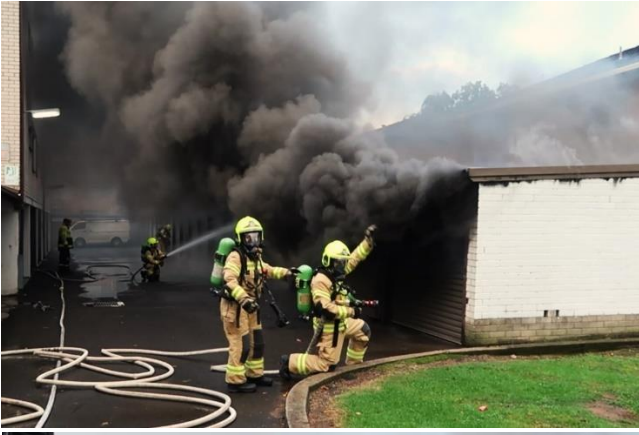
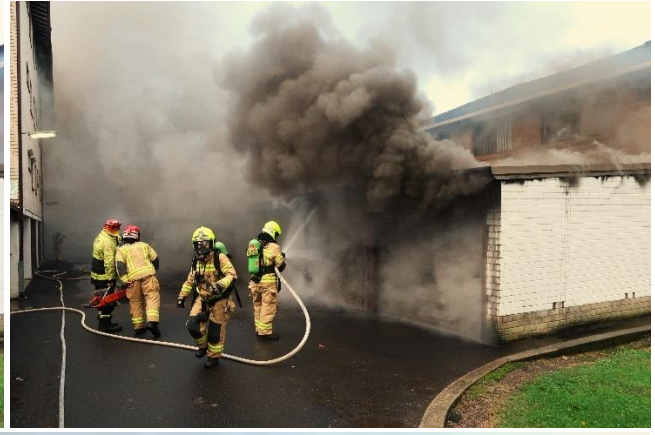
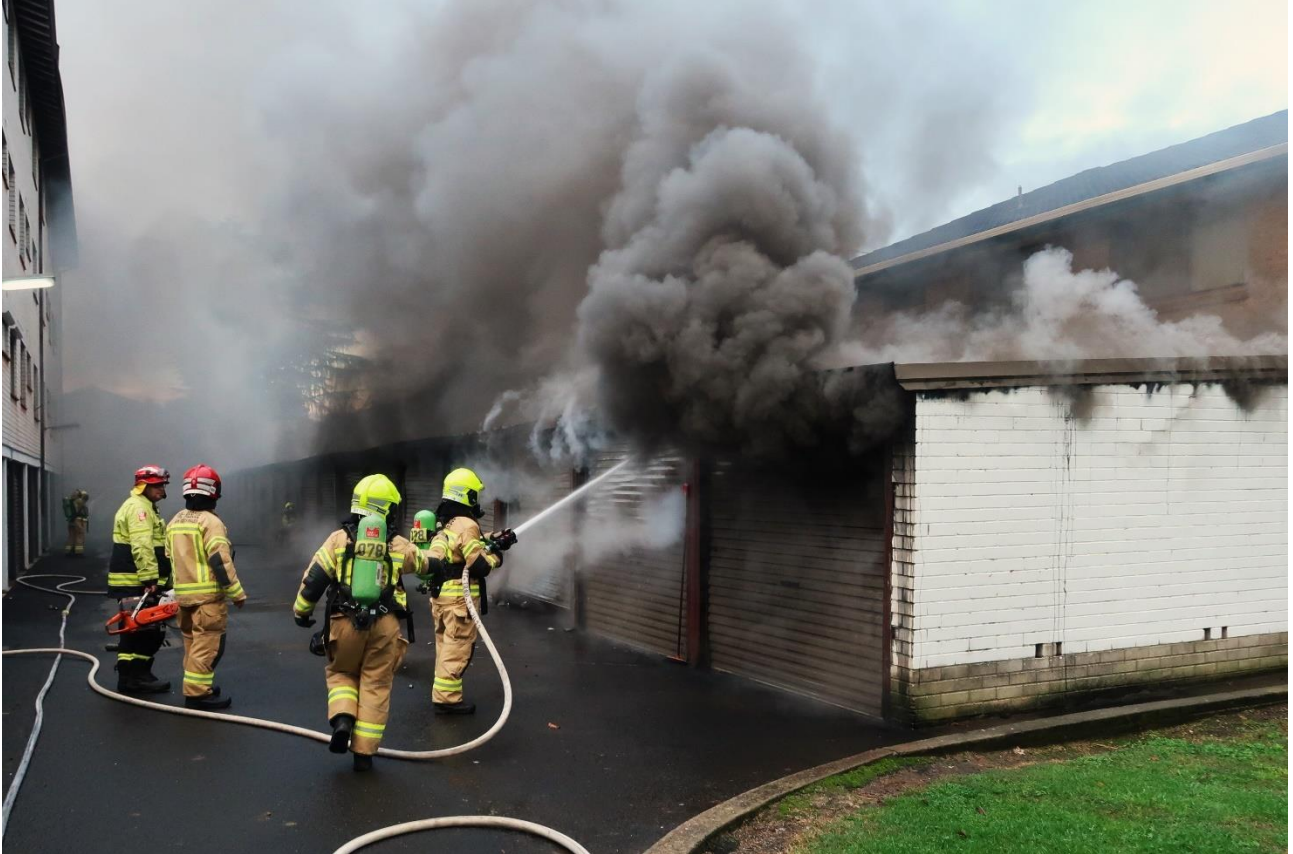
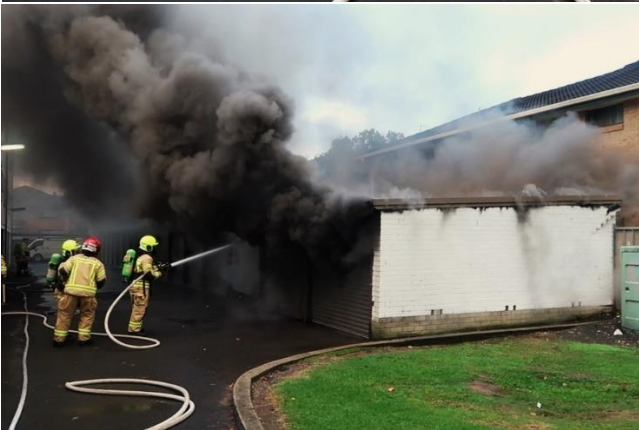
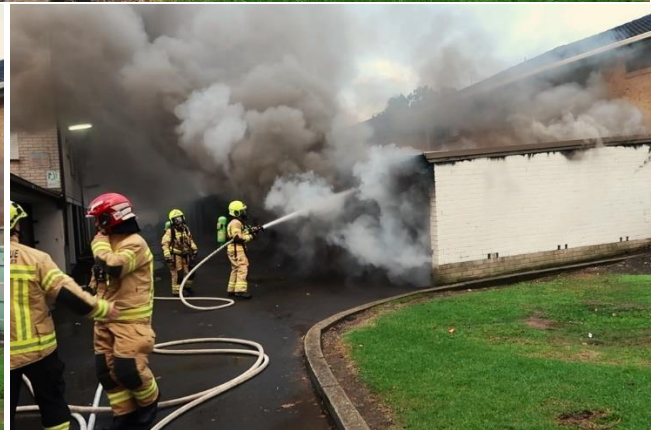
The second attack line is placed in operation by Rescue Pumper 78 Firefighters Joshua Codrington and Sue Bayliss. Hazmat Pumper 77 Firefighters have established a cut-off at the mid point of the complex. The photograph on the bottom left shows the colour smoke is beginning, indicating firefighters are having an impact and fire intensity is reducing. Out of view are firefighters establishing protection of Charlie Exposure.

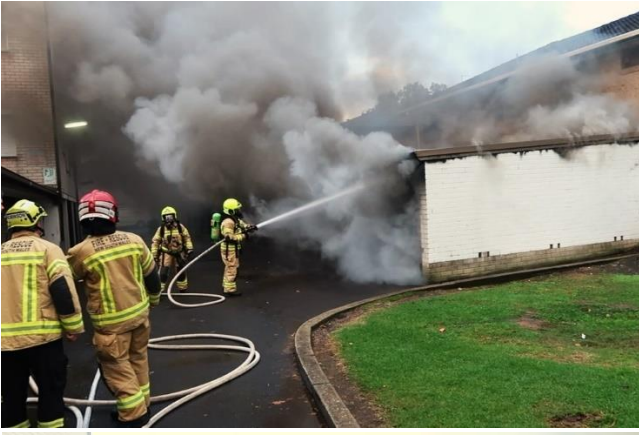
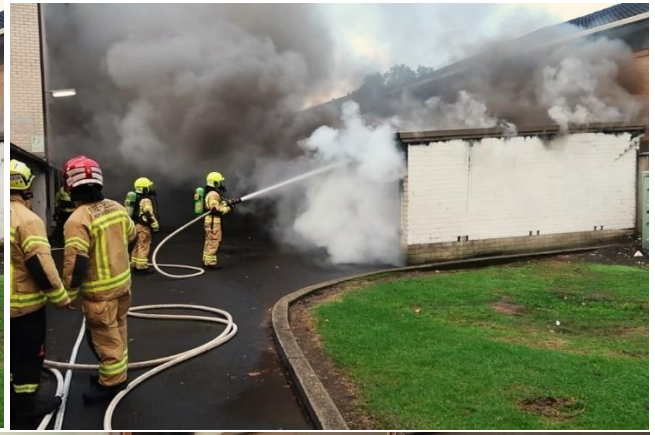
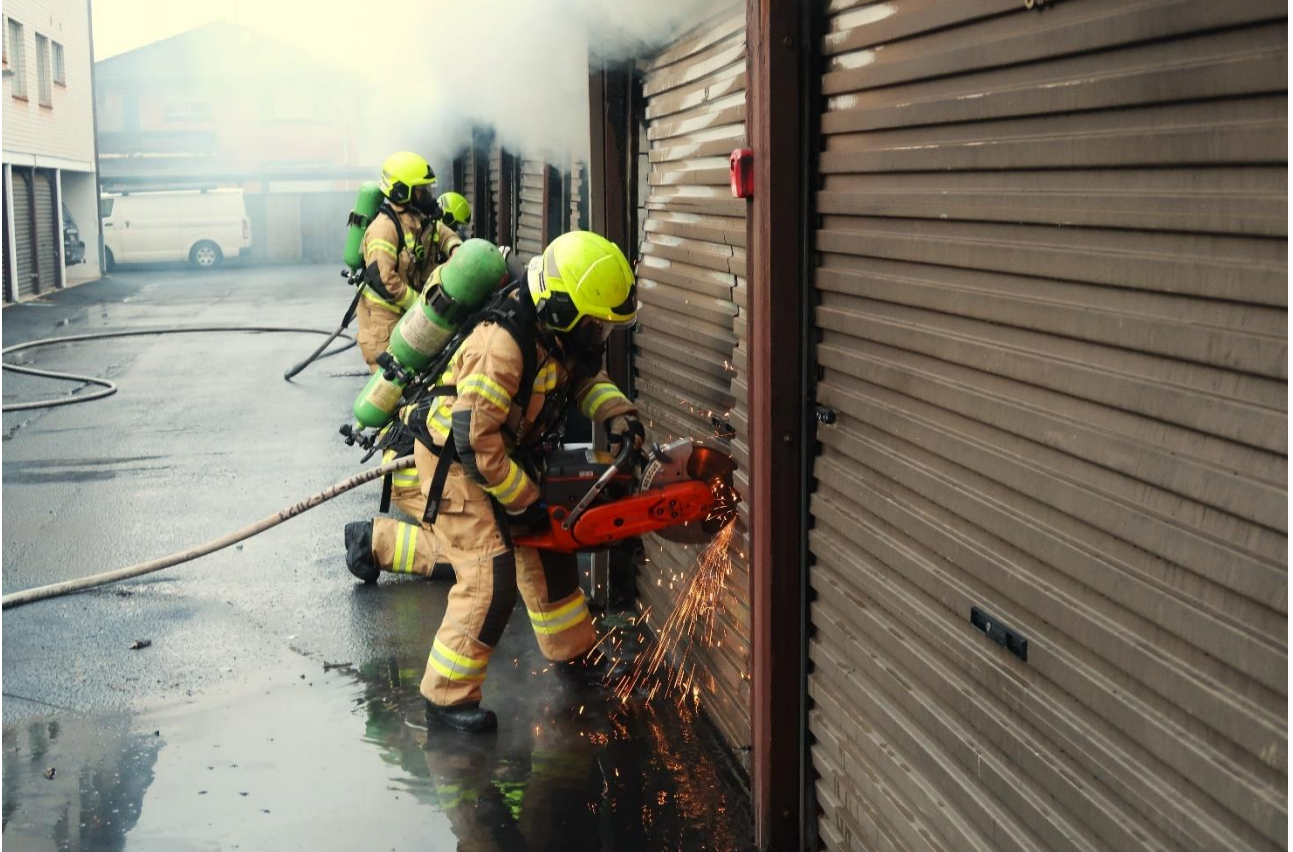
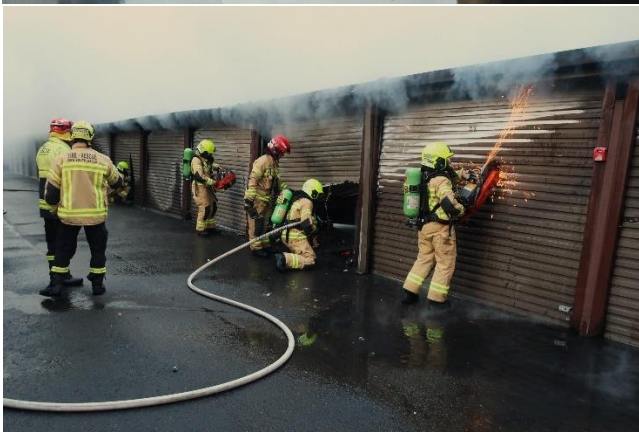
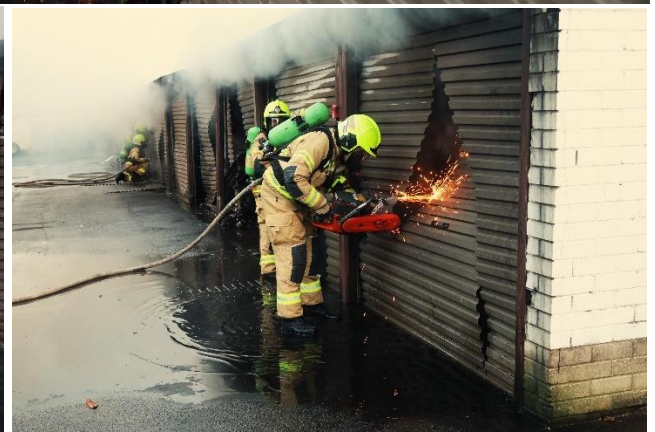
Top: Smoke is almost white, indicating good progress achieving fire control is being made. The power saw crews are moving forwards, from the cut off at the middle of the complex towards the beginning of the complex. Fire attack crews are working just behind the entry teams, extinguishing fire as they move forward. The coordination between the entry and fire attack crews was excellent. This was a great display of teamwork.

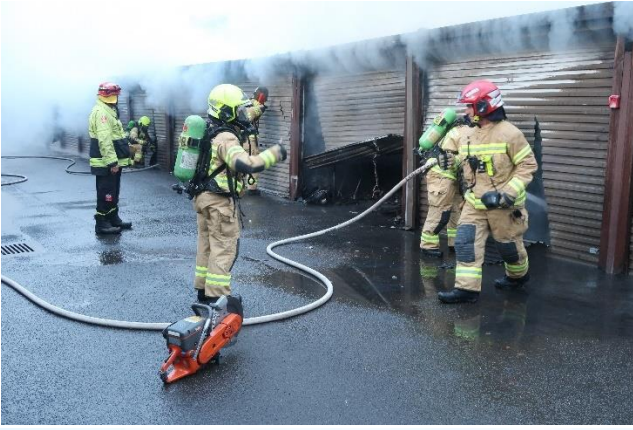
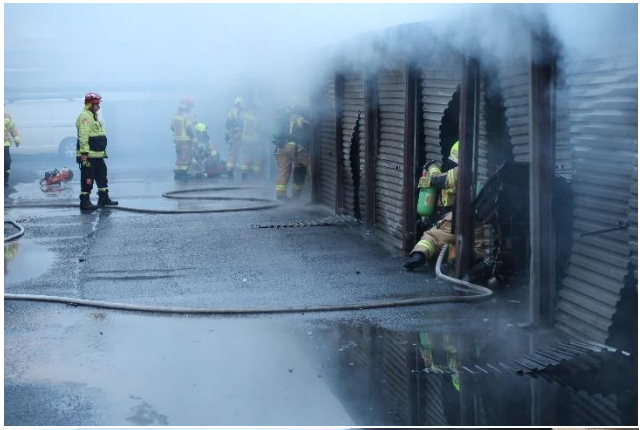
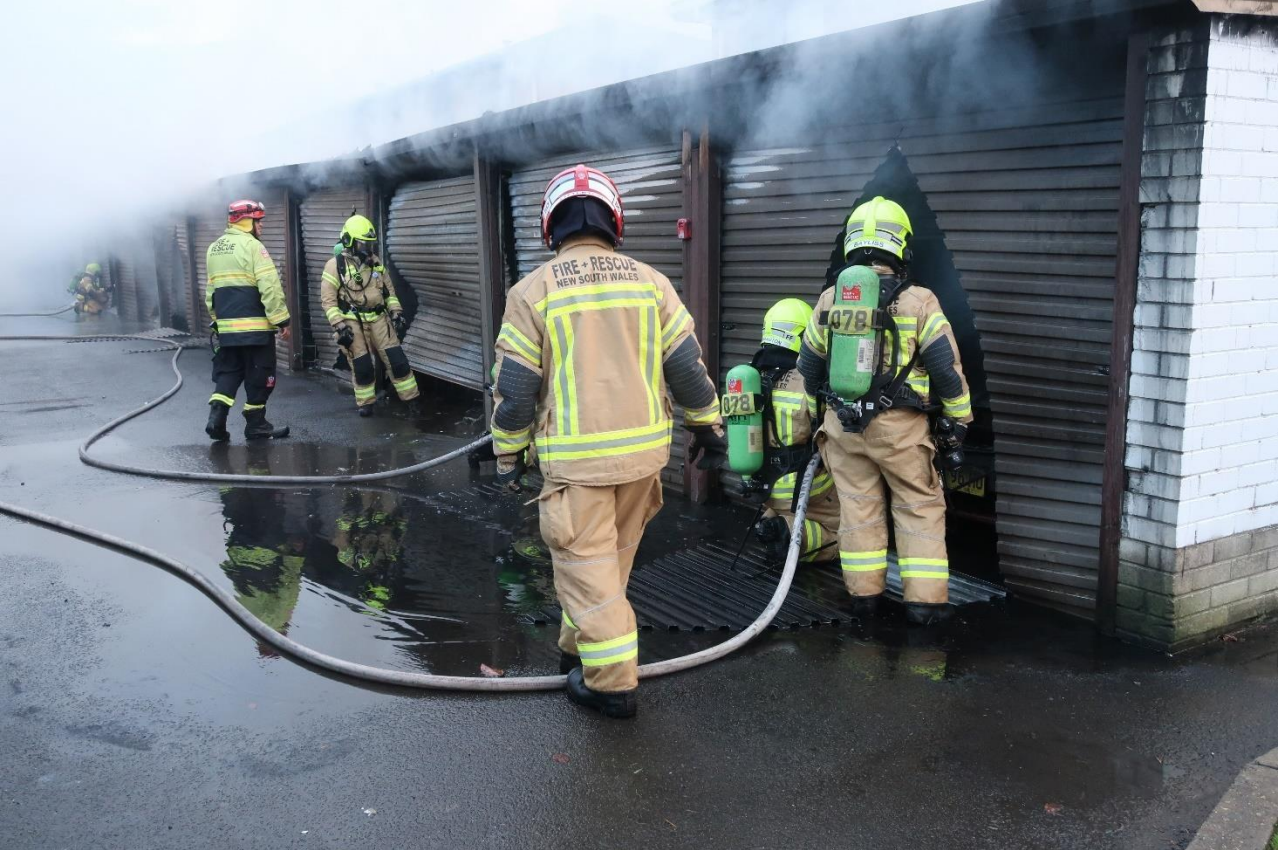
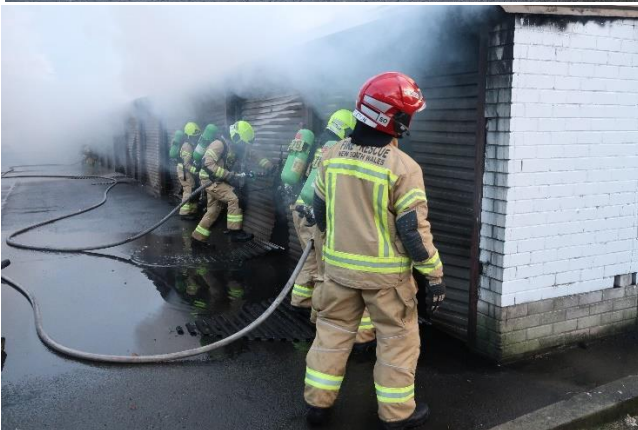
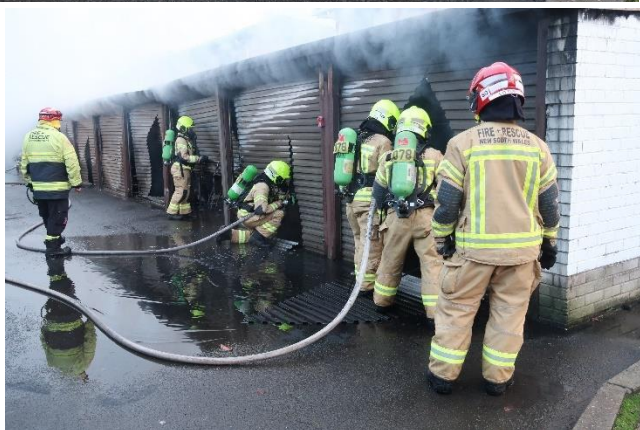
The fire has been contained, fire spread has been stopped and fire control has been established. Under the watchful eyes of S.O.s John "Carlos" Henry and Nigel Littleton, firefighters begin final extinguishment of stored materials within the individual garages. The garages contained many hazardous materials and volatile products, including LPG cylinders, stored flammable liquids, aerosols and polyurethane foam-based good; firefighters continue to exercise full precautions.

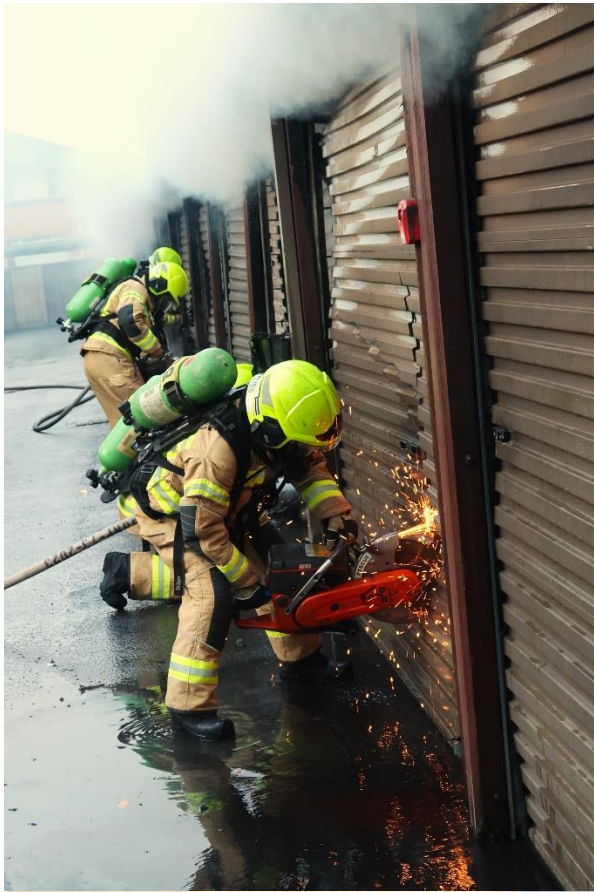
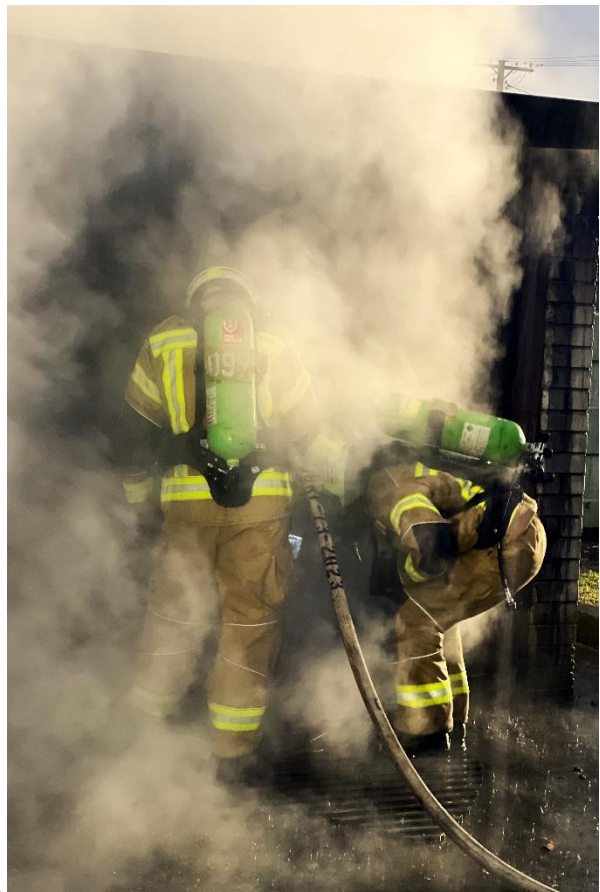
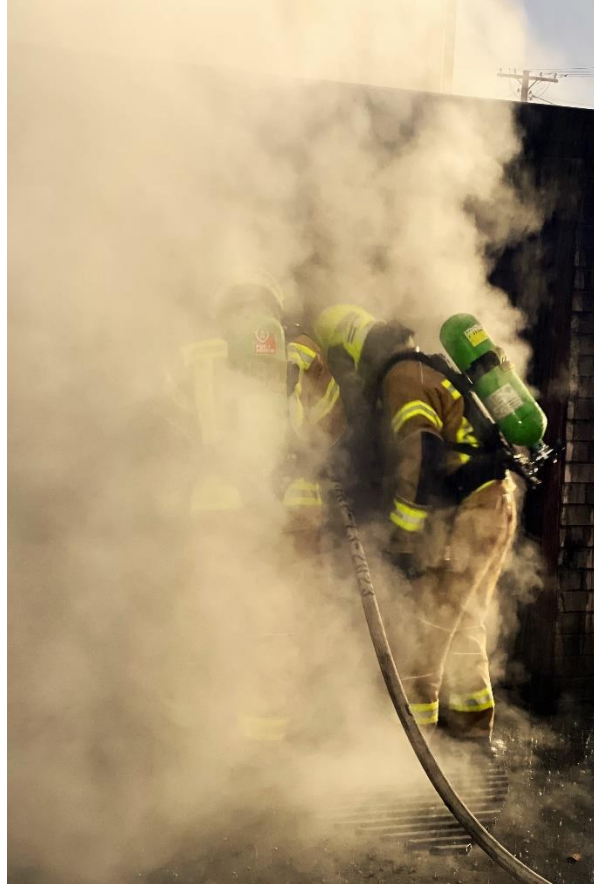
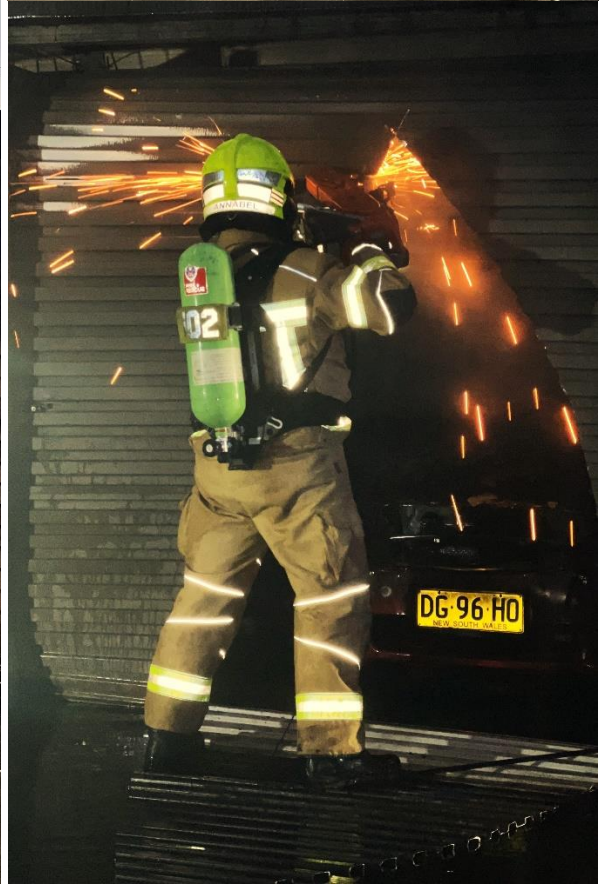
Firefighters Sue Bayliss (top left) and Bruce Annabel (lower left) cut into the garage roller doors, allowing fire attack crews to undertake extinguishment. CAP97 crew firefighters Gavin Hartge and Leon Duke work on the garage containing the involved car. Pictures top right and lower courtesy S.O. Pat Thompson.

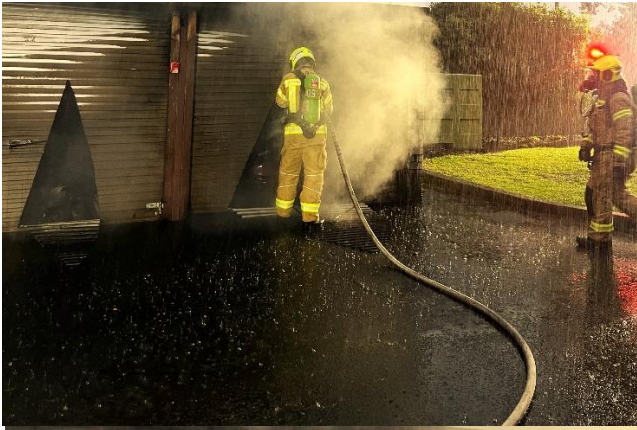
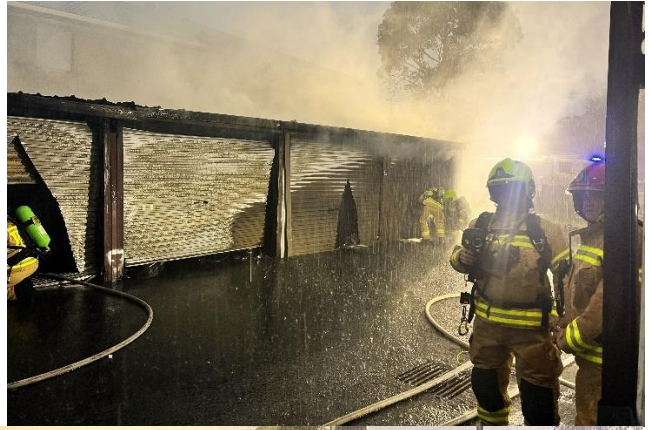
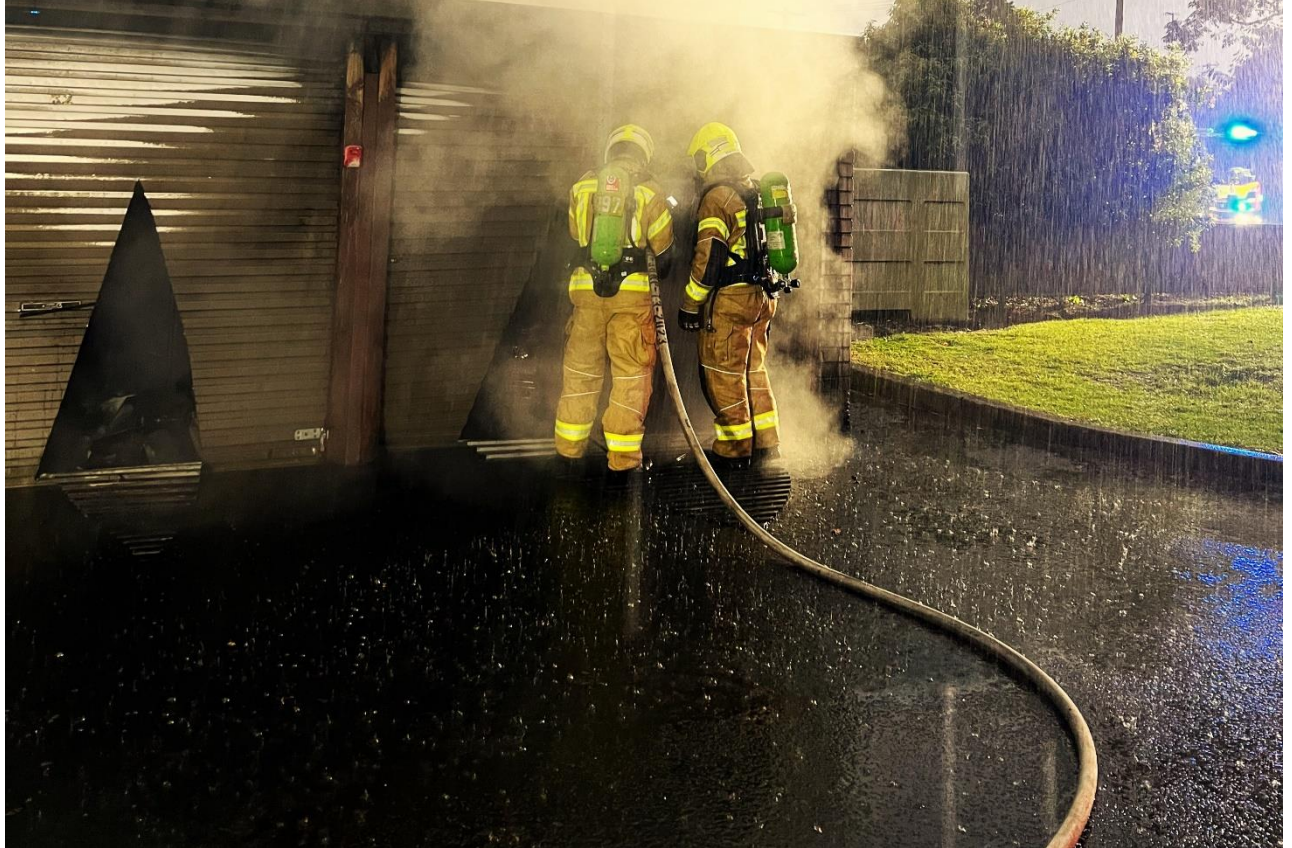
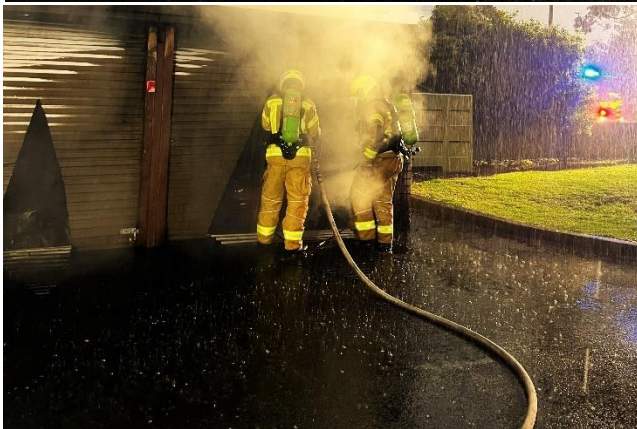
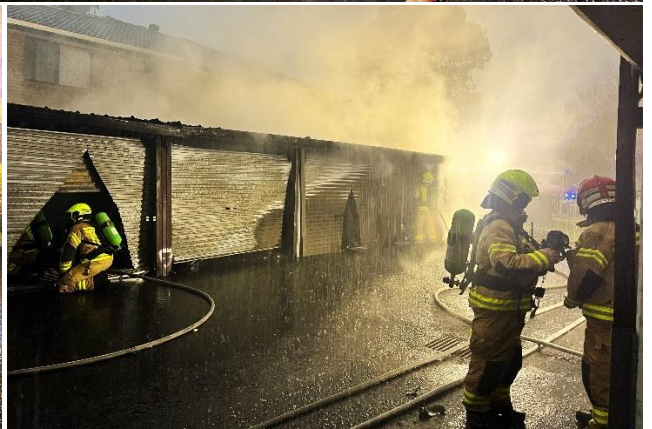
Light is fading as heavy rain falls on the fireground on a cold and wet late Autumn afternoon. CAFS Aerial Pumper 97 firefighters Gavin Hartge and Leon Duke continue extinguishment of the car fire. All pictures courtesy S.O. Pat Thompson.

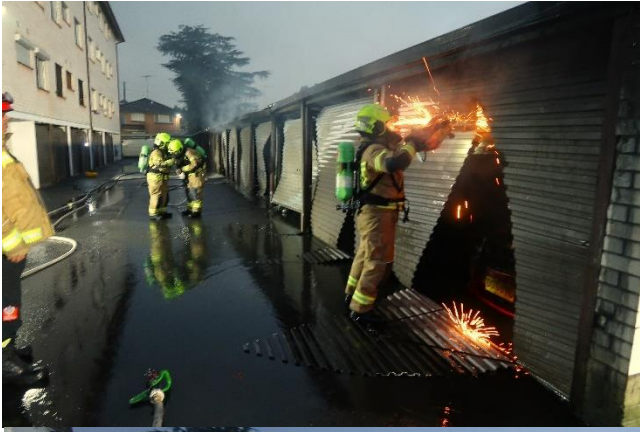
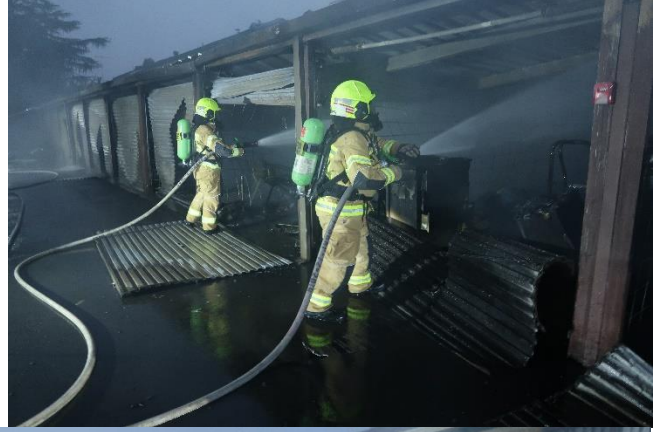
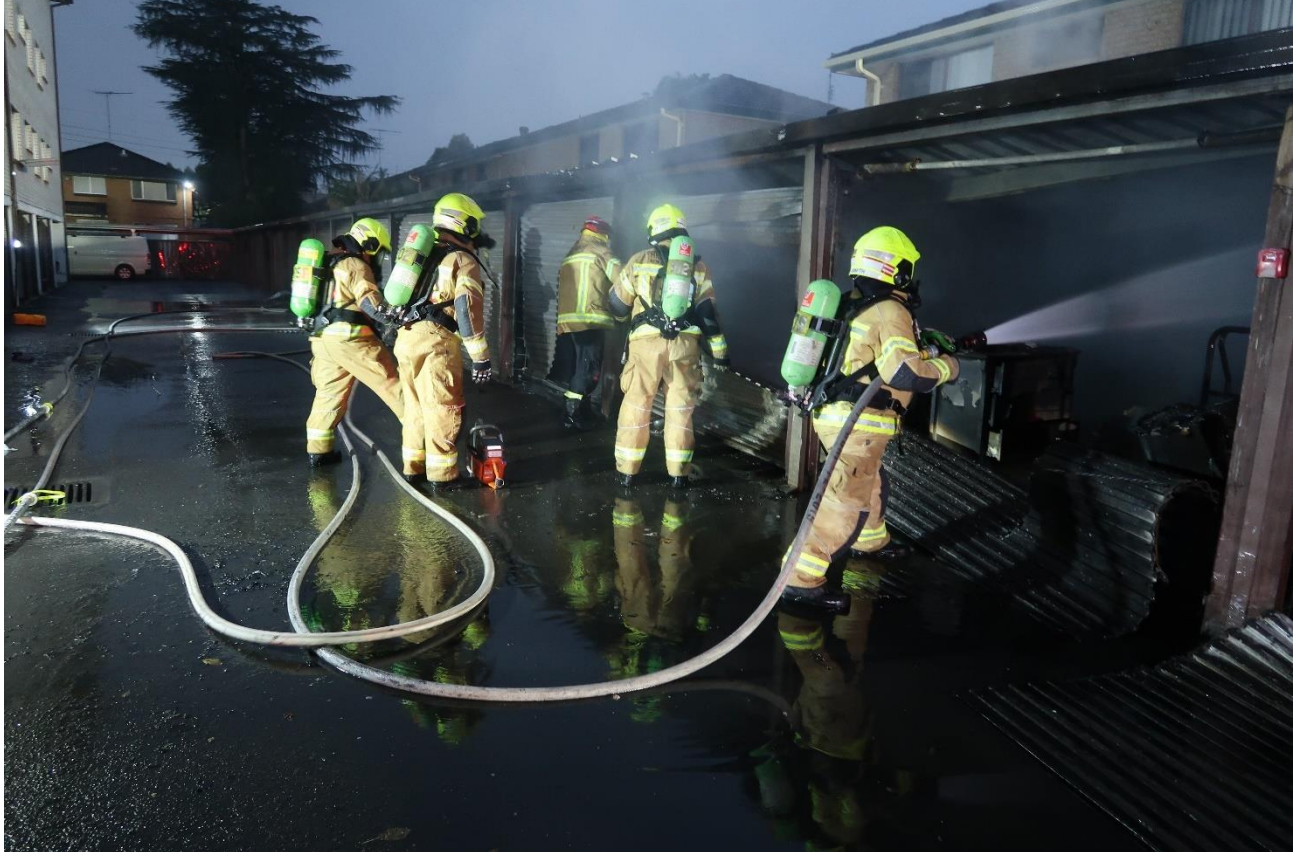
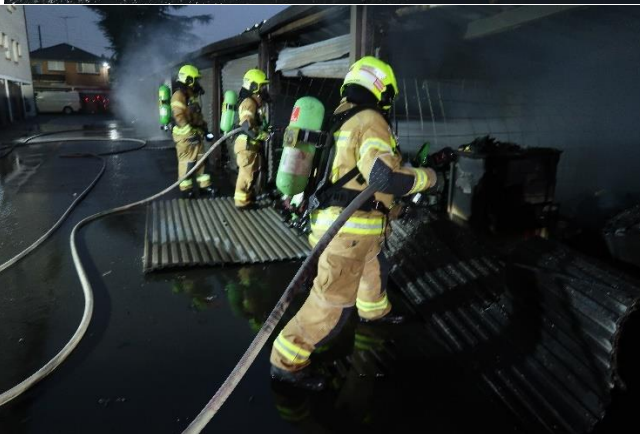
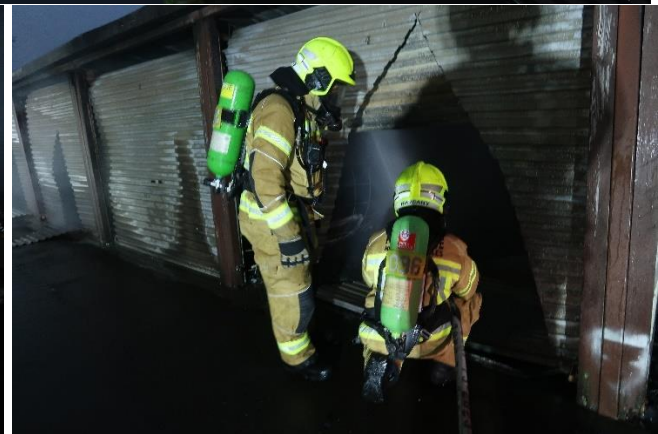
Firefighters continue to complete final extinguishment. Some of the garage openings are widened to improve access. Fire is deep-seated and smouldering. All firefighters continue to wear SCBA.

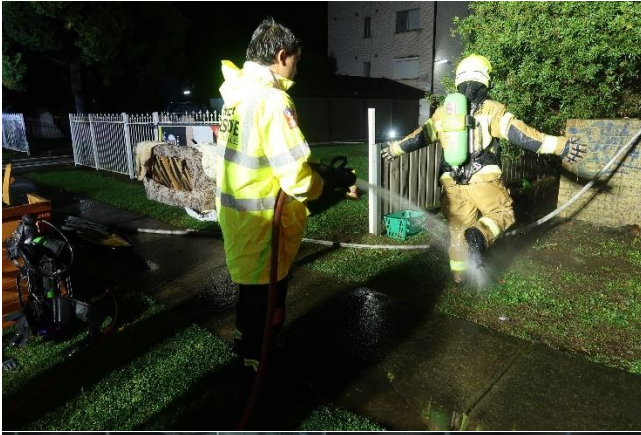
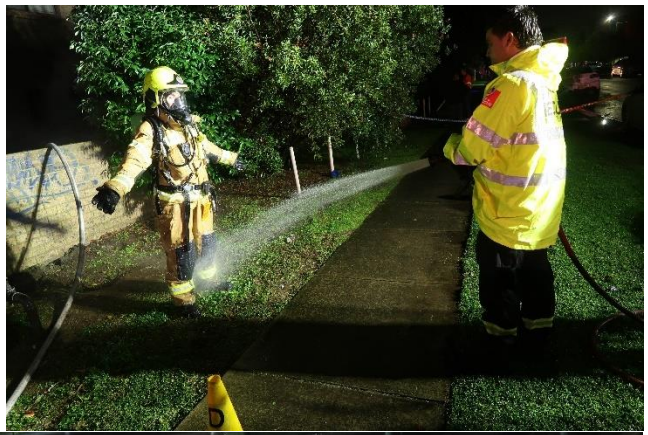
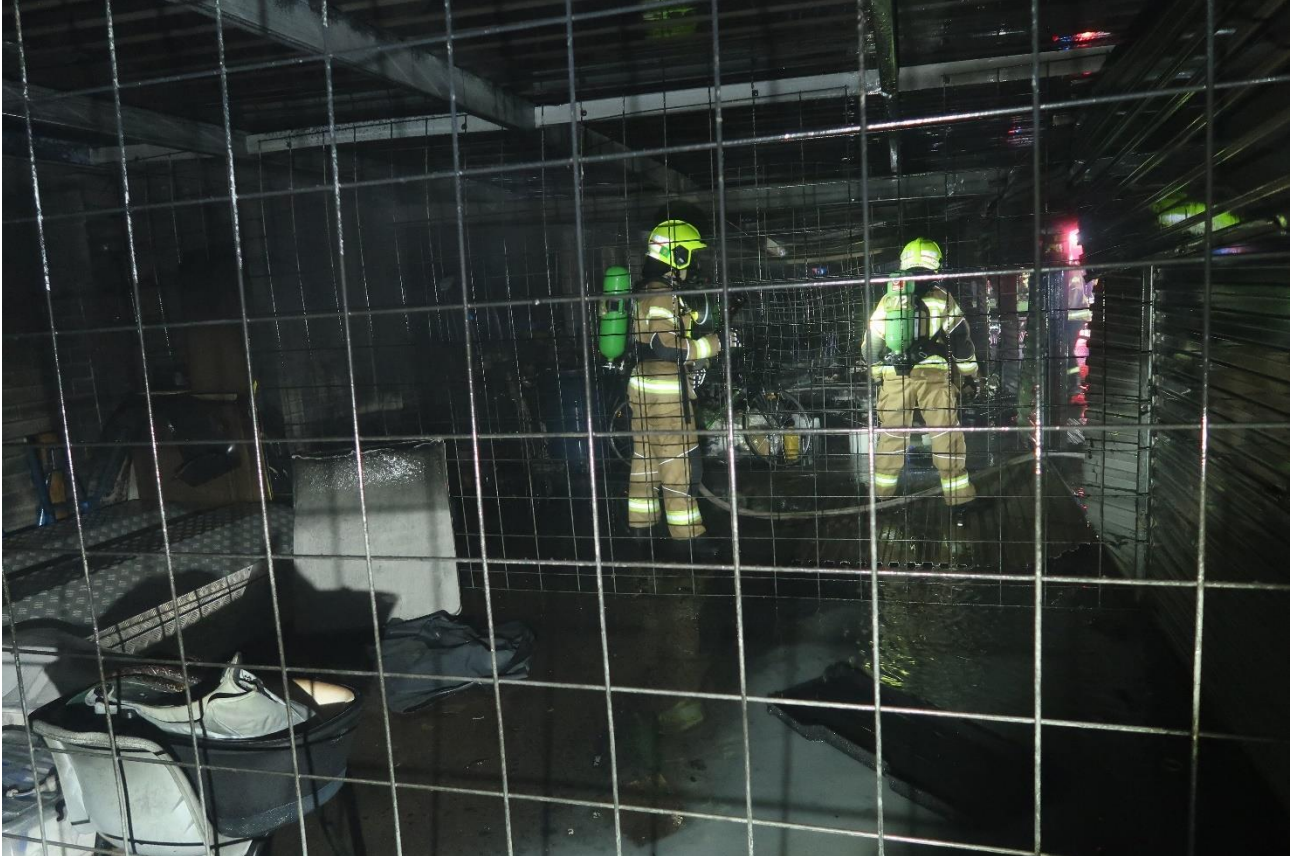
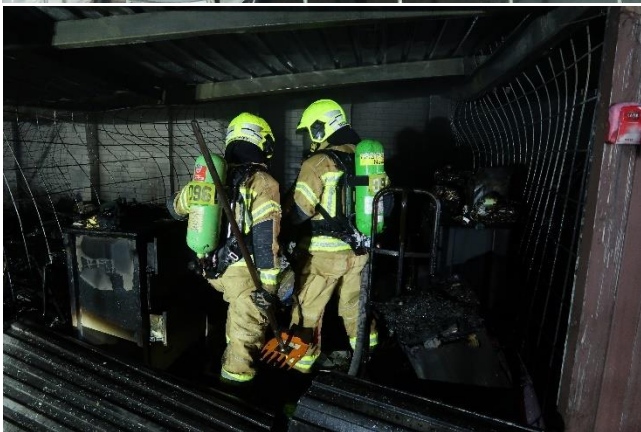
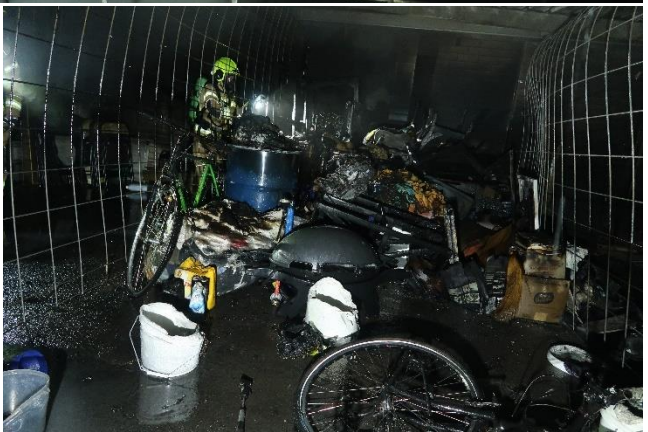
Top: Firefighter after-fire decontamination is a critical element of all firefighting operations. Pumper 98 was tasked with the duty of establishing firefighter decontamination. All firefighters who left the SCBA wearing zone went through decontamination. Middle and lower: Pumper 96 and 72 firefighters complete the final stages of overhaul.

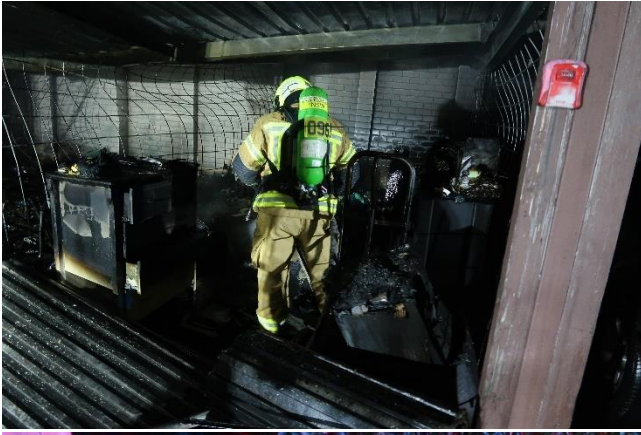
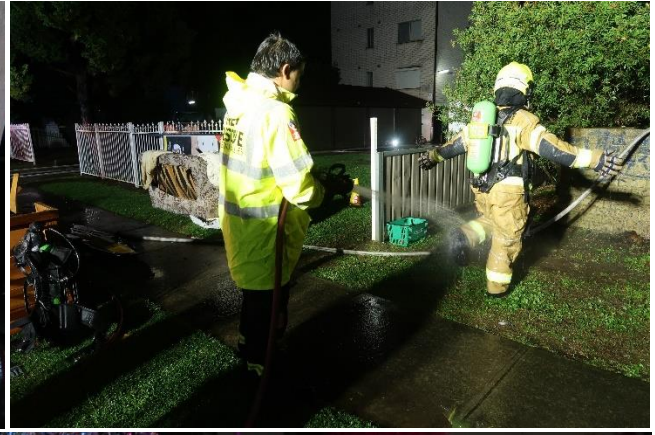
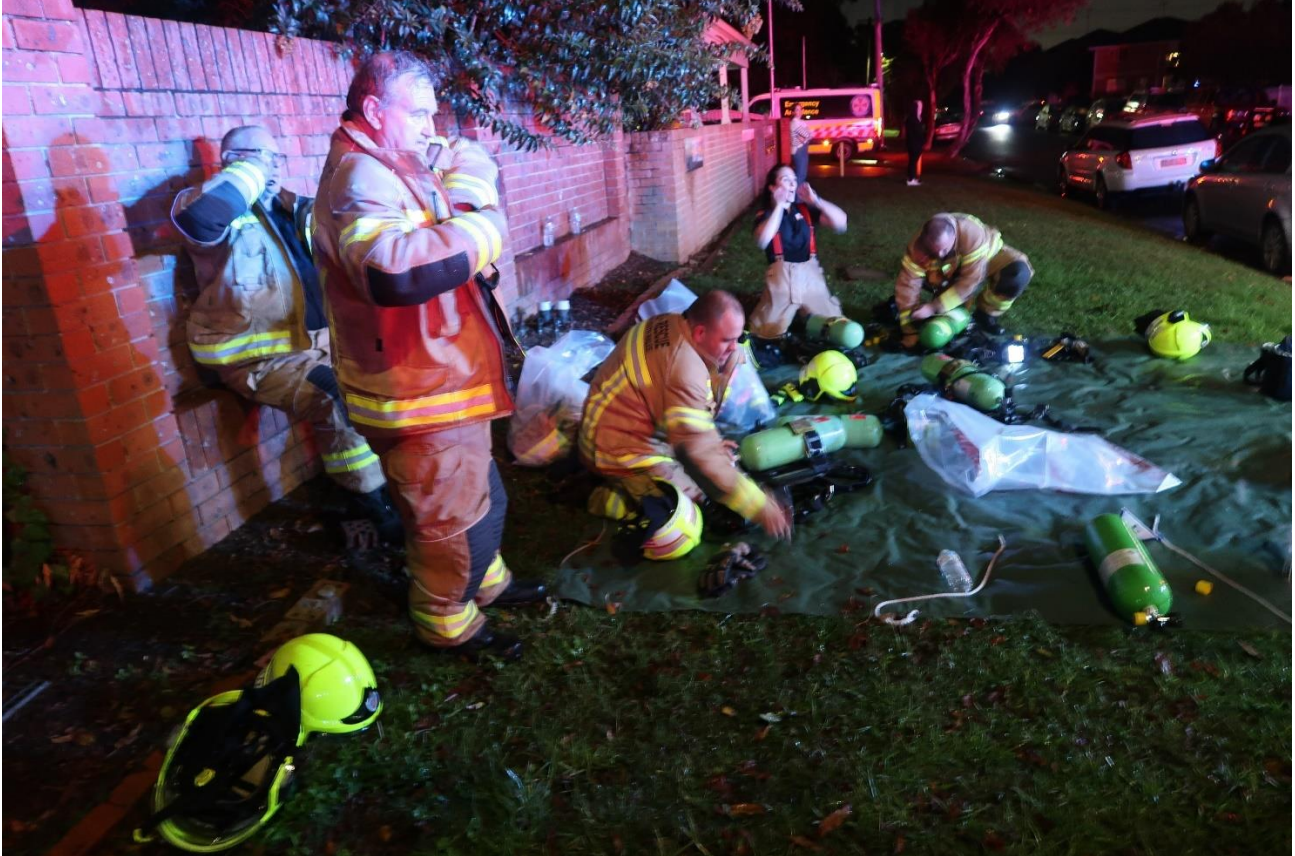
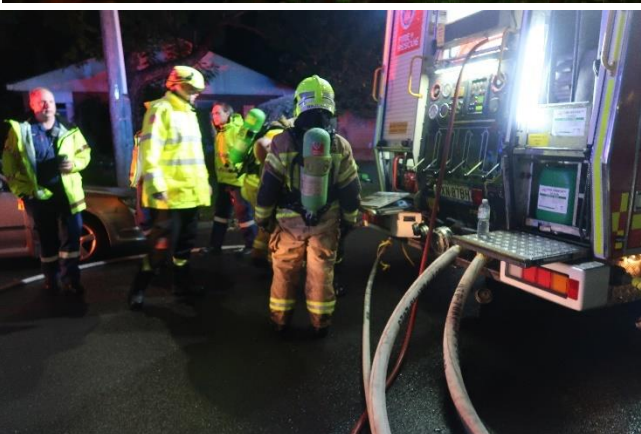
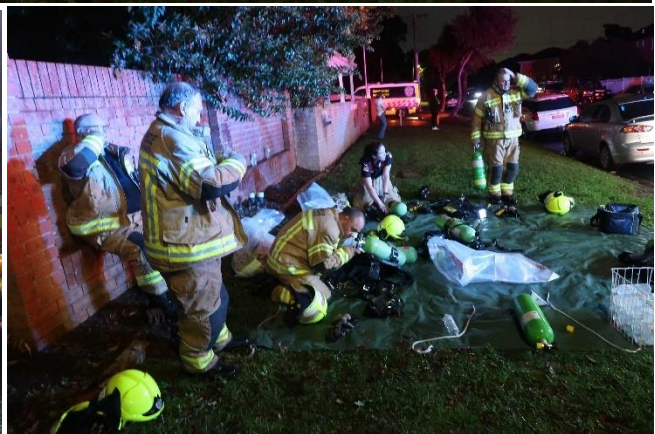
Helping to improve firefighter welfare: After crews complete tasking operations they pass through the after-fire decontamination, before going to B.A. Control and then to firefighter rehabilitation.
