## **MW1 C STATION TRAINING AND INCIDENT CASE STUDIES**

**FILE NO. 2024 /07.**

**LEARNING FROM THE PAST: 14 PUMPERS  
AND 2 AERIALS CALLED TO SMITHFIELD  
PALLET FACTORY FIRE**

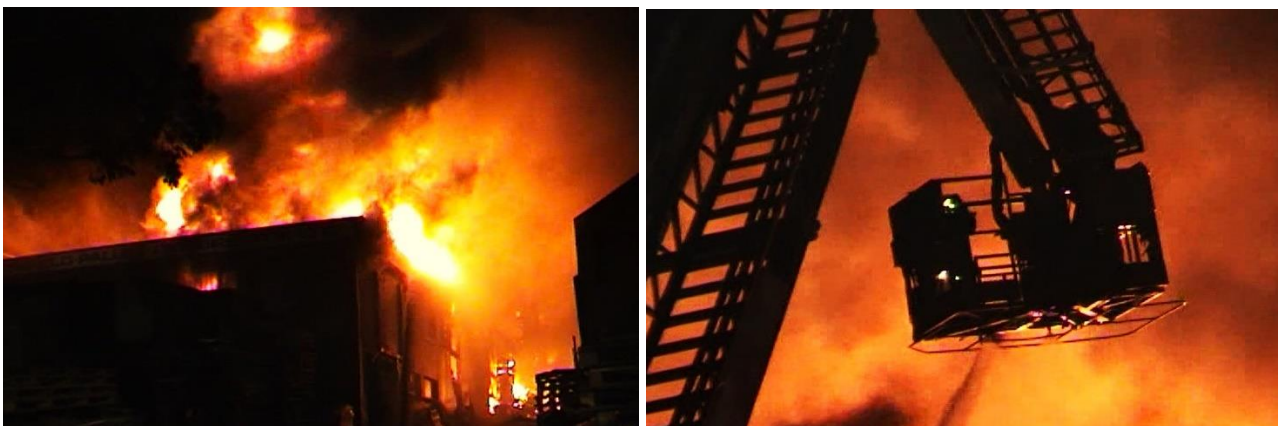
(left) Heavy fire activity vents from the fully involved pallet manufacturing factory. (right) Ladder Platform 27 provides a protective stream along the side of Exposure B. Despite the intensity of the fire, firefighters protected all exposures under threat.

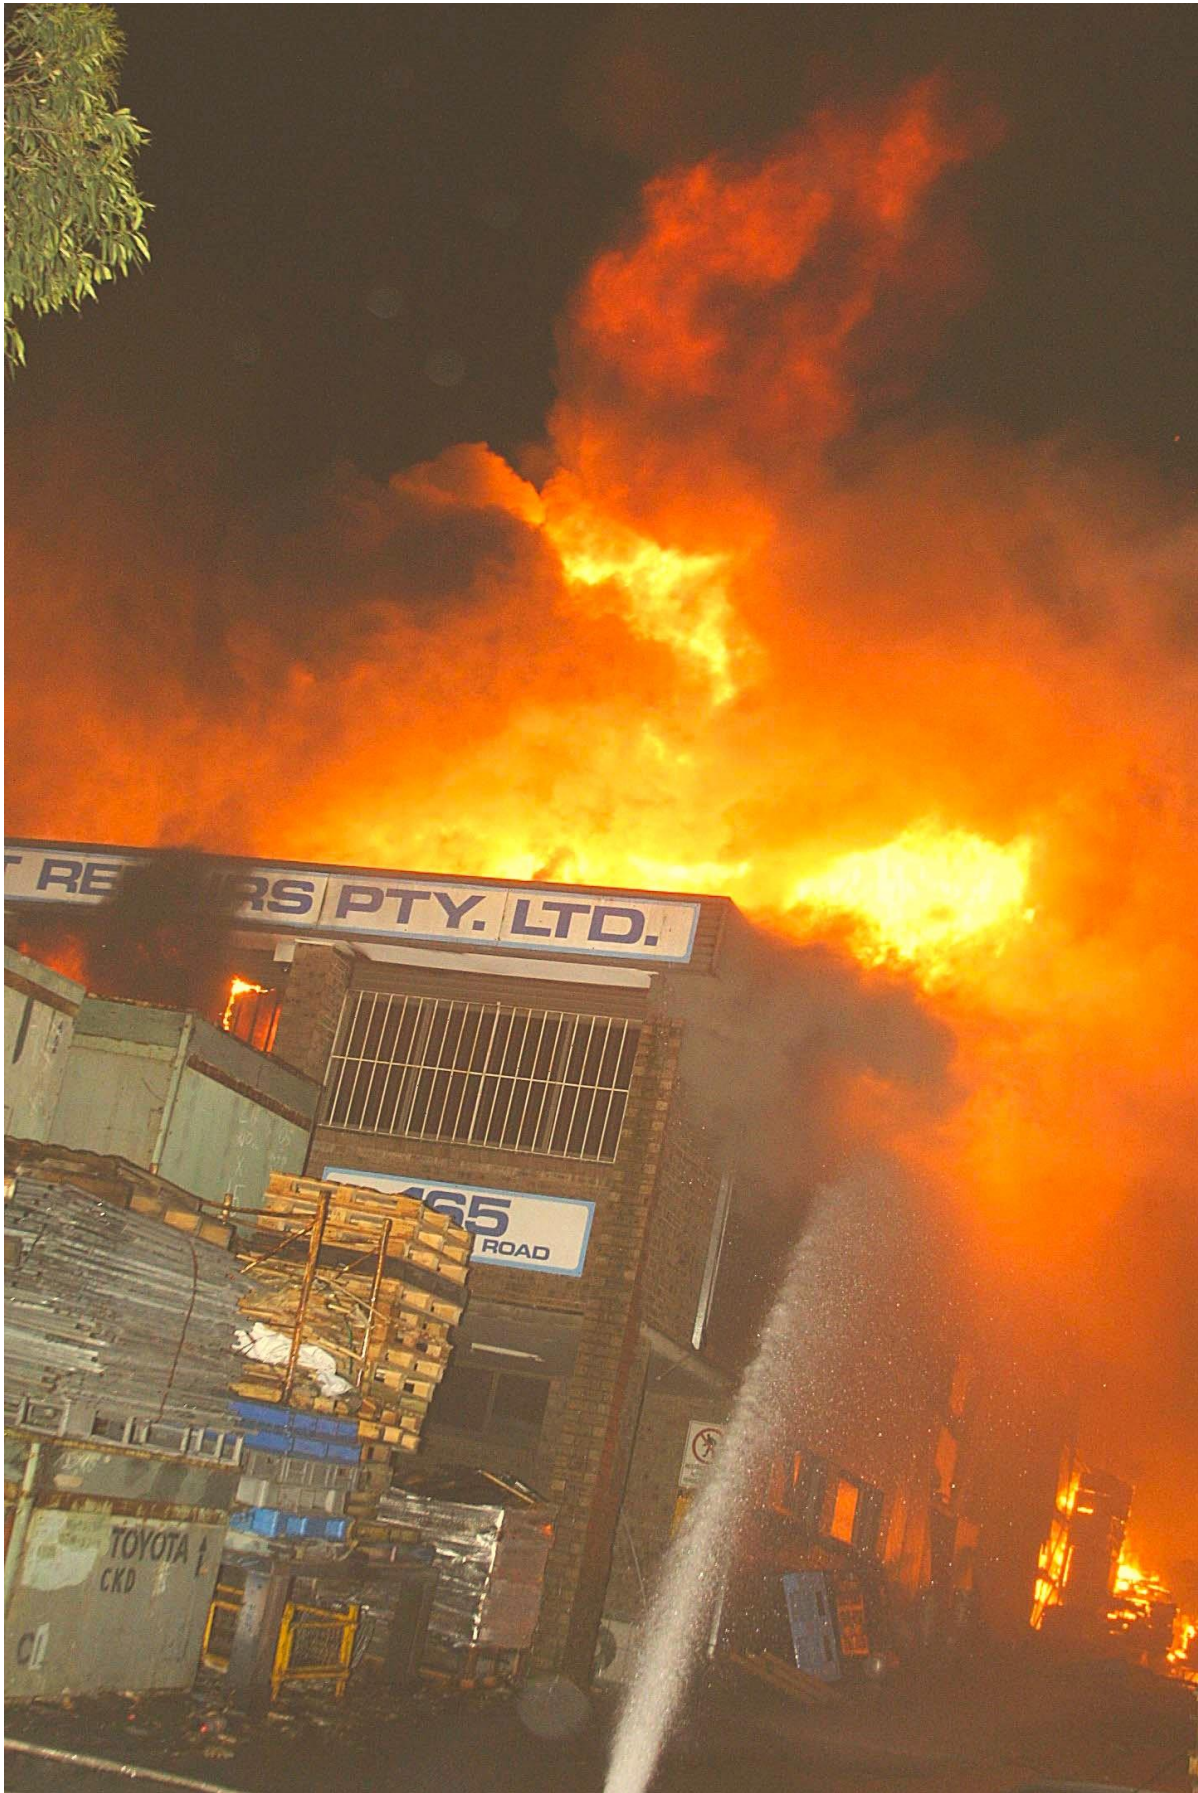
Fierce flames vent from the fully involved factory.

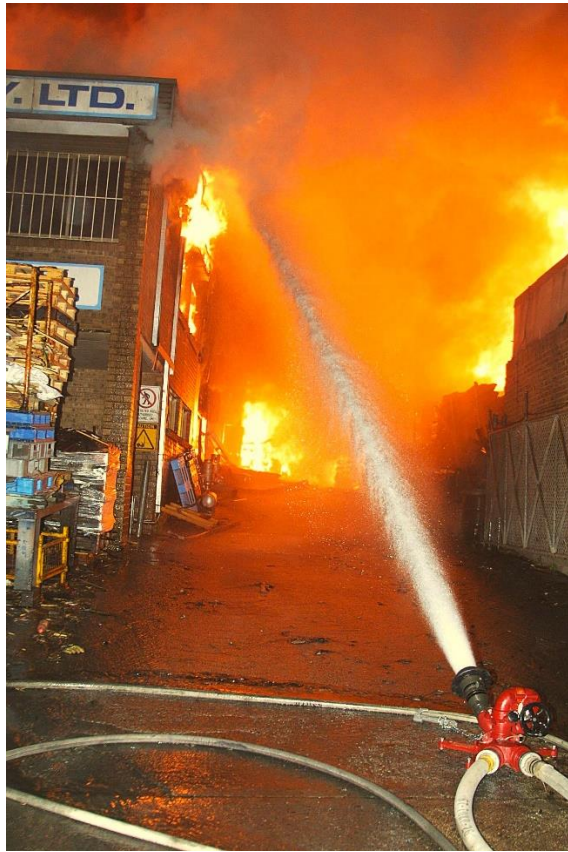
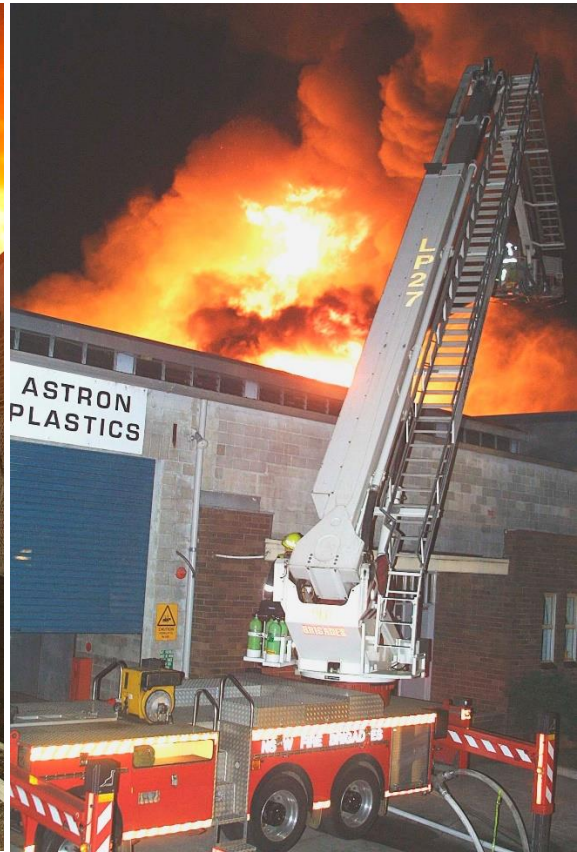
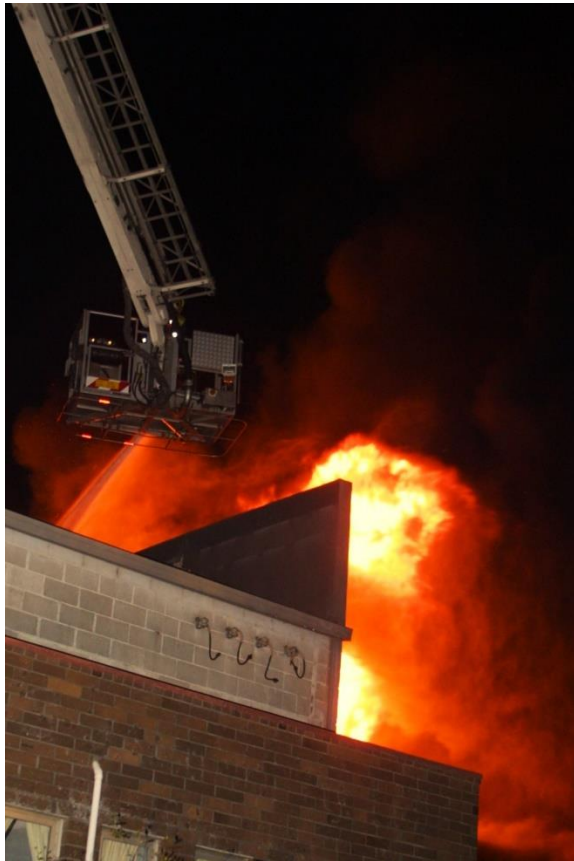
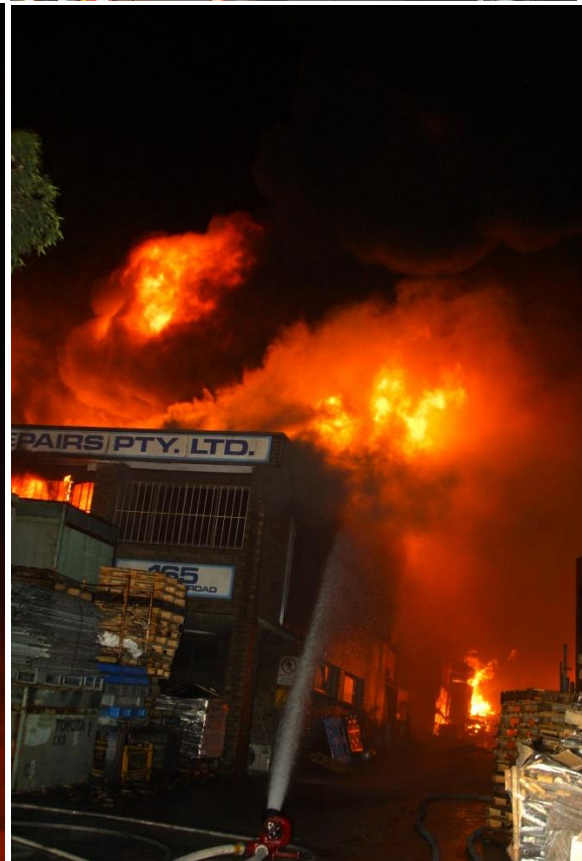
Firefighters battled ferocious fire conditions as large flames and explosions erupt from the involved factory. Ladder Platform 27 operates from Sector B, directing an aerial stream along the wall of the Exposure B warehouse, stopping fire from entering the warehouse. The aerial stream was alternated between fire attack and exposure protection. A ground monitor stream is directed into the involved factory.

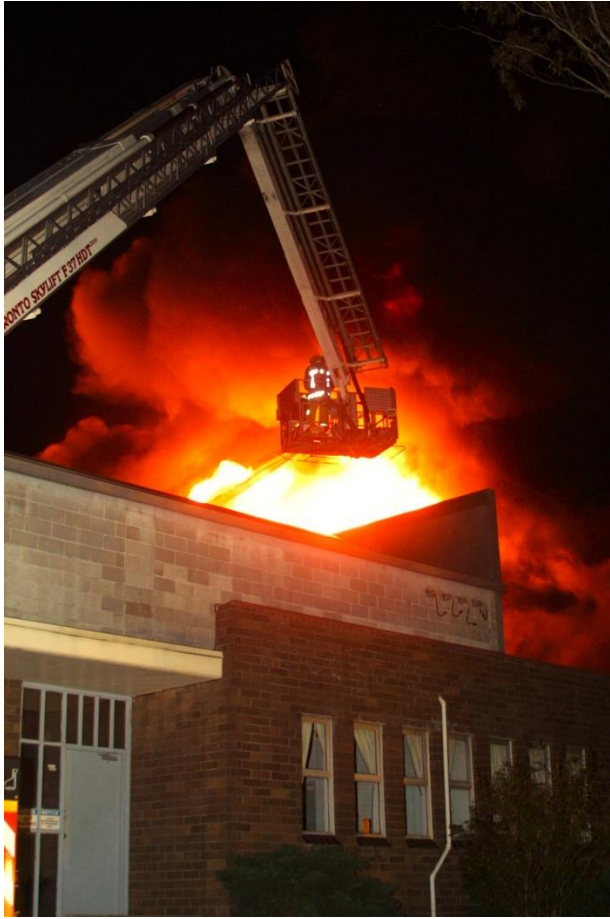
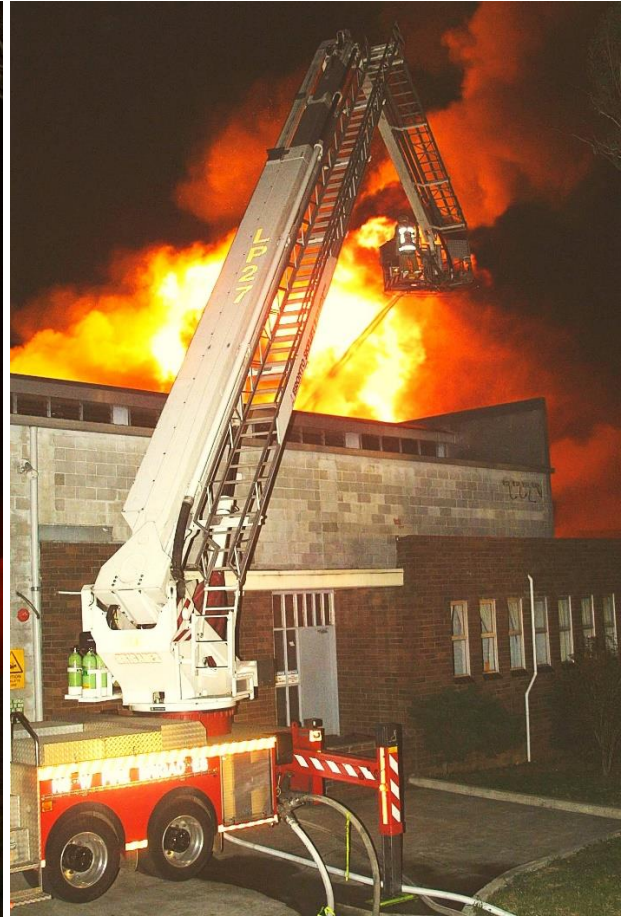
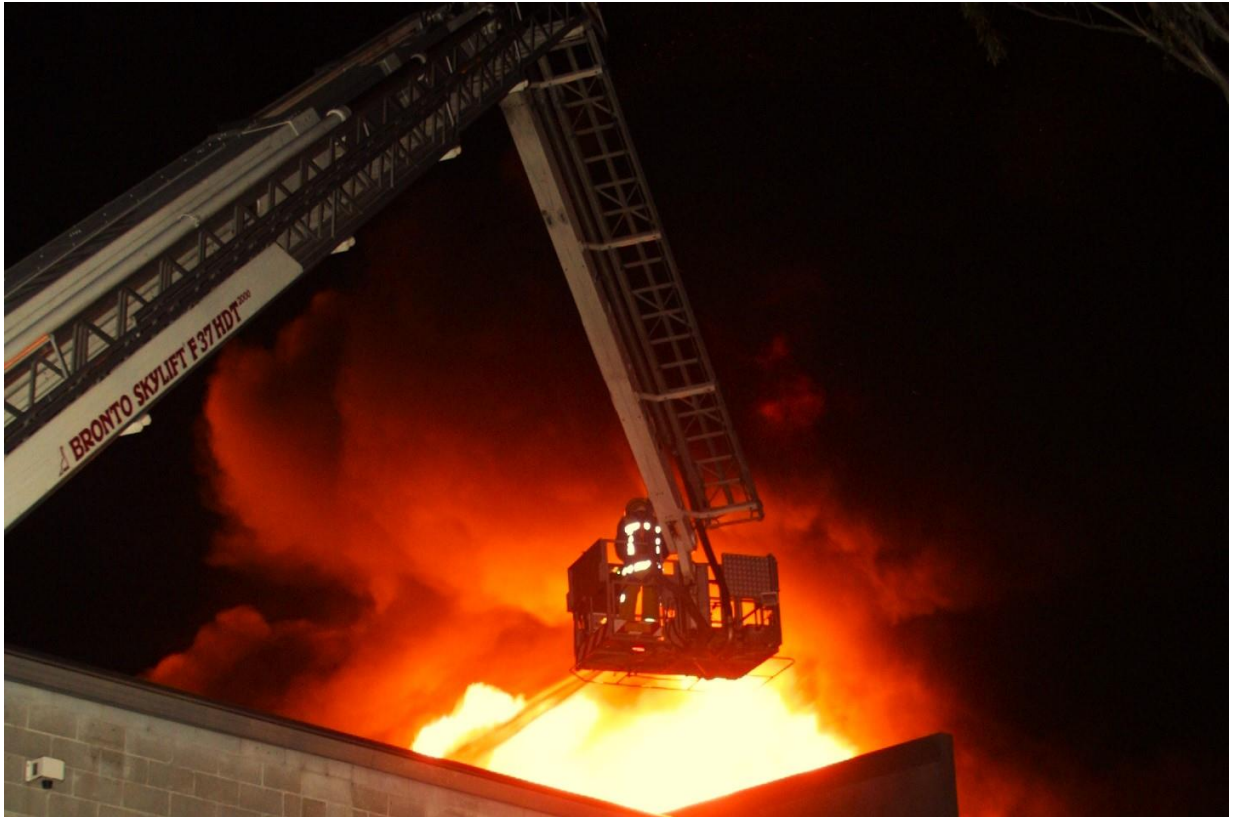
Firefighter Grant Creighton works from the Ladder Platform 27 aerial cage, directing an aerial master stream along the upper wall of the Exposure B warehouse which is being heavily impacted by fierce flames. Explosions continue to erupt from the factory. Despite these extreme fire conditions, firefighters successfully saved the exposure.

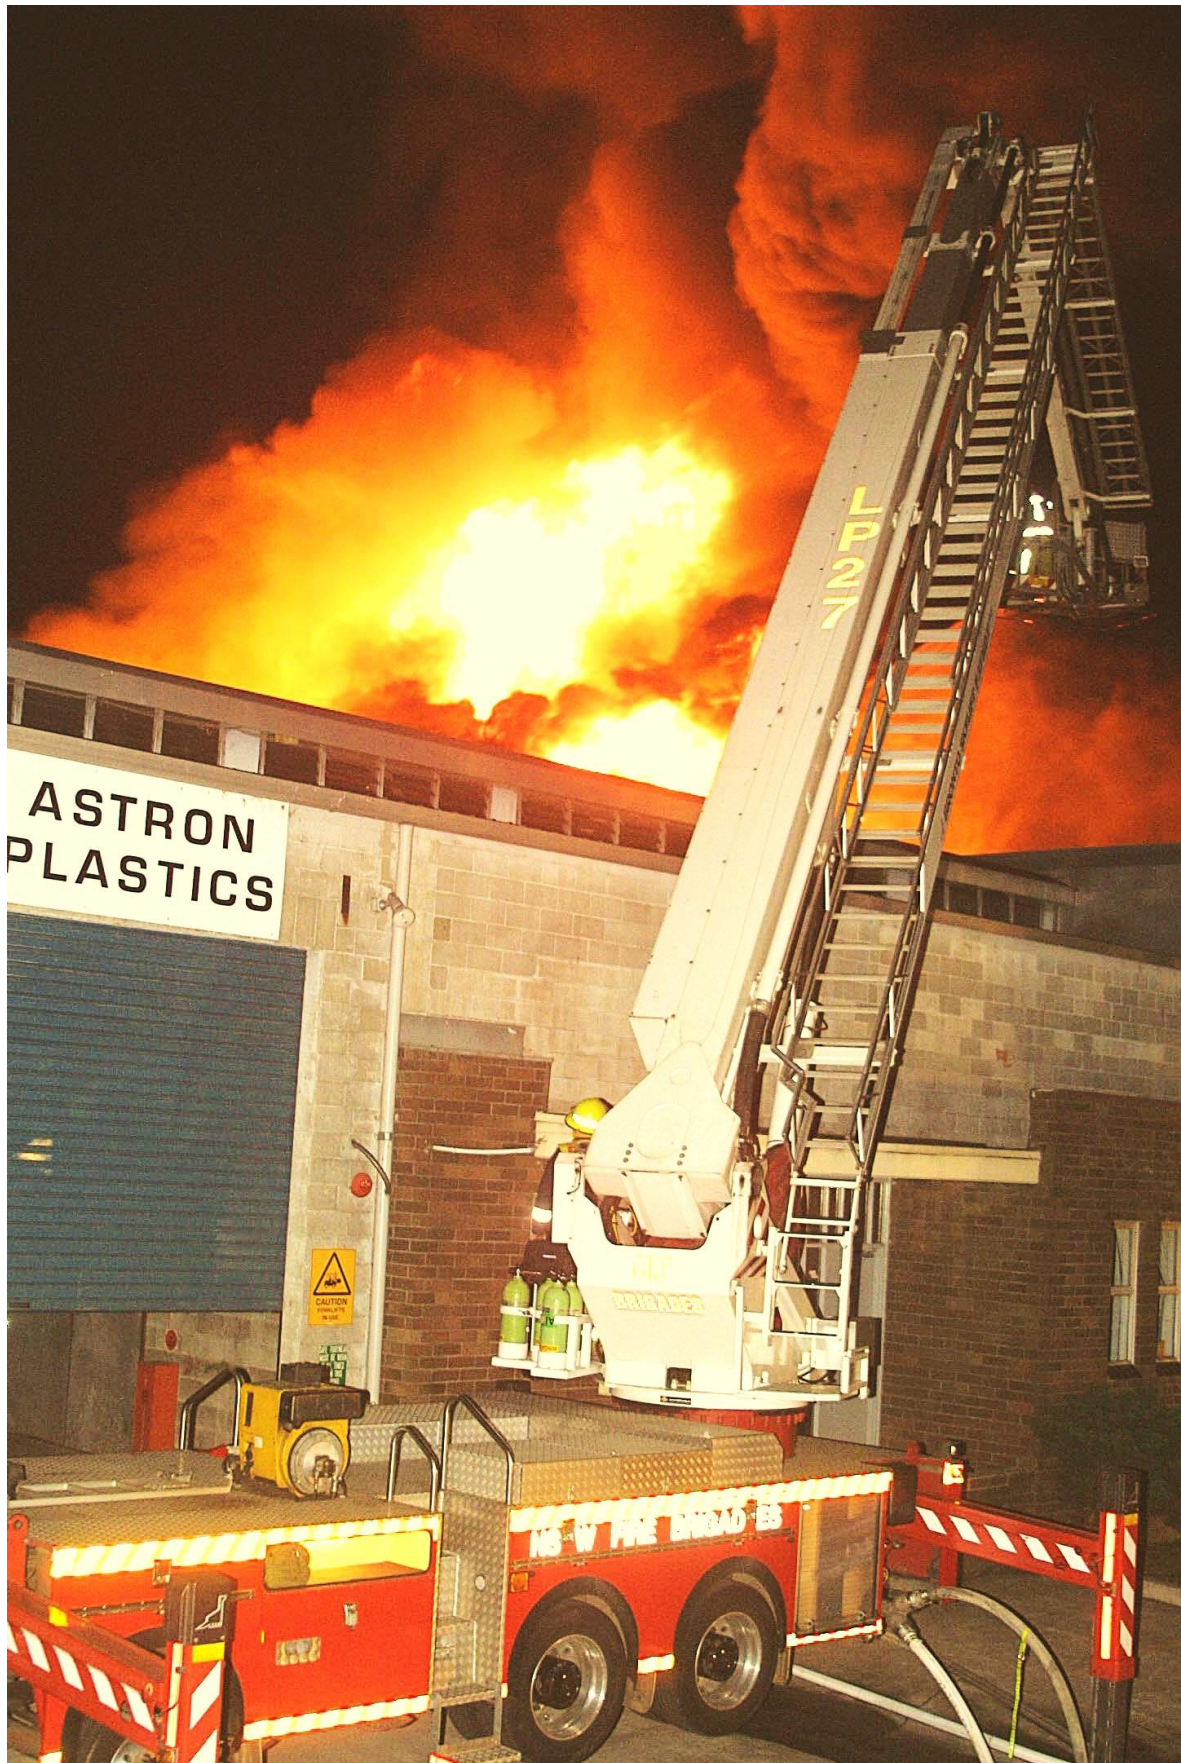
Ladder Platform 27 directs a protective steam along the wall of the Exposure B warehouse. Fire activity from the involved factory was ferocious.

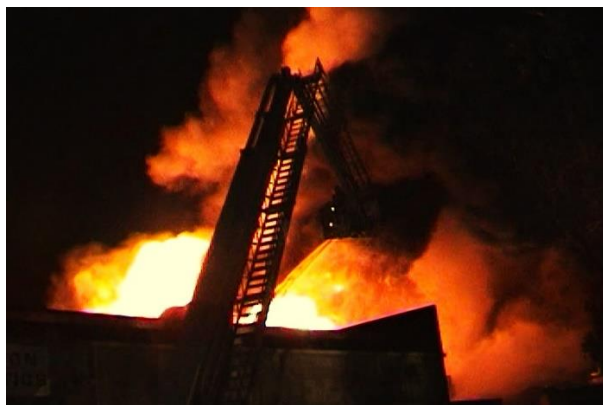
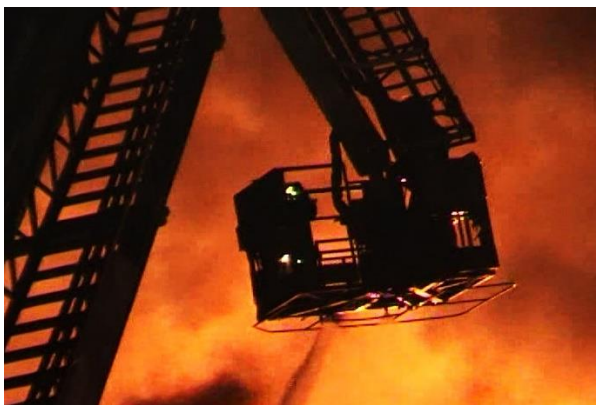
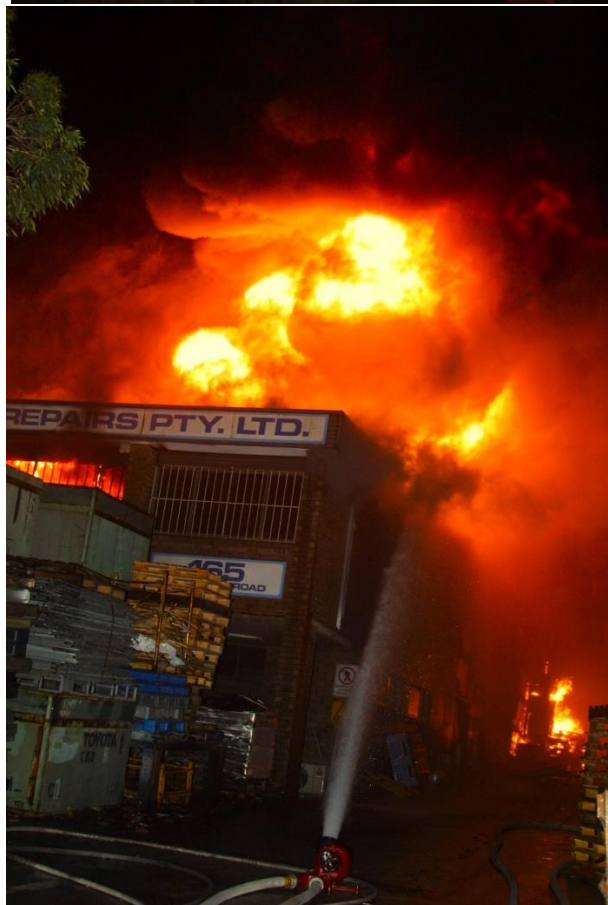
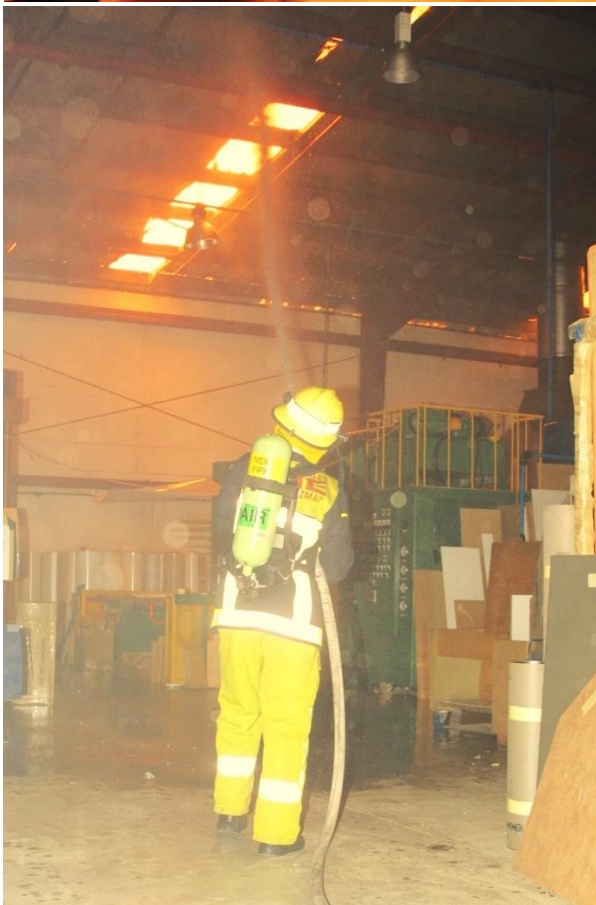
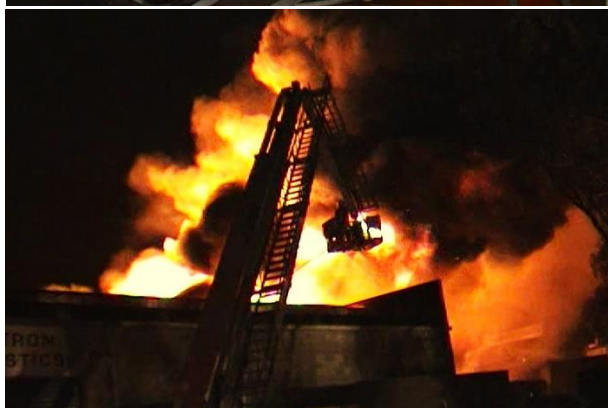
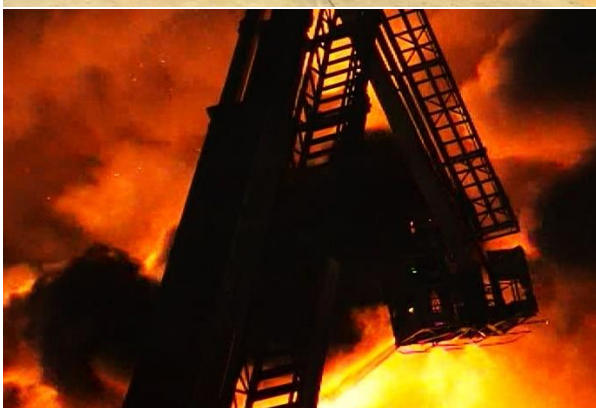
Ferocious fire conditions erupt from the fully involved factory. Ladder platforms 8 and 27 protecting heavily threatened Exposures B and C. Firefighters operating inside Exposure D direct cooling streams onto the breached roof skylights where burning embers are entering.

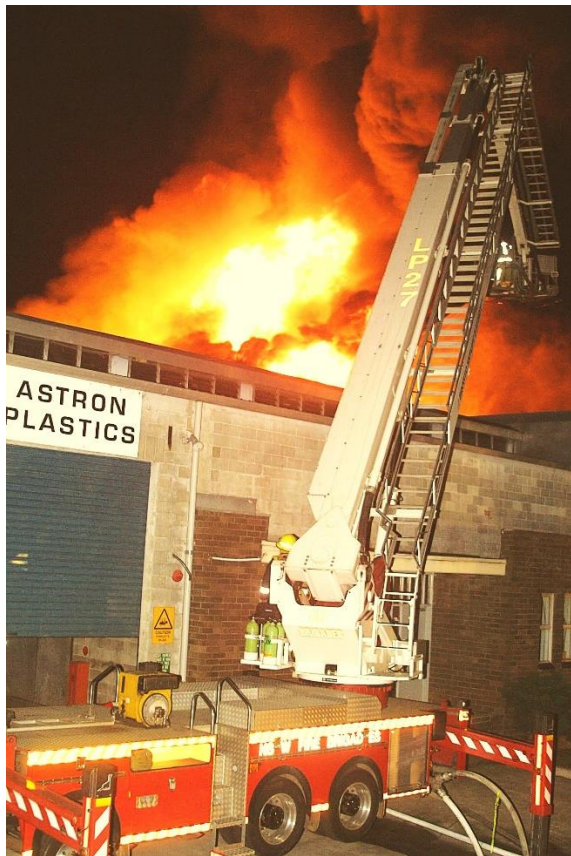
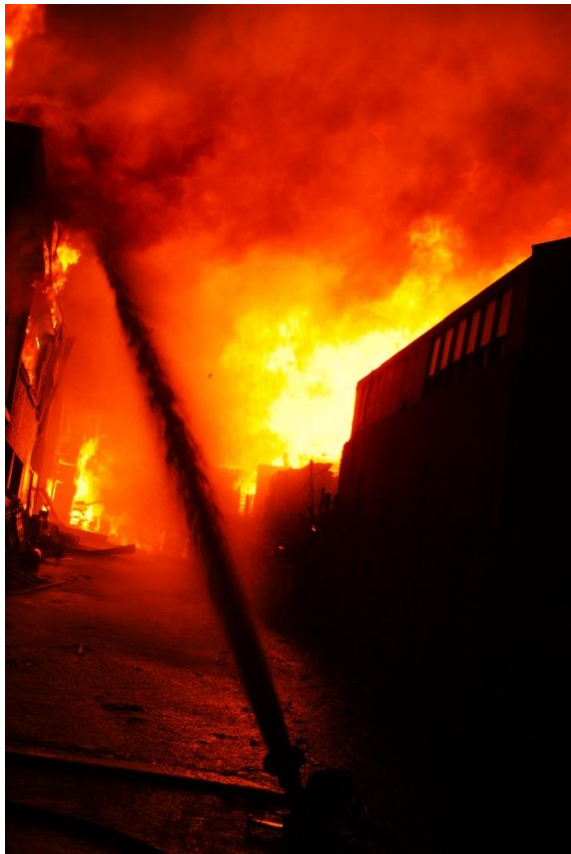
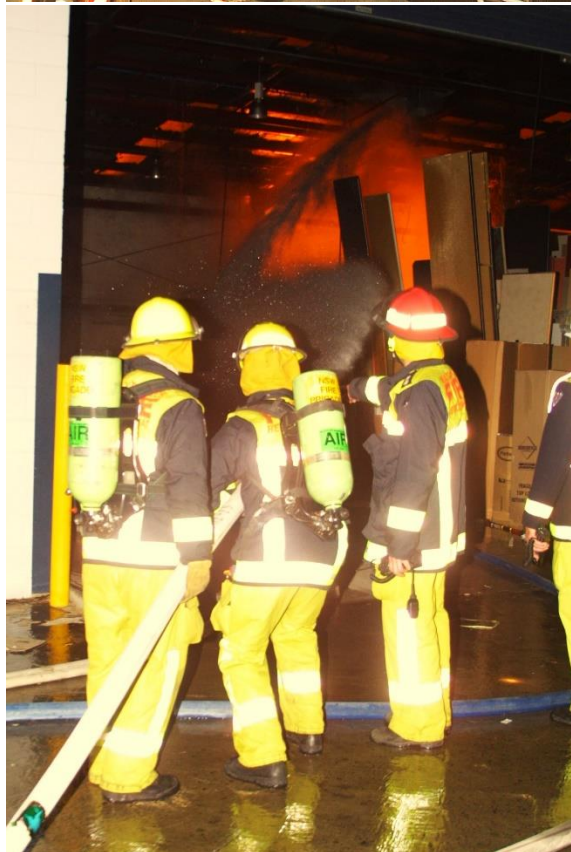
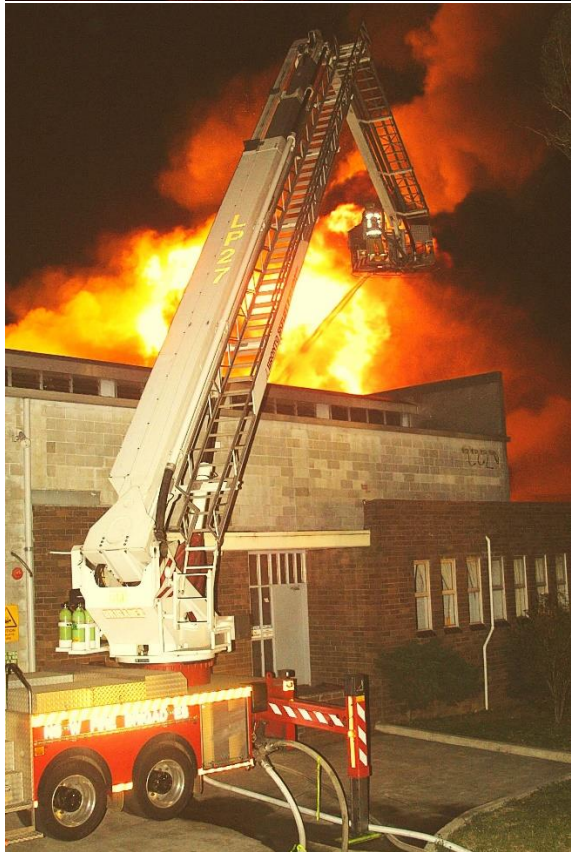
Exposures on all sides of the factory came under significant threat. Ladder Platform 27 directs a protective steam along the eastern wall of Exposure B. Firefighters have gained entry into Exposure D, where fire is beginning to enter the factory through a collapse wall.

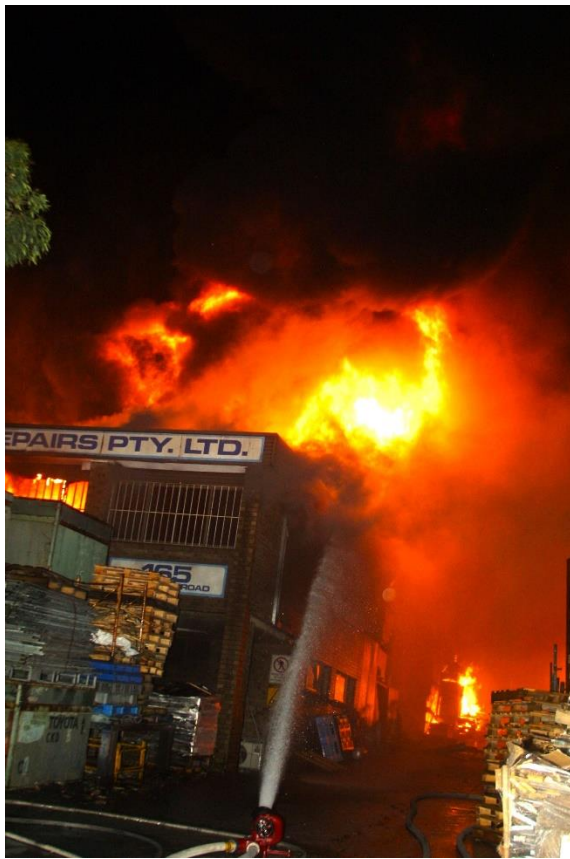
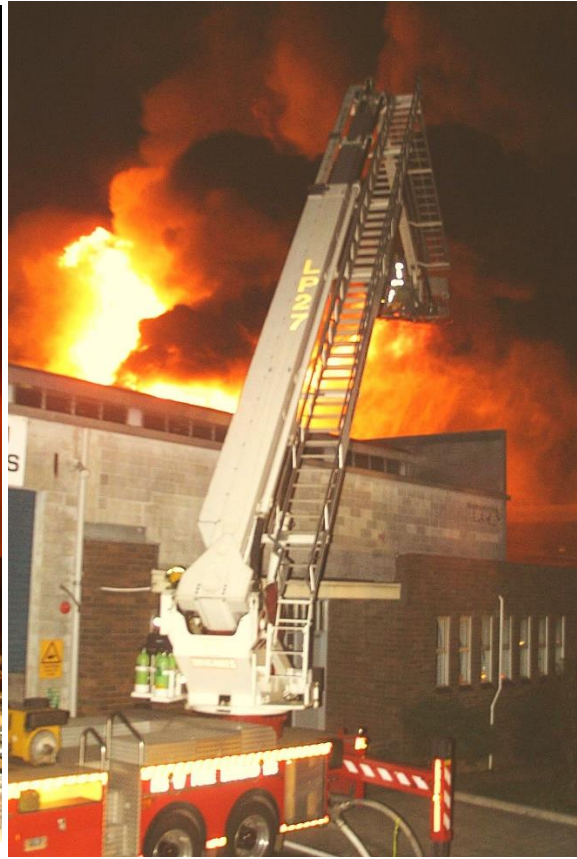
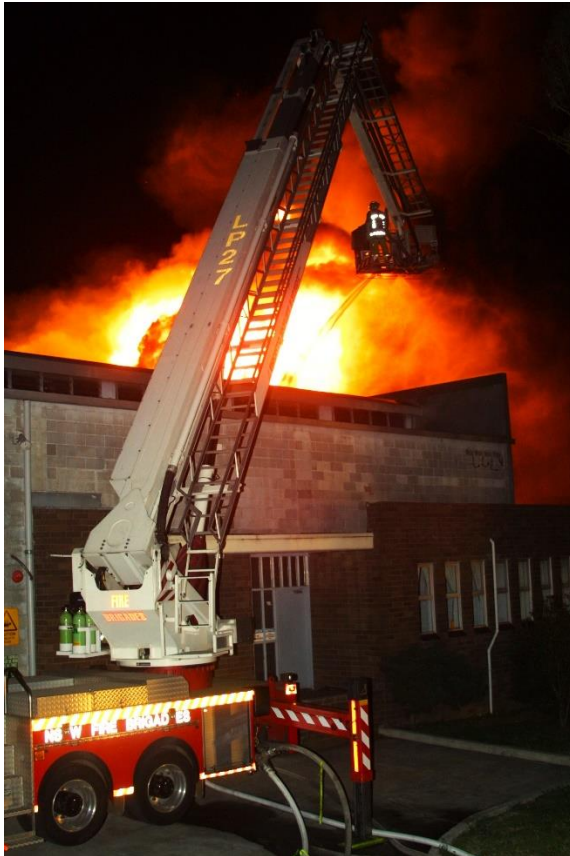
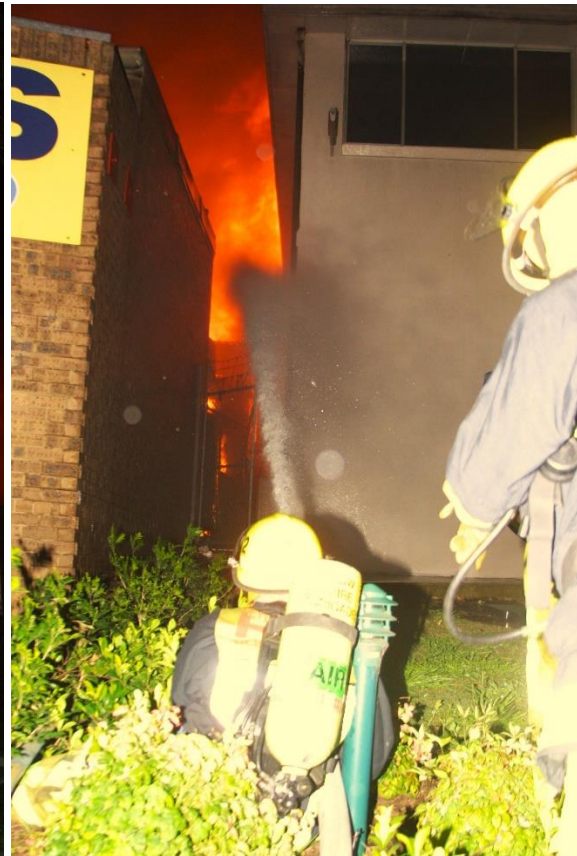
Fierce flames erupt from the fully involved factory. Fire activity was ferocious. Top left: a ground monitor in operations. Top right and lower left: Ladder Platform 27 attacks the fire and protects heavily threatened Exposure B. Lower right: Firefighters direct a protection stream between the burning pallet stack and heavily threatened Exposure D.

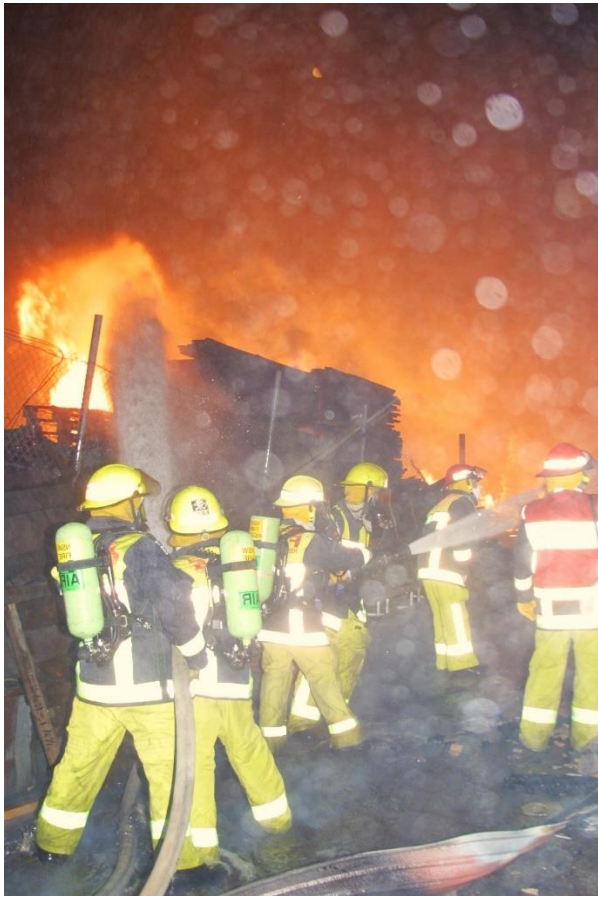
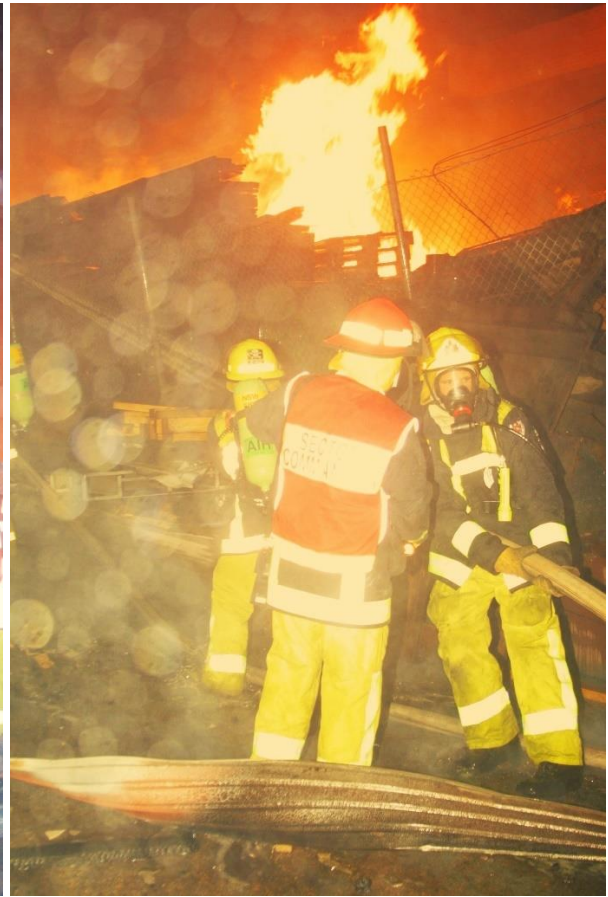
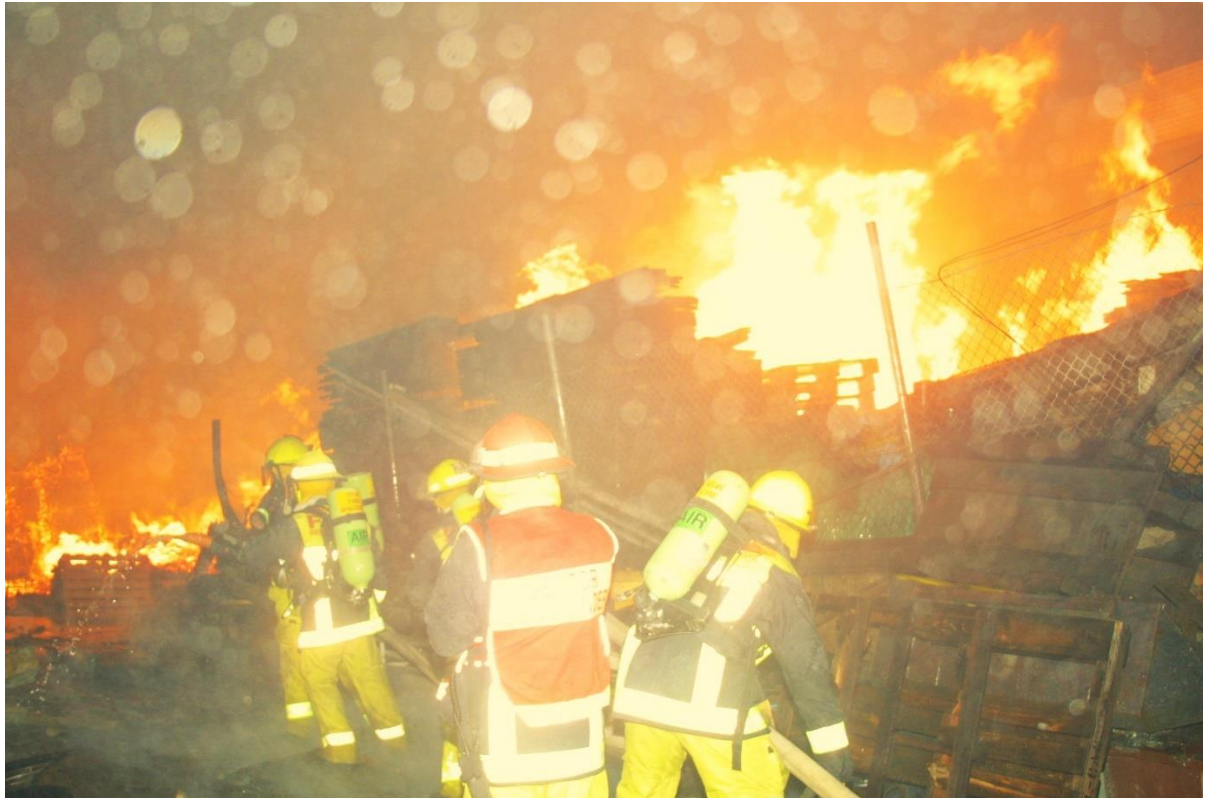
Firefighters begin to push in towards the fire with 70 mm attack lines. Working from the driveway of the factory, firefighters are fighting fire on all sides, involving the fully involved factory, timber stacks and the large pallet stack. Heat from the fire was extreme. All crews are wearing SCBA.

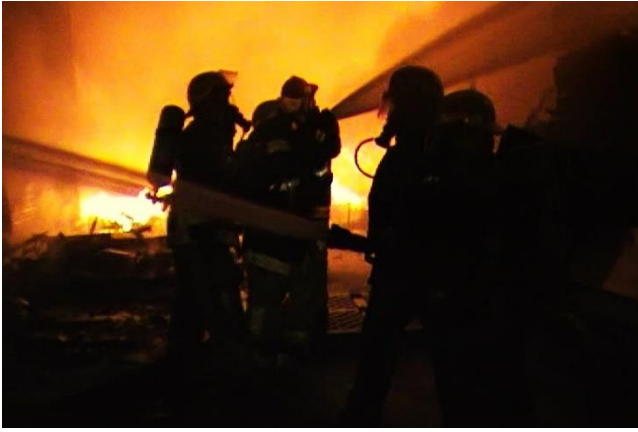
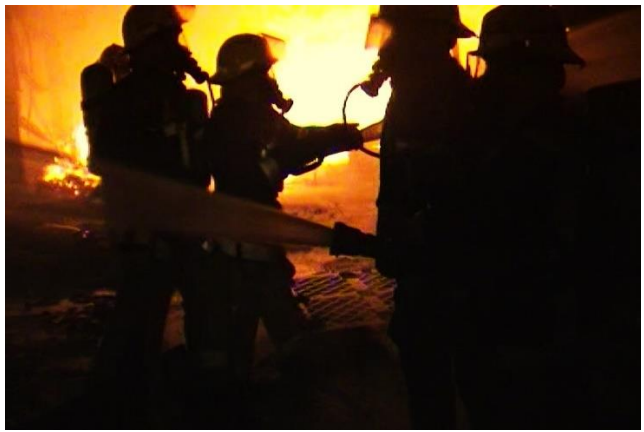
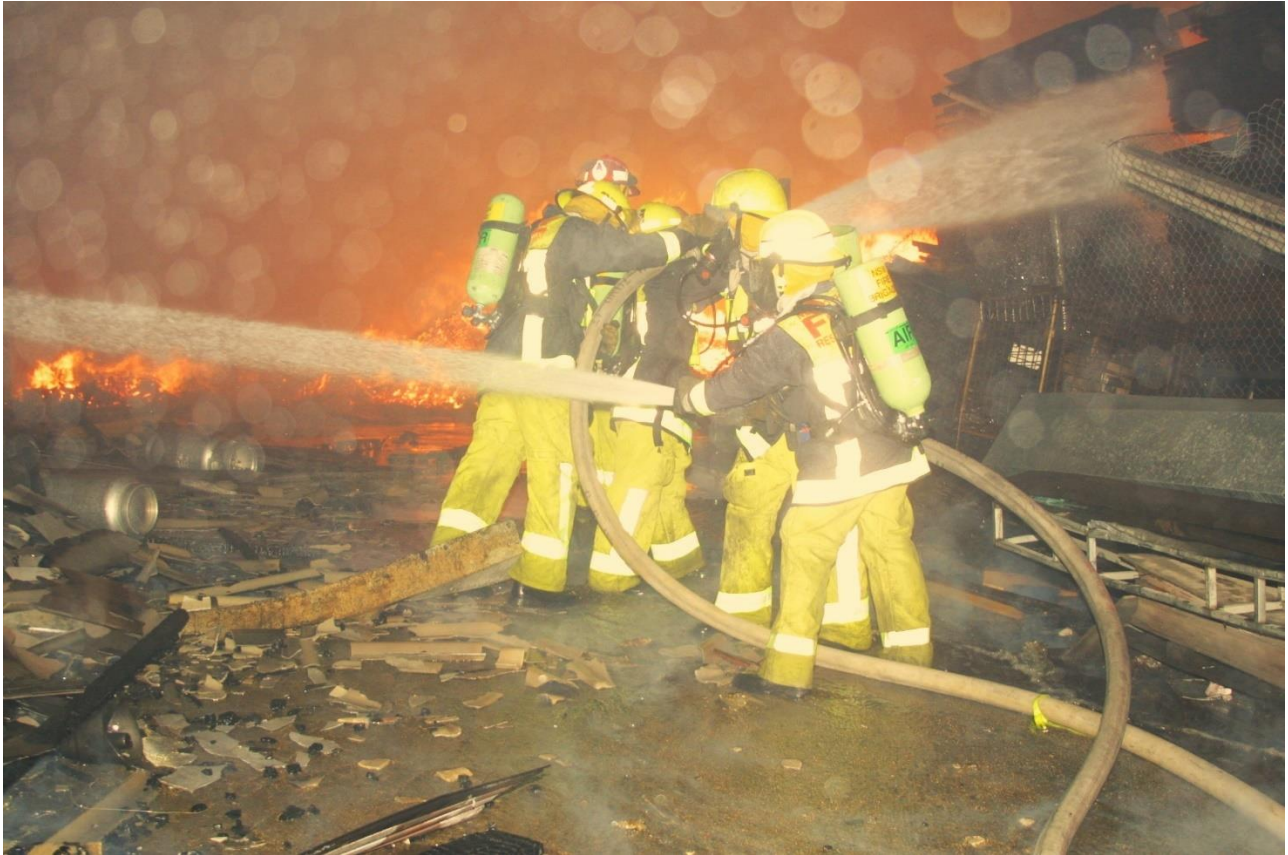
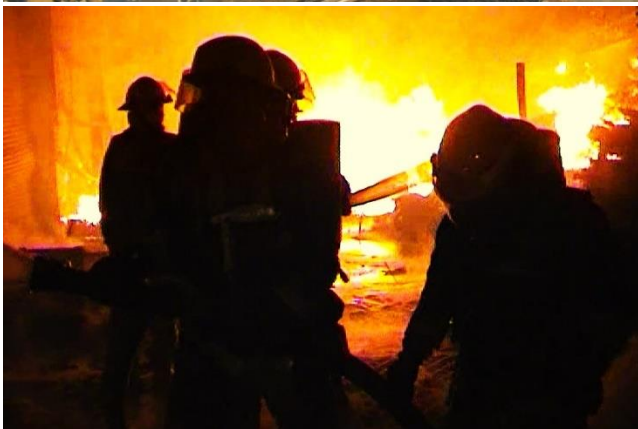
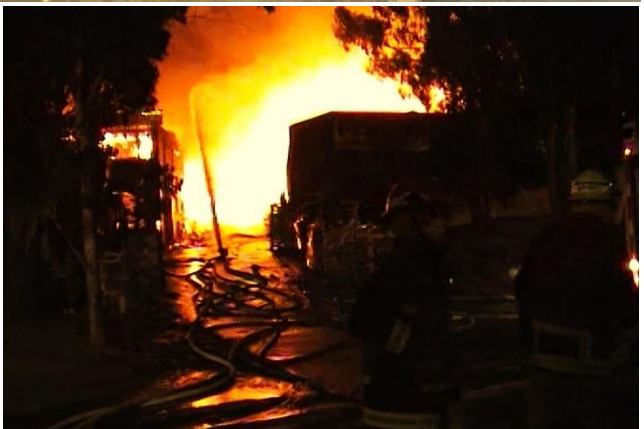
Firefighters begin to push in towards the fire with 70 mm attack lines. Working from the driveway of the factory, firefighters are fighting fire on all sides, involving the fully involved factory, timber stacks and the large pallet stack. Heat from the fire was extreme. All crews are wearing SCBA.

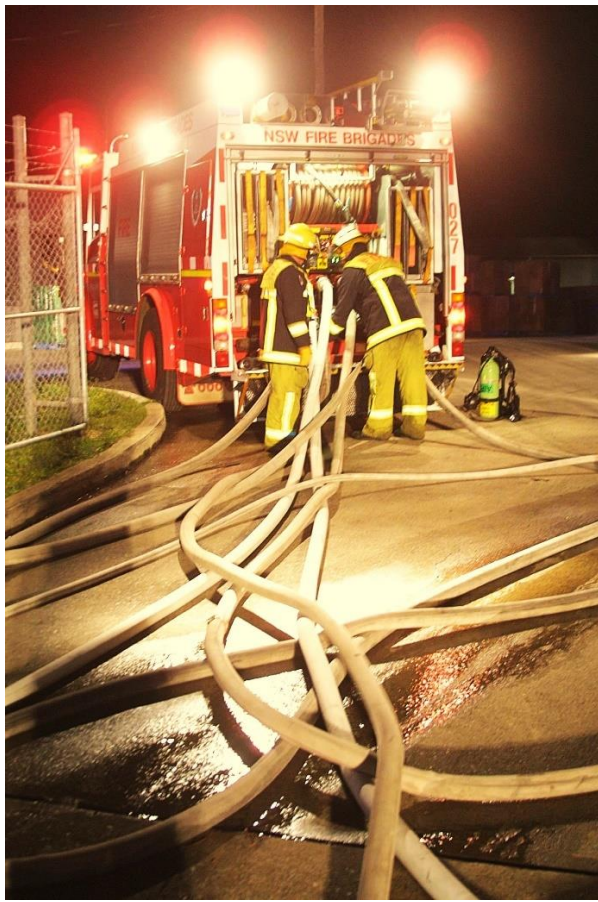
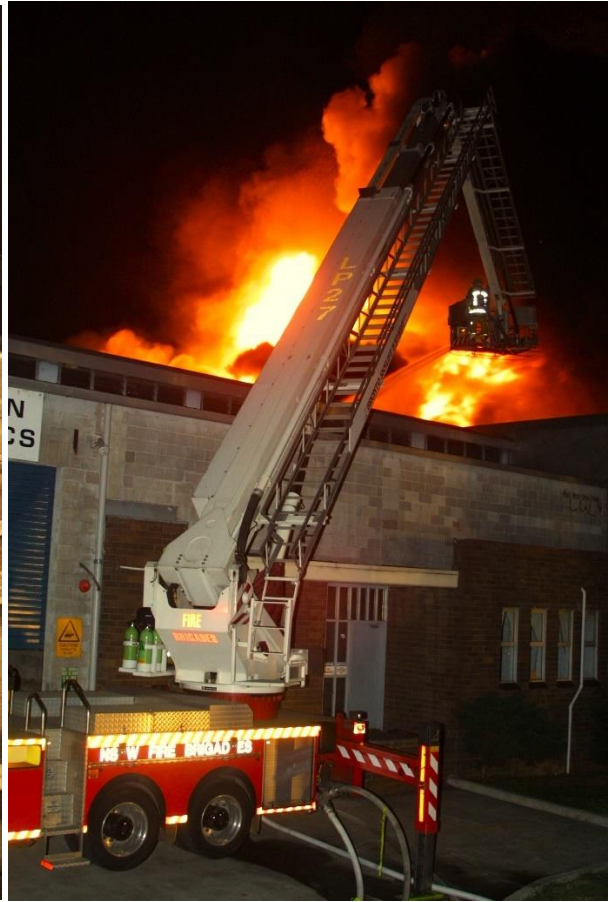
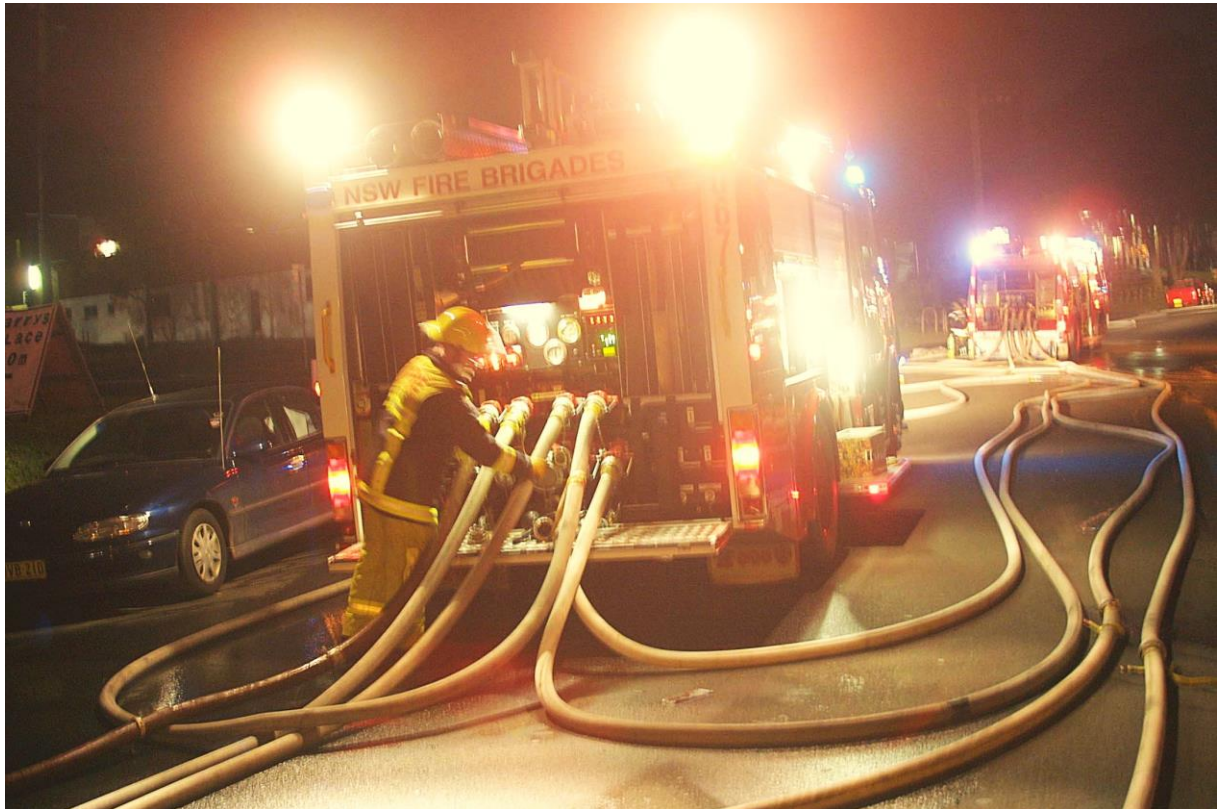
Establishment of an effective water supply was absolutely critical to containing the fire and achieving fire control. Firefighters established multiple water relays. Top: Pumper 27 supplies water to Ladder Platform 27. Lower: Pumpers 67 and 57 relay water to the fireground. Successful relay pumping is a critical requirement at major structure fires. Firefighting can only be effective if there are adequate water supplies.
