## **MW1 C STATION TRAINING AND INCIDENT CASE STUDIES**

**FILE NO. 2024 /07.**

**LEARNING FROM THE PAST: 14 PUMPERS  
AND 2 AERIALS CALLED TO SMITHFIELD  
PALLET FACTORY FIRE**

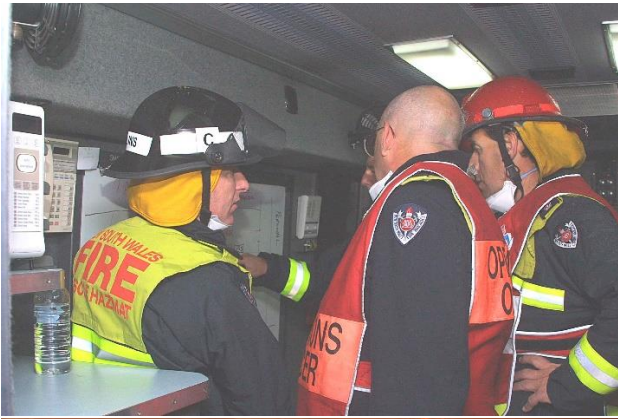
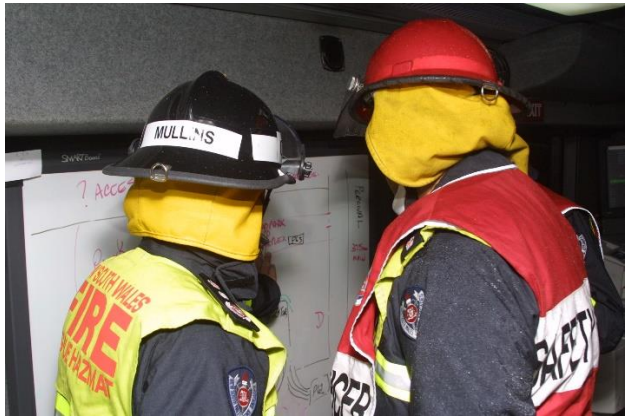
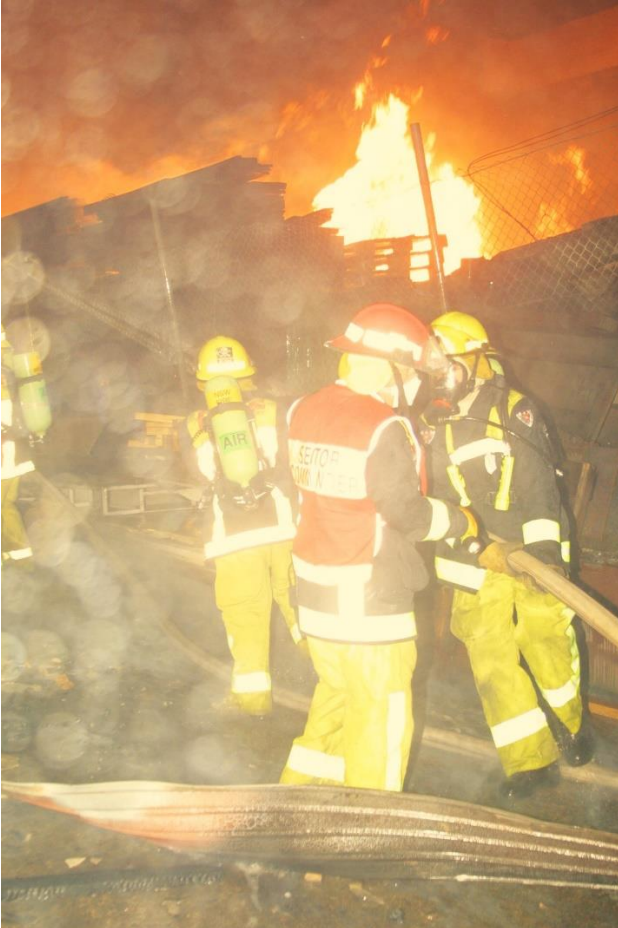
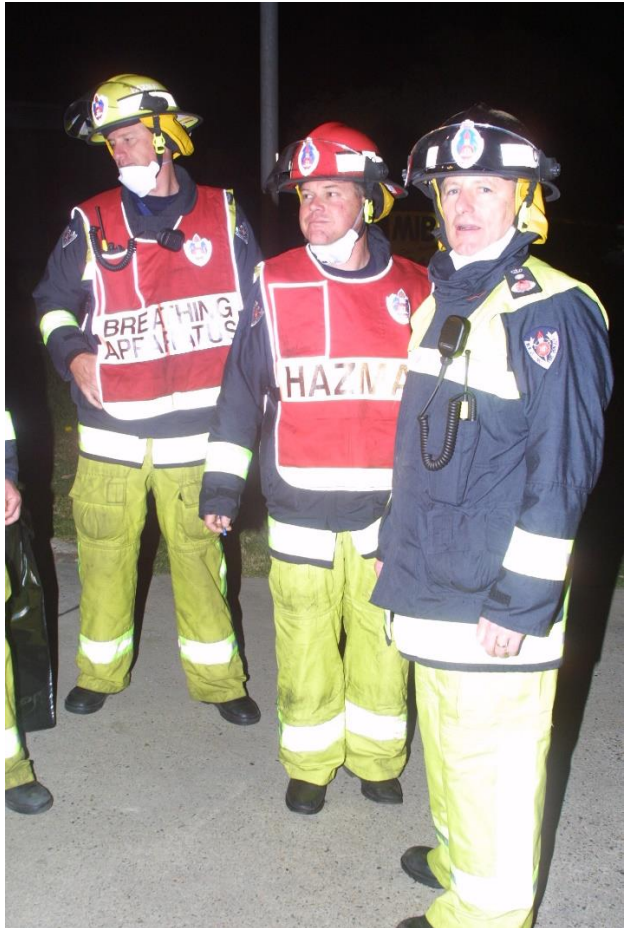
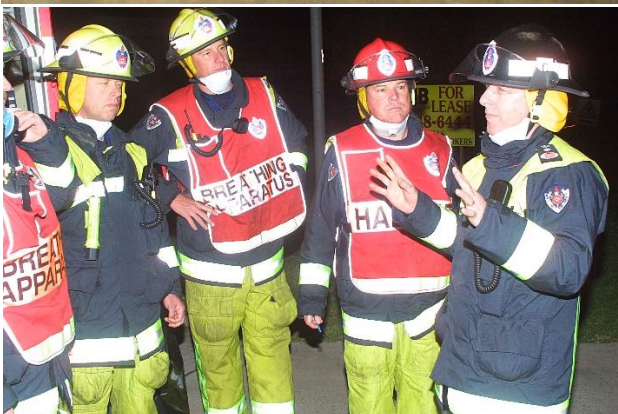
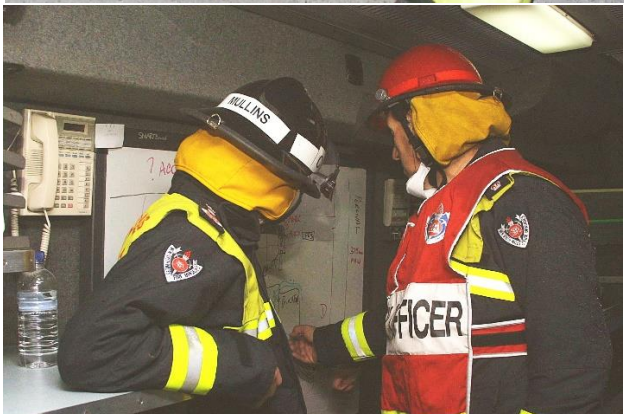
Commissioner Greg Mullins visits the fireground. The Commissioner receives a briefing from the Incident Controller and Safety Officer aboard the Incident Control Vehicle and talks to crews at the fireground. Firefighters pull attack lines deeper into the factory yard (Middle left).

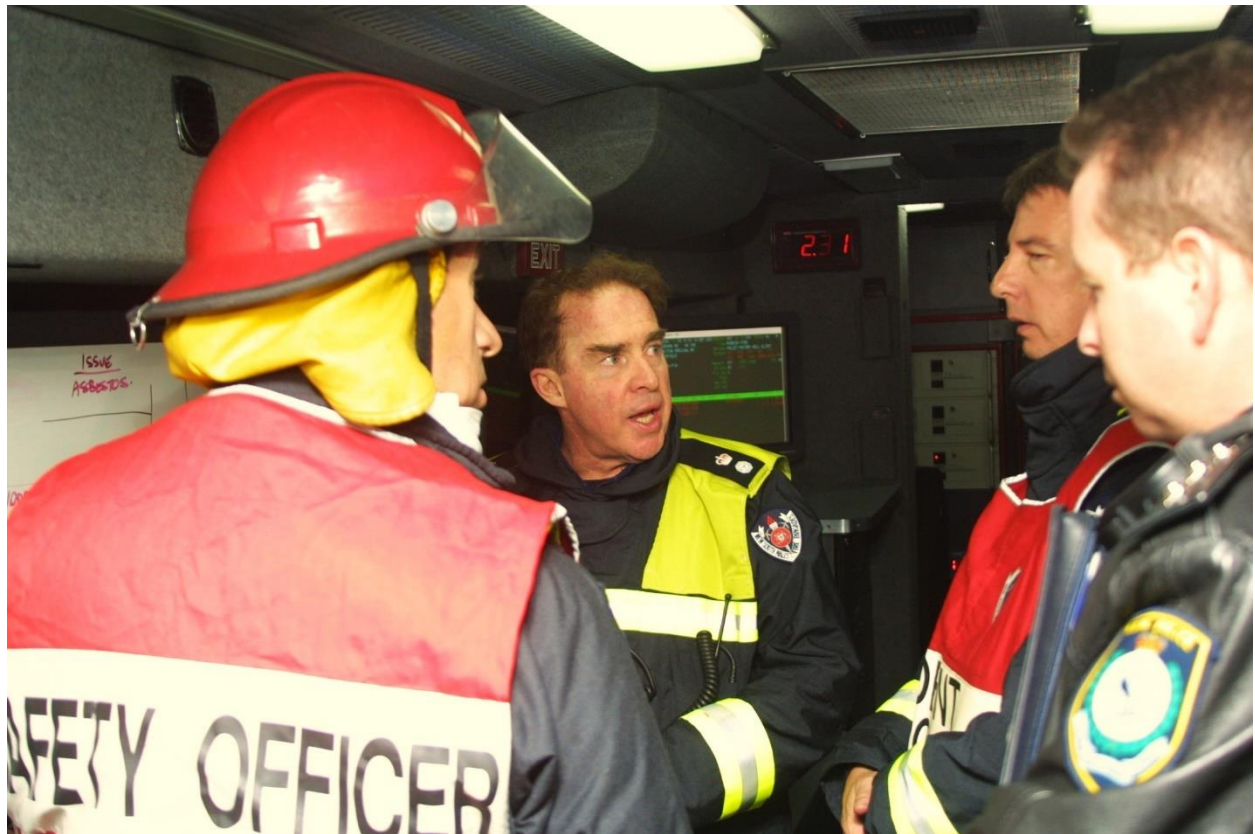
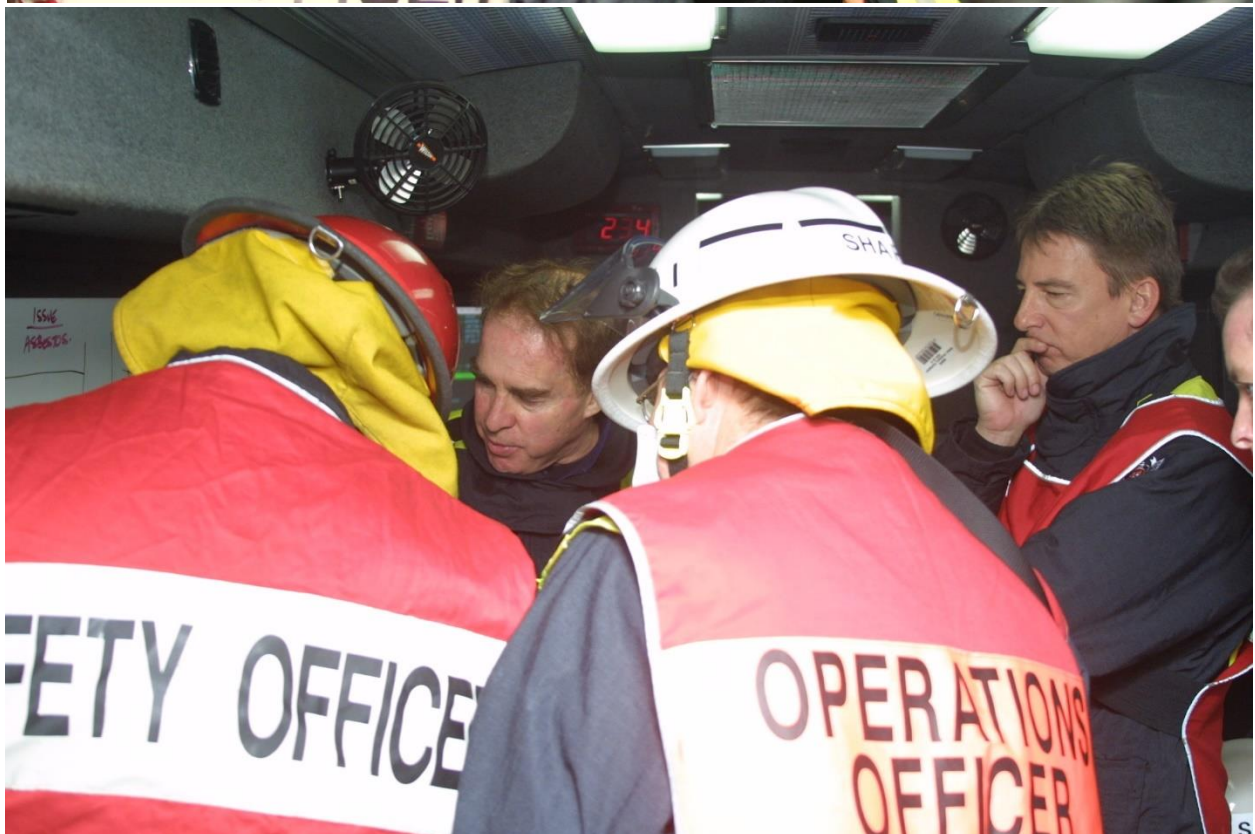
Fireground Command: Inside the Incident Control Vehicle fireground commanders, including Inspector Steve Lyons (Safety Officer), Superintendent Andy McLeod (Operations Officer), Inspector Peter Shapter (Divisional Commander) and Assistant Commissioner Murray Kear (Incident Controller). The Police Duty Officer was also present as determinations are made concerning the size of the evacuation area.
